“Dried Material” in the 241-AY-102 Annulus

Michelle Hendrickson, CHMM, PE
Clean-up Section Engineer
Nuclear Waste Program
WA Department of Ecology
September 19, 2012 Groundwater Team Meeting

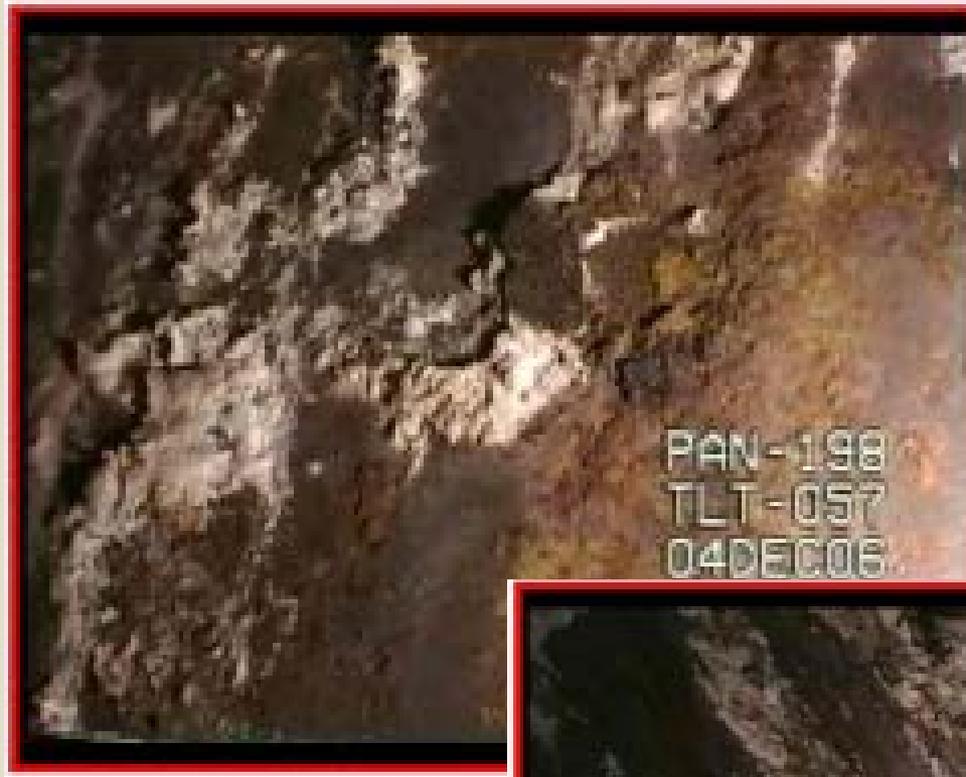
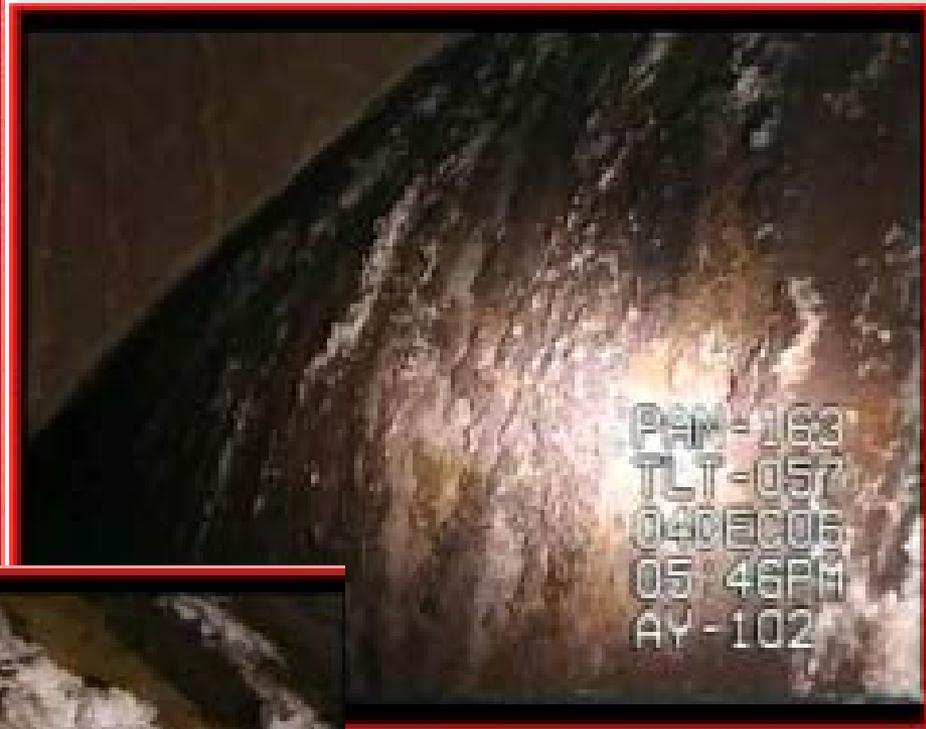
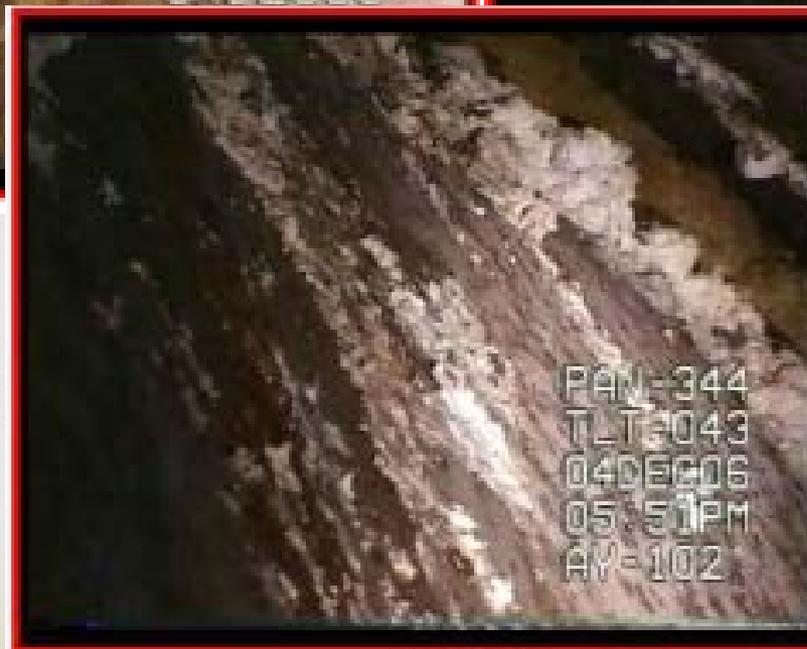
Crystals in Haunch
