324 Building

Characterization

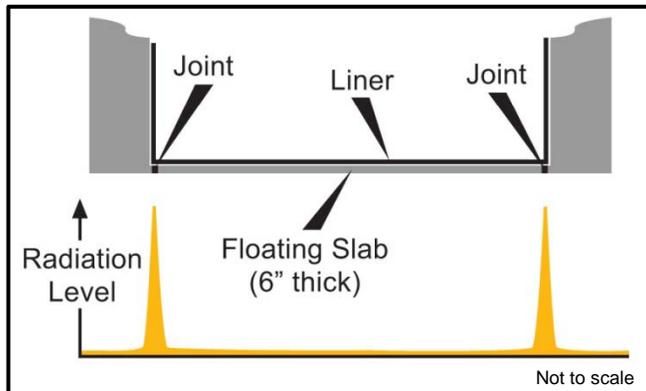
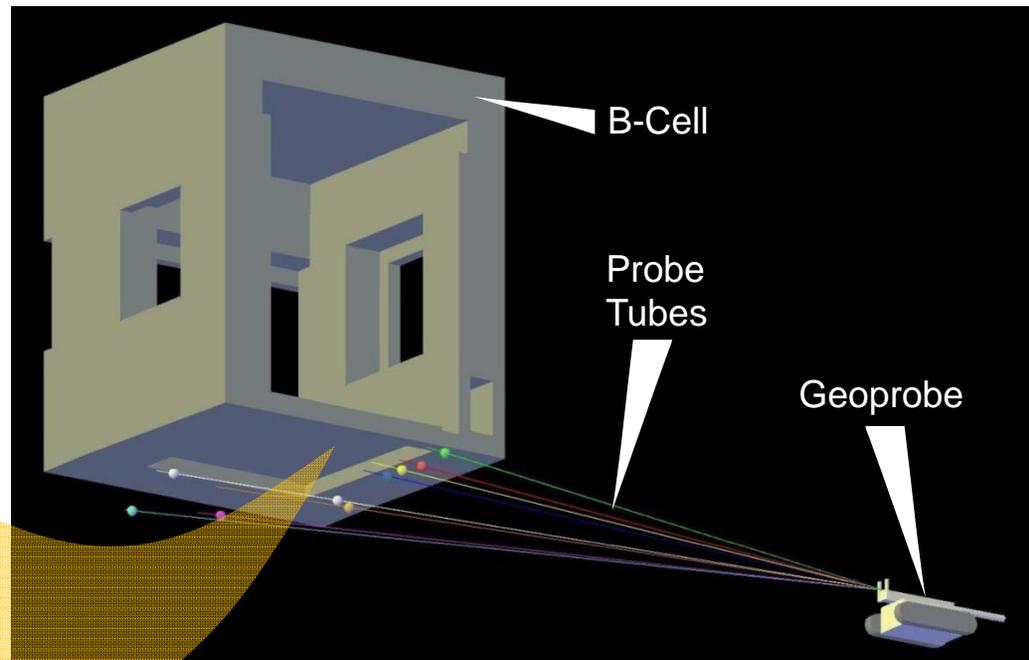
Closed-end tubes were pushed approximately 60 feet under 324. Radiological instruments discovered the presence of contaminated material below B-Cell. Readings peaked at 8,900 R/hour directly below concrete joints in the slab floor of B-Cell.
