Five-Year Surveillance Report for the 105-C, 105-D, 105-H, 105-F and 105-N/109-N Safe Storage Enclosures

Document Type: RPT

D. G. Ranade
Mission Support Alliance

Date Published
March 2016

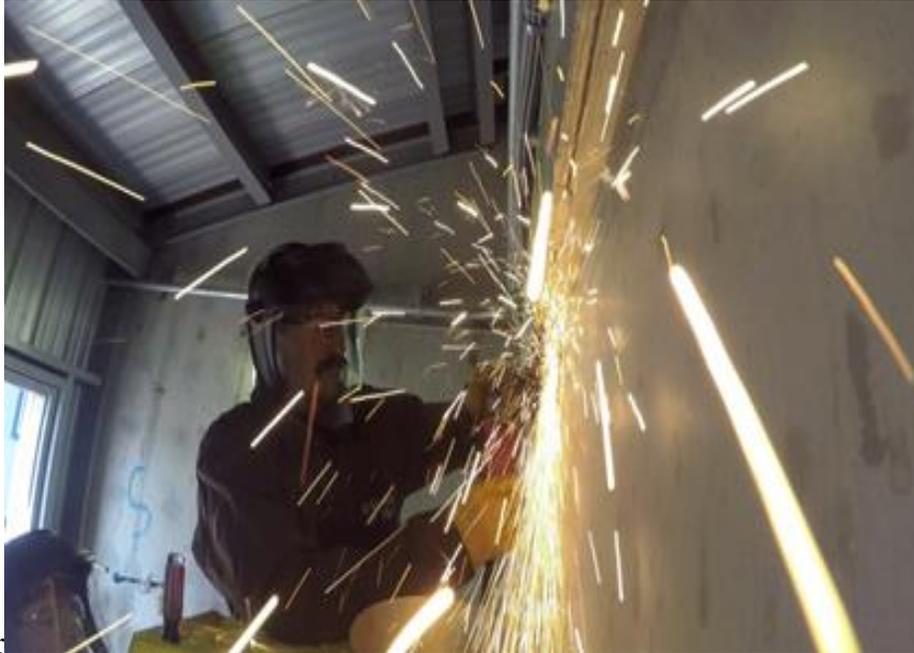
The interior doors were opened by grinding off the welded plate that secured each interior door, as shown in Figure 1. The air inside the SSE was sampled by placing large-volume air samplers in the threshold of the SSE to ensure safe radiological conditions. The SSEs were then allowed to “breathe” for several days using natural ventilation to reduce the potential for radon buildup. No forced-air ventilation was required, consistent with previous surveillances. The outer door of the vestibule was kept locked during this period.

Figure 1. The Carpenter Grinding the Welded Plate.

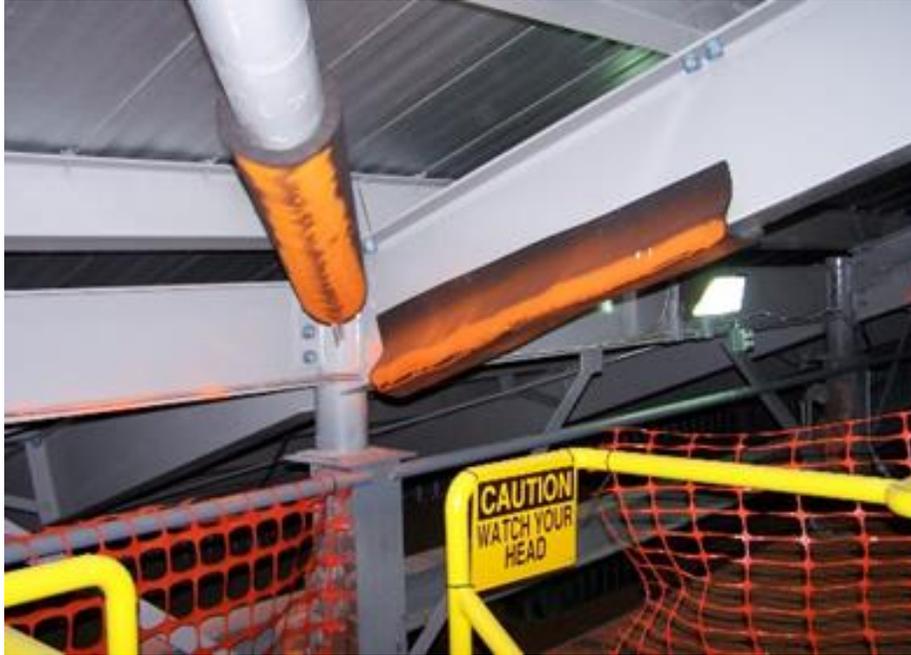
Barriers and postings such as those shown in Figure 3 are used to prevent unwarranted access to hazardous areas within the facility and to inform personnel of potentially hazardous conditions that exist in the SSE.

Figure 3. Barrier and Posting at 105-D SSE.

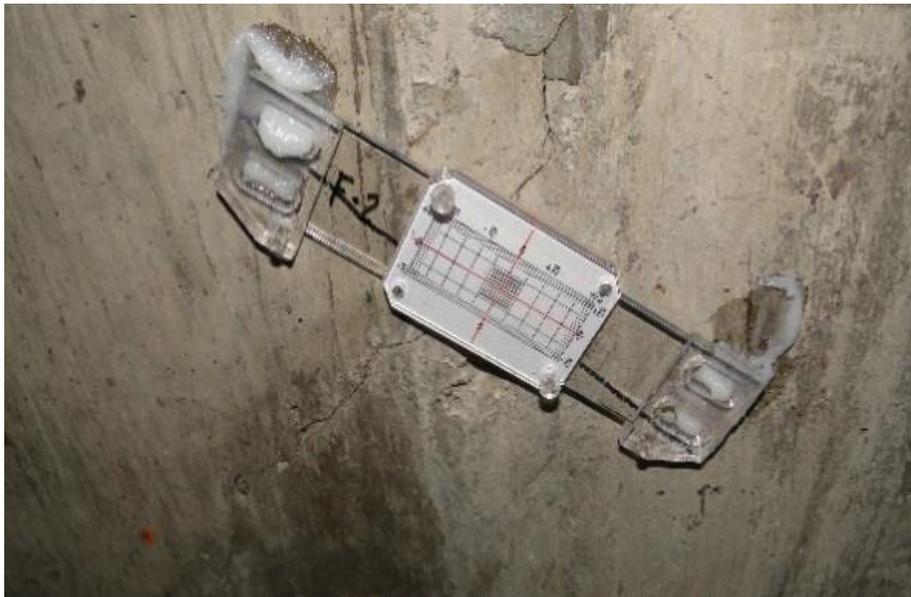
Vertical cracks in the original concrete wall near and inside the vestibule were noted in the 105-F and 105-D SSEs. A crack monitor, shown in Figure 5, was installed in each of these SSEs to monitor any potential displacement along the cracks with time. It is interesting to note that similar cracks were observed in the 105-B Reactor building, which has construction very similar to the 105-F and 105-D SSEs. Bat guano and/or spider webs were present in all the SSEs. Live and dead bats were observed in some SSEs and evaluated by the IH for health and safety purposes. The inside conditions were dry in all of the SSEs and little or no evidence of water intrusion was noted. No evidence of groundwater intrusion was noted in any of the basement floors.

Figure 5. Crack Monitor Installed at 105-F.

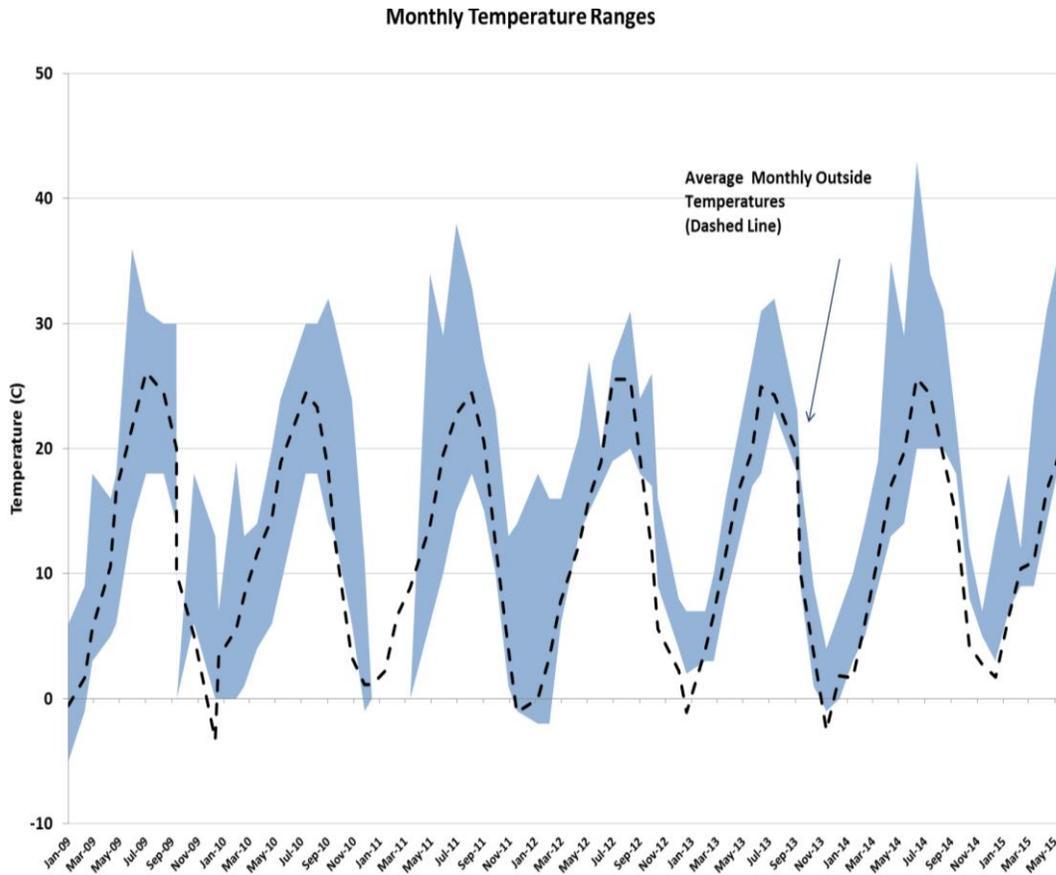
The temperature and flood-level sensors were operating within the acceptable ranges. A problem was observed with one backup temperature sensor reading in the 105-D SSE. It is not known whether the backup sensor is malfunctioning or the switch is malfunctioning. Data collected

since 2009 are presented in Figure 6. These data show that monthly maximum and minimum temperatures inside the SSE structures track with average outside temperatures. Additionally, none of the SSEs show evidence of surface water or groundwater flooding (alarm conditions) (Figure 7). Continued monthly monitoring of these systems may not provide any additional value.

Figure 6. Monthly Temperature Readings and Average outside Temperature.

4. Work with the Tri-Party agencies to discontinue the temperature and flood-level sensor monitoring. The data set to date clearly demonstrates that no upset conditions

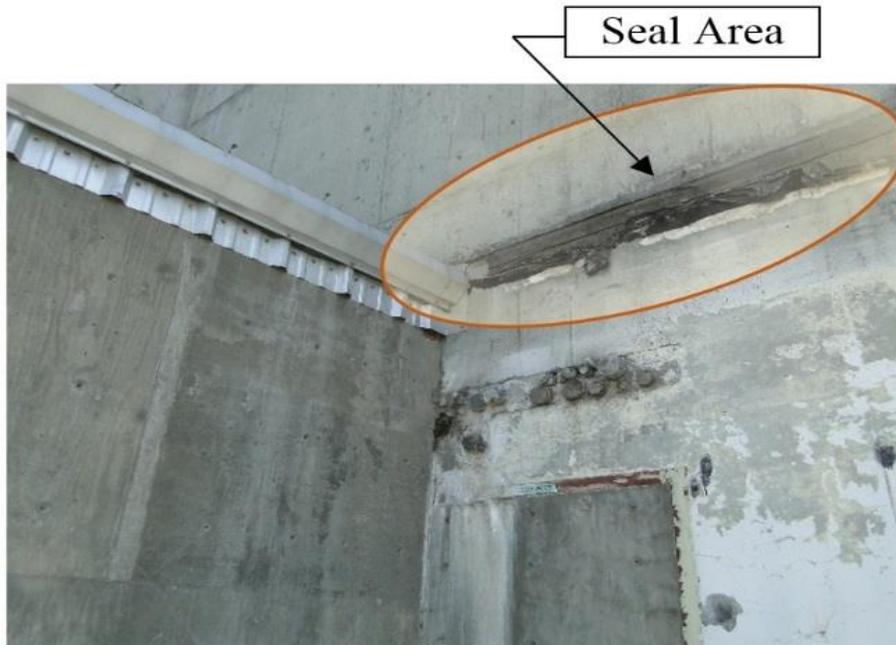
2. There is evidence of very slow water in-leakage at a pourback/roof structure junction at grade level; the leak is so slow as to only form white deposits, as shown in Figure 8.

Figure 8. The Area to be Sealed at the 105-C SSE.

The proposed action is to seal the outside area (Figure 8) where the in-leak may be occurring.

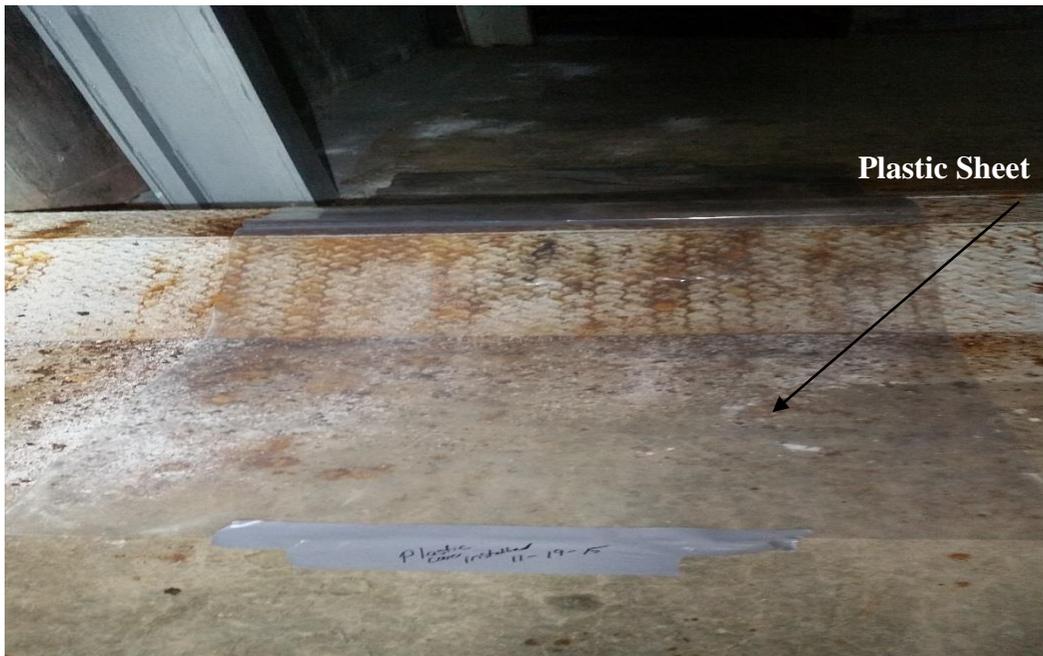
Figure 9. Plastic Sheeting on Floor under Corrosion Area in 105-N (60-foot level).

The floor area under the ceiling was covered with a clean sheet of plastic (Figure 9). Monitor the plastic sheet for accumulation of rust falling from the ceiling to evaluate potential corrosion rates.

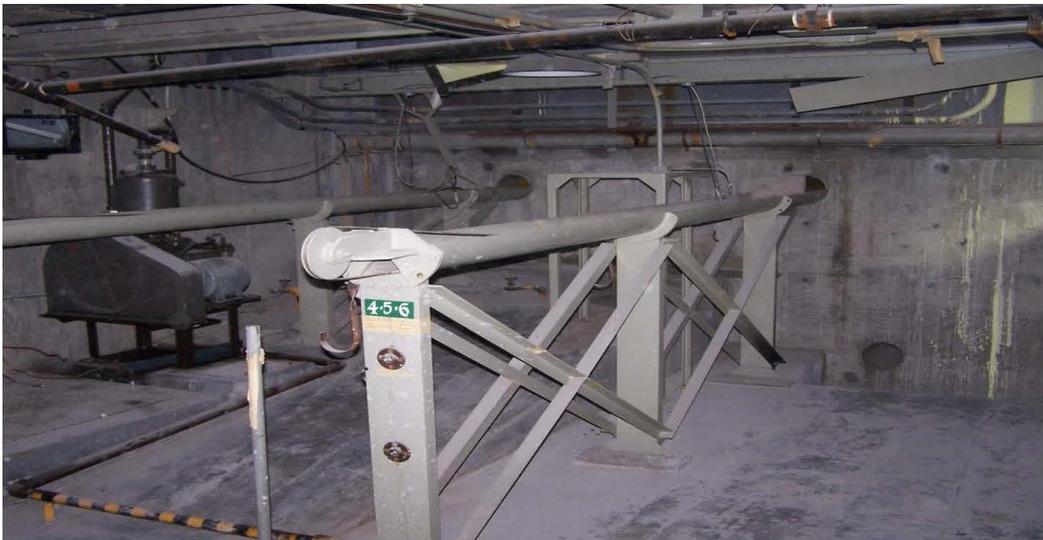
Photo 2- Rear face, only reactor that route leads to this, lots of left over items that are potentially hazardous.

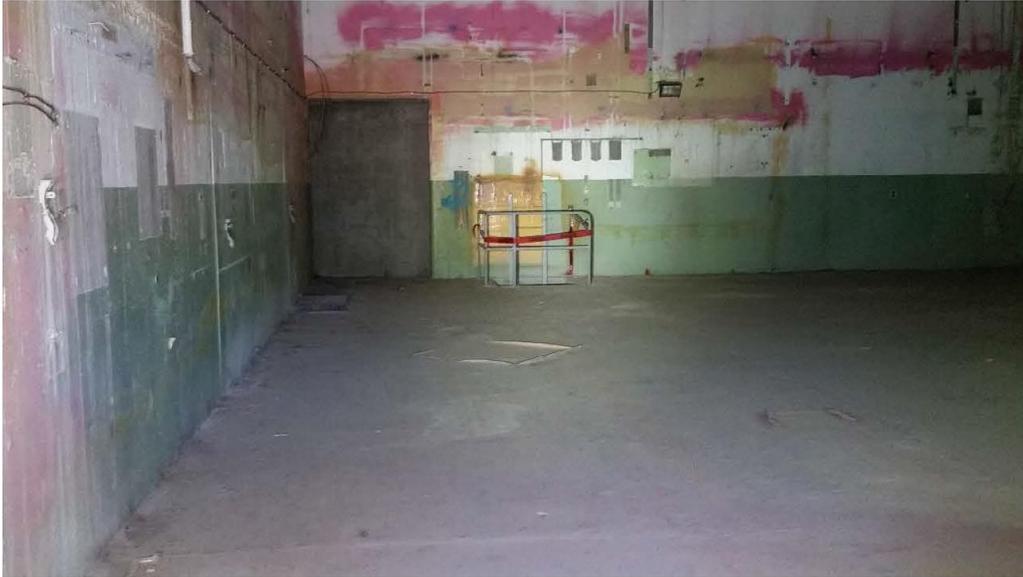
Figure 1 Looking at guard rails around floor hole from 105 C door.

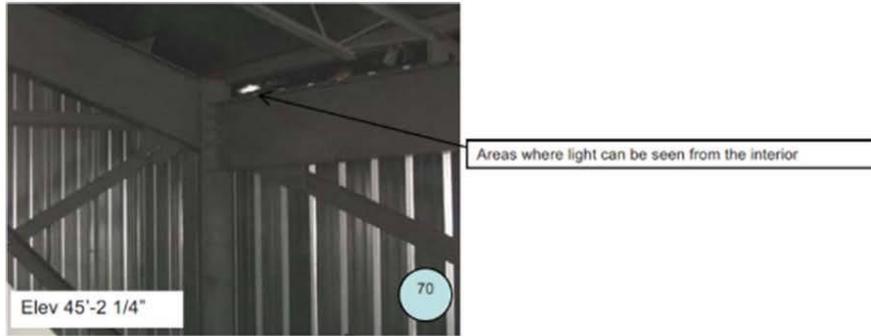
Item 70 – 2008 Detail SS Details, Soffit area between wall and roof, Elev. 45'-2 1/4", visible light thru gaps,

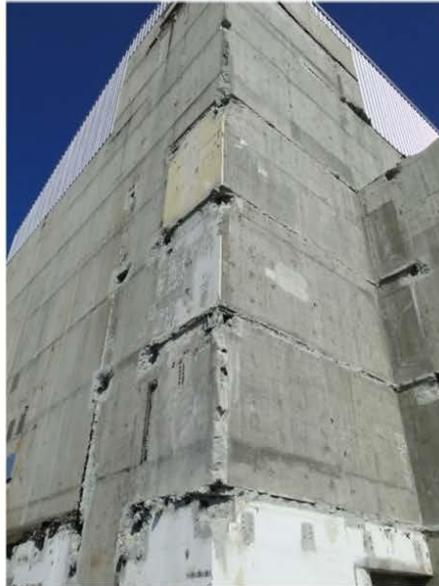
Item #4 2008 Detail Exposed aggregate and rebar at SW corner of building exterior- spalling

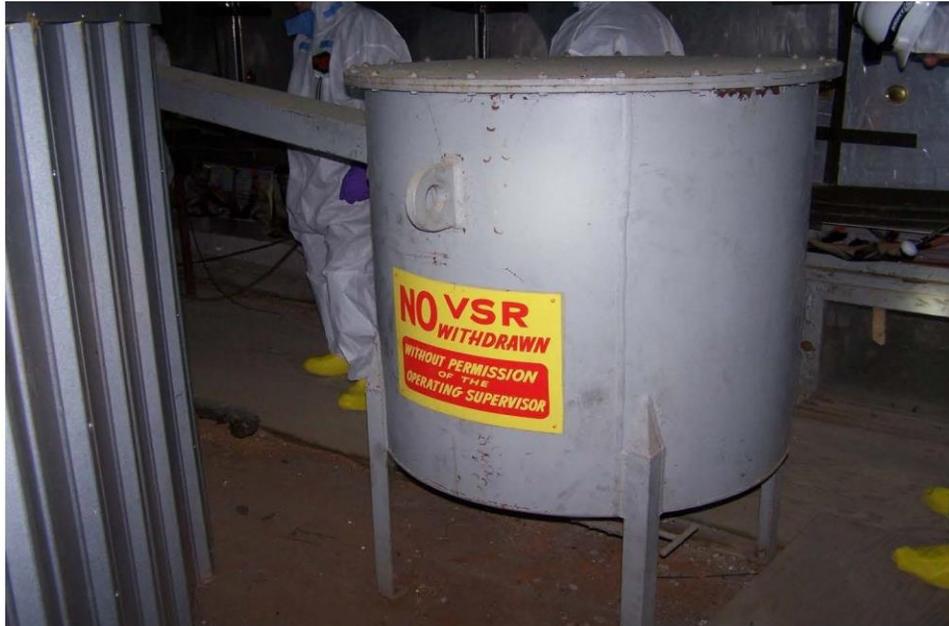
Photo 9 (Struck by hazard is actually on the back side of this tank, painted orange)

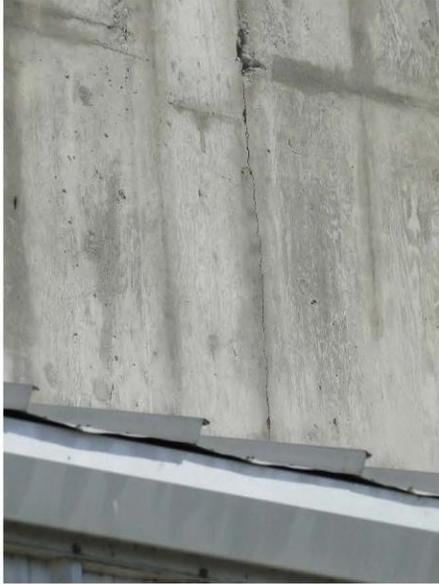
3676 Wall crack on exterior wall above vestibule

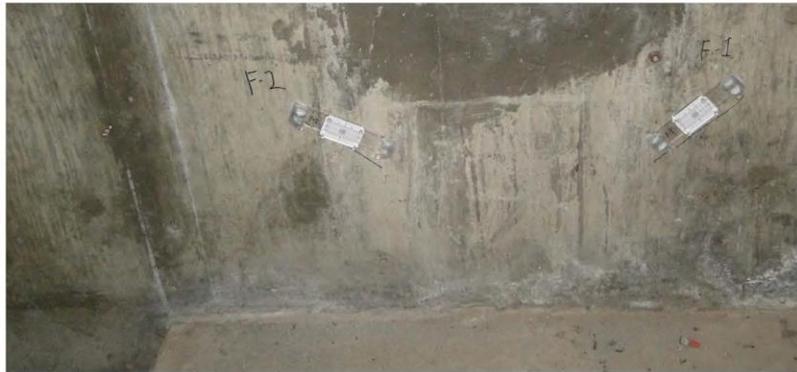
May 2015 update - Similar infills and cracks have been identified at both 105-D and 105-B (i.e., all of the original construction (1943) reactor buildings), along and below this infill. This confirms that this is not a demolition related or SSE construction issue.

Figure 1 – Crack Locations at top of stairs (after affixing Crack Monitors on 10/23/14)

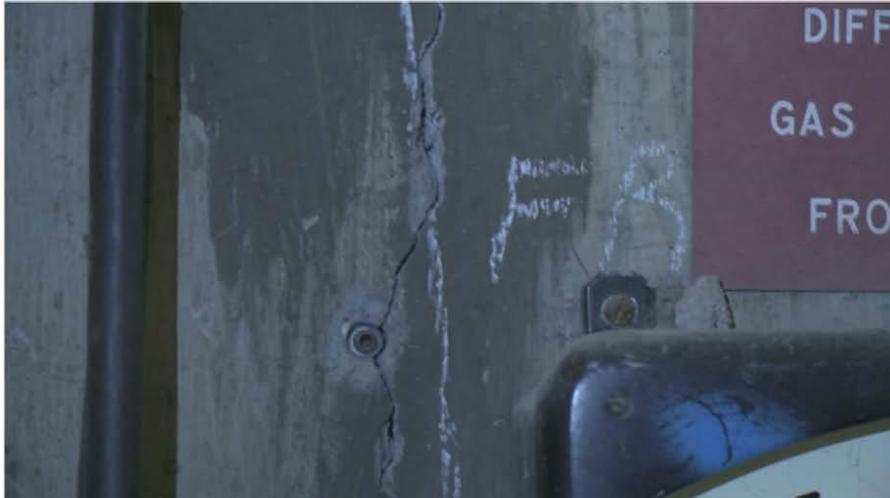
2981 Crack about 5 ft off floor

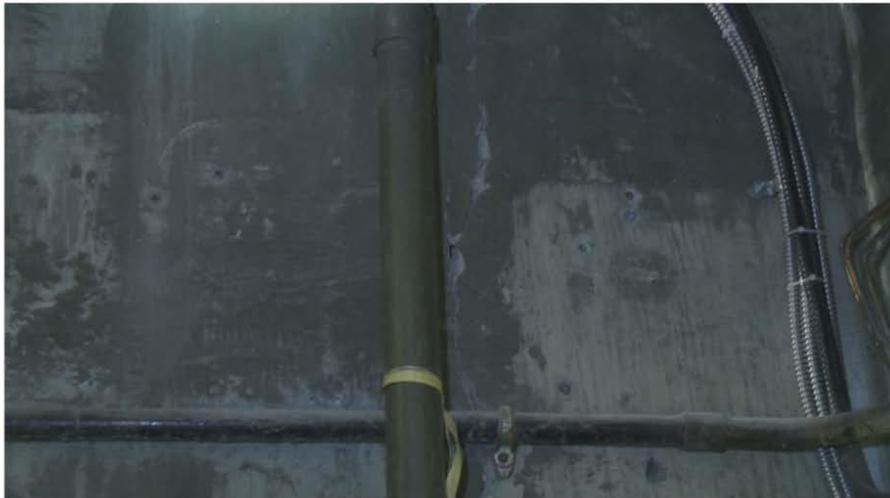
2982 Crack about 8 ft off floor

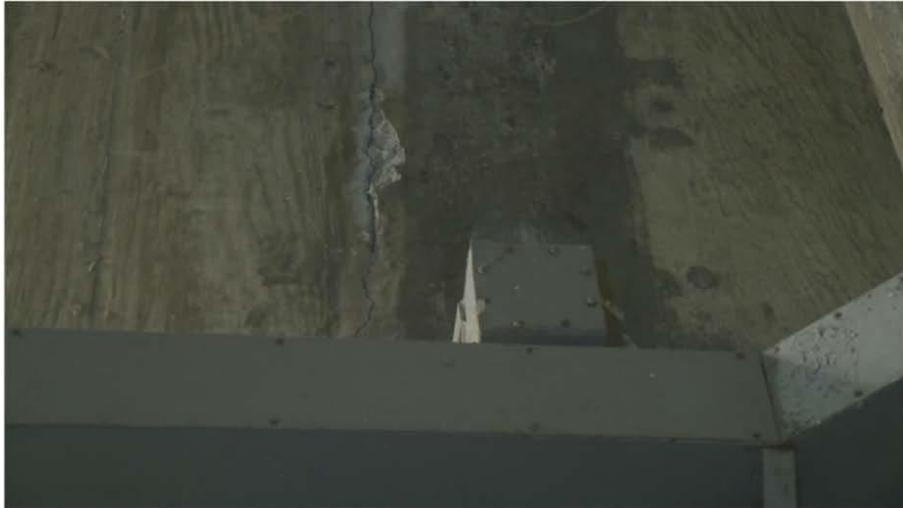
2014 Photo # 2984 Crack about 12 ft off floor

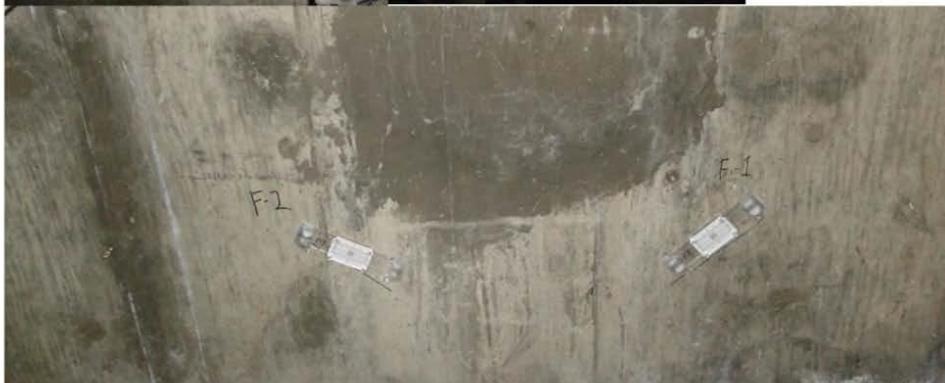
2014 Photos # 3124, 3125, 3119 As installed Crack Monitors at interior bottom corners of the infill

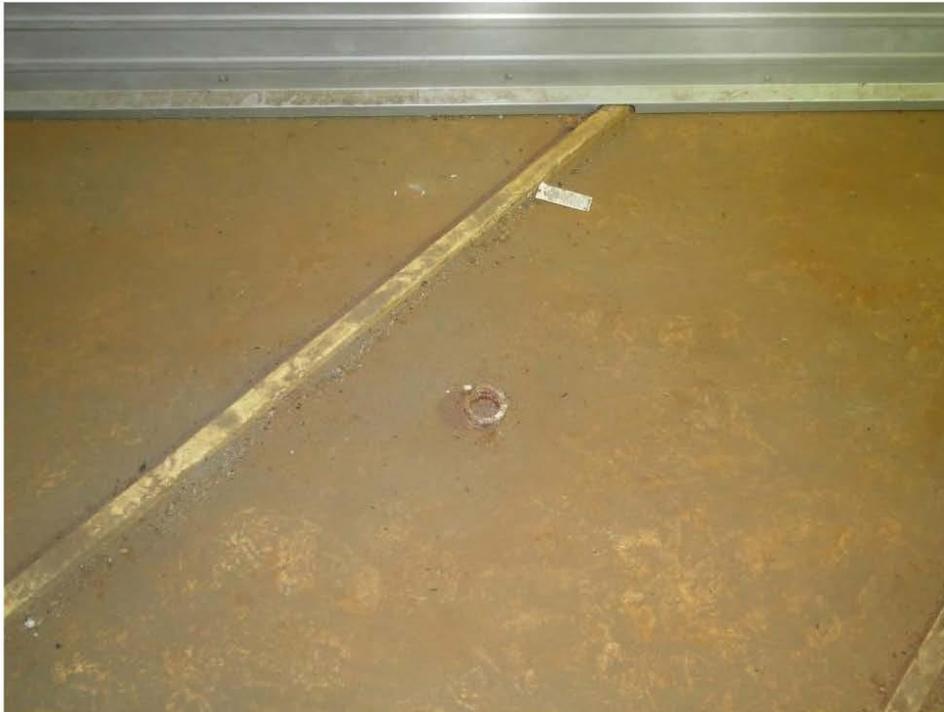
NEW ITEM 25A

3049 25A Contamination spot on SW corner next to top hat on floor
