Project Hanford Lessons Learned

Title: Failure to Take Appropriate Actions Leads to Electrical Shock

Date: October 10, 2005

Identifier: 2005-RL-HNF-0037

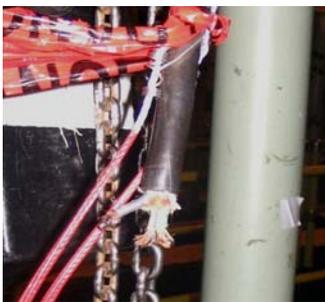
Figure 1

On June 24, 2005, a work crew entered 105 KE Basin to perform debris removal activities. A hoist with a long reach was required for the job. The only suitable hoist available for the job was the hoist identified on June 21, 2005, with the gloved plug. The SOM was again contacted by the operator regarding the surgeon's glove over the plug. At the direction of Shift Operations personnel, the glove was removed and the cord was surveyed and no contamination was found. Then the plug was inspected by an operator who saw no apparent damage to the plug or cord. The operator then plugged the hoist into a nearby receptacle, but the hoist failed to operate. Believing that the receptacle was inoperable, the operator decided to use a receptacle that was labeled "CAMS ONLY". At the moment that the plug was being inserted into the receptacle a spark was observed and the cord separated (Figure 1) from the plug (Figures 2 & 3), with the plug remaining in the receptacle.

Stress placed on the cord/plug interface during normal hoist operation likely caused the cord to pull out from the plug as the power cords are commonly stretched to full extension. The plugs are shop stock standard and the cord restraint clamping mechanism is smooth and not robust enough to handle the size/weight of the 30 foot long by ~5/8 inch diameter hoist power cord. The above conditions, combined with the failure to routinely perform electrical inspections of these power cords, plugs, and cord grips, contributed to the failure of the plug.

Hoist power cords should be inspected and the cord plug interfaces verified to be adequately secured. Cord plugs should also be inspected to determine if they are robust enough for the cord weight and replaced plugs when necessary.

Examine power cords to determine if cord grip or other strain relief devices should be used to prevent damage and install the appropriate devices where necessary. Proceduralize the mandatory use of cord grip devices where necessary.

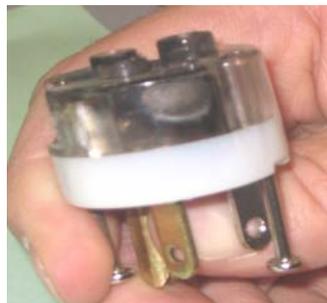
Figure 2

Inspection of the plug cap indicated that the internal strain-relief in the cap was not snug around the cord. The short inside the plug at the cord interface occurred because the cord pulled loose from the plug. This caused the wires to come in contact with each other as they were plugged into an energized electrical receptacle, resulting in a short circuit.
