Good Work Practice

Title: Work Near 230 Kilovolt Electrical Transmission Line

Date: July 11, 2006

Identifier: 2006-RL-HNF-0027

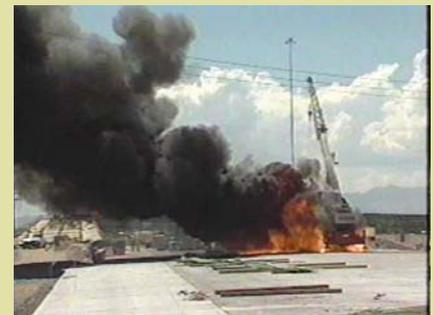
Here you see the crane in contact with the power line and on fire.

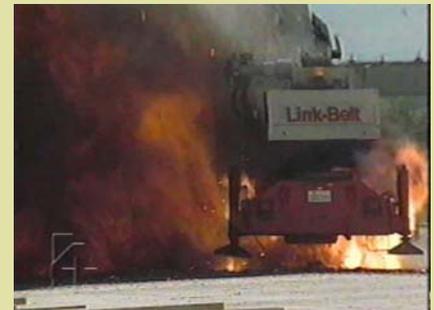
Here is a shot of the crane actually being blown into the air during a subsequent explosion.

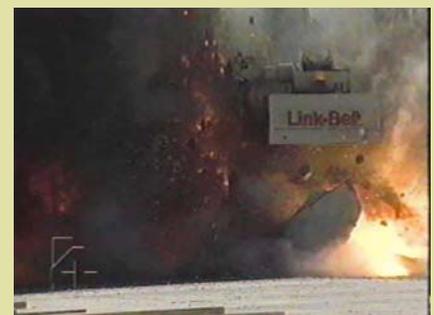
The base of the crane then arcs to the steel reinforcement bars in the concrete, actually causing the concrete below the crane to explode!
