# Caution Bulletin

**Title:** Assumptions Contribute to Arc Flash Incident at 331 Building

**Date:** August 24, 2006

**Identifier:** 2006-RL-HNF-0036

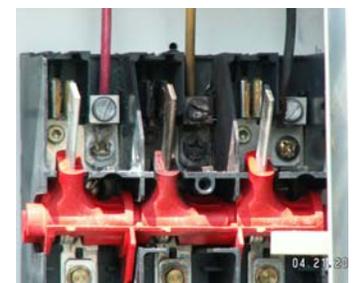
Close-up of contact point

A factory-provided arc suppressor, designed to prevent phase-to-phase arcing within the combination motor starter, was in place during the Safe-Condition and Safe-to-Work checks. The design of the arc suppressor, however, limited access and visibility of the phase lugs (the intended point of contact).

Use of the probe holder on the Fluke model T-2 meter to position the test probe could have resulted in failure of the probe to contact the phase lug. The two most likely scenarios were:

- If the probe was not positioned in the meter probe holder correctly, or if the probe shifted position (slid back) in the holder as a result of contact with other conductors during previous checks, the probe may not have reached far enough through the arc suppressor to make contact with the phase lug.
- Staff performing the checks could have mistaken contact with the arc suppressor as contact with the phase lug without any distinct indication from the Fluke model T-2 meter.

The investigation team was not able to determine conclusively which of these scenarios was responsible for the ineffective Safe-Condition and Safe-to-Work check associated with this work. They were, however, in agreement that lack of contact caused the false indication of a de-energized state of the combination motor starter supplying power to chilled water pump #2.

Electrical Safety and LOTO procedures and training should require workers to verify the electrically de-energized condition (Safe-Condition and Safe-to-Work Check) by observing the test meter probe contact with the component to be tested. Procedures should also incorporate the option, where appropriate, to allow for verification of the test meter probe contact by watching presence of electrical energy and the test meter indications falling when de-energized.
