# Information Bulletin

**Title:** Plastic Glove Box Port Covers Discovered to Crack and Fail Over Time

**Date:** August 24, 2006

**Identifier:** 2006-RL-HNF-0037

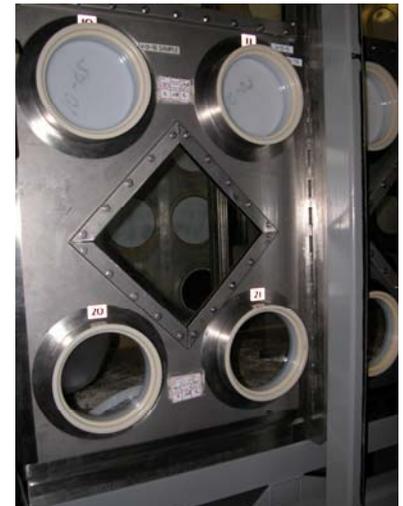
**Lessons Learned Summary:** Several Sergeant (supplier name is now Chemical Research Laboratory CRL) plastic port covers manufactured in 2003/2004 were discovered to have failed causing air in-leakage into the glove boxes on which they were installed. The material used in the manufacture of the port covers is believed to be inadequate. Port covers in use or in storage should be inspected to ensure they are able to perform to their required design specification.

**Example of Plastic Port Covers (top)**

**Recommendations:** Facilities that have installed CRL Port Covers plastic port covers manufactured in the 2003/2004 time frame should inspect covers that are in use and storage to ensure they are able to perform to their design function.
