Urgent Bulletin

Title: Improper Use of Man Lift Leads to Operator Fatality

Date: October 3, 2006

Identifier: 2006-RL-HNF-0041

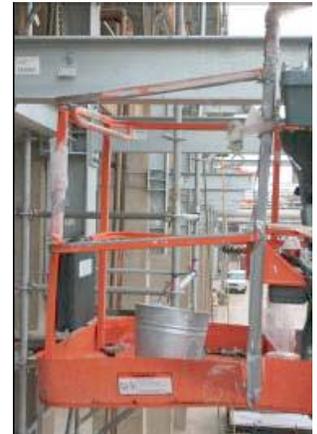
1. The equipment operator maneuvered the man lift into a location which had numerous obstacles – it was a very tight space. There were only a few inches of clearance between the basket and the upper and lower I-beams. The immediate overhead obstruction required the equipment operator to lean forward/crouch/stoop in the basket to avoid being pinned between the control panel and the I-beam.

3. The equipment operator used the man lift improperly throughout the day and applied a vertical force to the basket prior to the final incident.

The man lift (pictured in orange) had very little room to maneuver between the I-beams (pictured in grey.) Prior to the incident, the equipment operator used the man lift to apply a force on the beam.

Recommendations: BP Texas City has updated its man lift policy, hazard assessment form and a pre-use inspection record to remind workers and supervisors that the equipment needs to be in proper working order and that equipment should be used only for its intended use (i.e. ensure safety devices are functional, do not exceed load capacity, etc.)

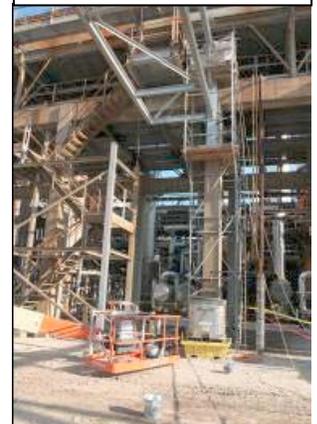
The picture shows the basket of the man lift on the ground. The equipment operator tried to maneuver the basket between the upper I-beam and the lower I-beam.
