Just-In-Time Report

Configuration of Some Waste Drums Prevents Proper Engagement of Parrot-Beak Drum Handling Devices

January 25, 2007

2007-RL-HNF-0003

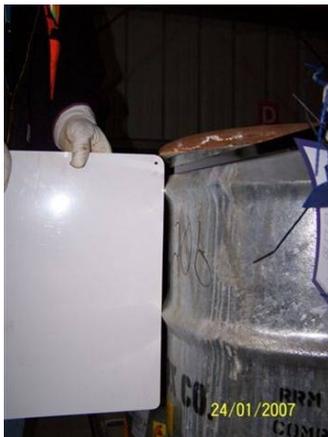
Figure 1: Normal Drum Chine

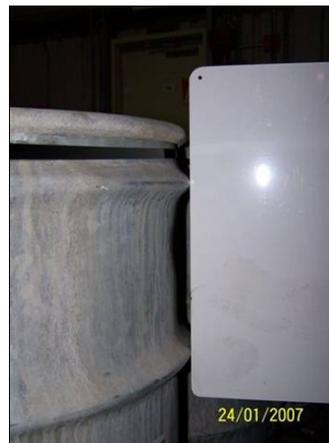
The top chine of the container protrudes $\frac{3}{4}$ to 1 inch beyond the outer diameter of the top ring (see picture).

Figure 2: $\frac{3}{4}$ -1 inch Gap Cause by Chine

Contributors: The top chine is also located approximately 1 inch higher than the height of more commonly used drums. This contributes to the interference.

Managers/Supervisors	Workers
<p>Use a straight edge long enough to span two chines to determine chine Outer Diameter relative to top ring Outer Diameter.</p> <p>Discontinue use of this type of drum handling device for drums with larger chines.</p> <p>Identify other drum handling tools which mitigate the interference from the larger chine.</p>	<p>Verify full engagement of drum handling devices prior to lifting drums</p> <p>Use of extension tools for drum survey prevented a worker injury.</p>

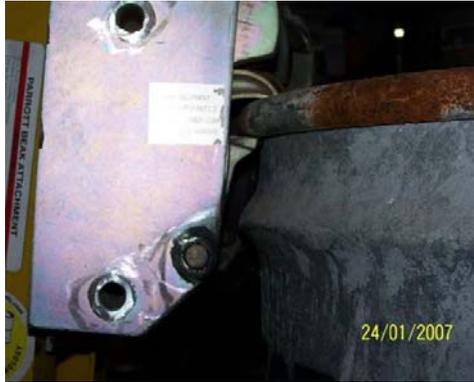
Figure 3: Full Engagement

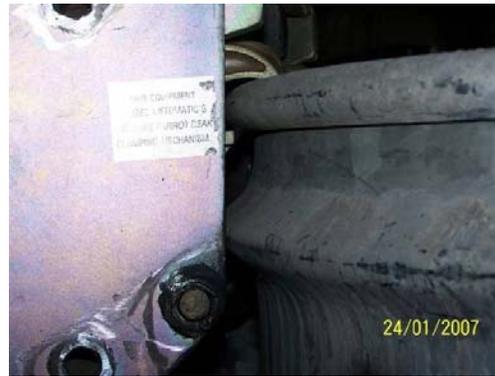
The diameter of the top chine interferes with the parrot beak drum handling device.

Figure 4: Poor Engagement due to Interference
