# Caution Bulletin

## Mobile Office Trailer Fire

March 24, 2008

2008-RL-HNF-0003

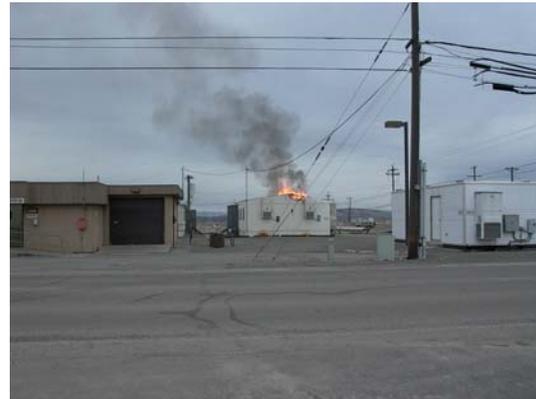
On arrival, the HFD crew witnessed fire in the double-wide office trailer and confirmed that the fire had burned through the roof on the south end. The fire was burning in rooms on the south end and had traveled throughout much of the enclosed space above the ceiling towards the north end of the structure.

The High Limit Safety Cutout device and associated wiring were inspected for damage. It was determined during the investigation that one of the two devices had failed electrically before the fire started as evidenced by a fused contact. This failure eliminated the capability of the device to deenergize two of the three HVAC unit heating elements. The failure of the Cutout to operate is considered an indirect cause of the fire.

Failure of the of the Cutout initiated a sequence of events that culminated with ignition of the wooden HVAC supply duct framing due to radiant heat from the heating elements. Insufficient clearance between the wooden frame and the HVAC ducting as required by NFPA 90B (and specified on the UL listed of the HVAC unit itself) and the close proximity of the wooden frame to the heater elements is a contributing factor. A recommendation of this report is to have the owners/occupants of MO's develop an inspection plan to evaluate HVAC duct for compliance with combustible material clearances.

The three heating elements, which are located no more than 8 inches from the ductwork over the wooden duct framing at the closest point, are capable of producing 15 Kw of heat. The radiant heat flux required for spontaneous combustion of wood is approximately 29 Kw/m<sup>2</sup>. The spontaneous combustion temperature of wood is approximately 600 degrees Celsius. Under normal operation, HVAC safety features will prevent the wood framing members from being exposed to temperatures that would result in spontaneous ignition. However, metallic heating elements can achieve a maximum temperature of approximately 1400 degrees Celsius. A failed Cutout in combination with a failed HVAC fan would produce the condition for spontaneous combustion of the wood in a very short period of time.

Projects owning or occupying MO's with wall mounted HVAC units should develop an inspection plan to inspect for proper clearance to combustible materials (i.e., wood framing, etc.) as required by the UL listing for the HVAC unit.

HVAC maintenance procedures should emphasize the need to perform a complete visual inspection of the high temperature cutout switches for any sign of damage or indications of overheating. Routine maintenance should also include a check of the wiring connections on these devices to ensure they are tight.

When buildings are being transitioned to D&D for demolition, ensure the prompt elimination of utilities and other related items is conducted. Although a fire of this nature cannot be predicted, isolation of the electrical power to these designated facilities would eliminate an ignition source which could potentially lead to a future similar event.
