Information Bulletin - Caution

Identifier: 2006-RL-HNF-0003

Title: Truck Tire Rapid Air Loss Leads to Rollover/Driver Injury

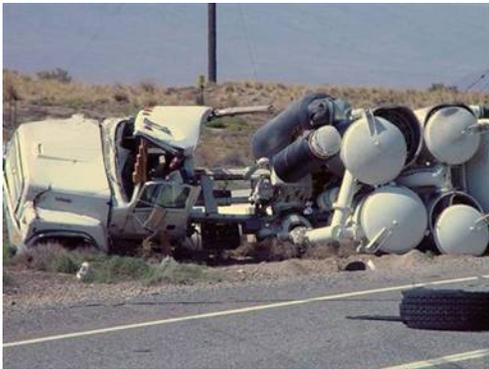
Analysis: The regulated guzzler truck is a radiologically controlled vehicle that is used for soil excavation. The unit weighs 45,000 lbs. The vehicle was traveling northbound on a two-lane, paved road to a new work location. Traffic was light, the weather warm (85 degrees F), there were light winds (6 mph), and there were light scattered clouds. The road was in good condition with no obvious road hazards present. The vehicle experienced a left front tire failure and veered left, crossed the oncoming traffic lane, rolled, and ended up on its side in a contamination area. The containment system of the vehicle was breached, but there was no loss of contamination control. The vehicle had successfully passed an annual DOT inspection in April of 2005, and a subsequent maintenance inspection was performed in August.

An independent accident reconstruction and analysis company reconstructed the accident. They determined that the vehicle was traveling 55-mph, and concluded with clear evidence rapid air loss or blowout of the left front tire, 143-feet of braking and side-slipping tire marks prior to roll over, 54-feet of scrapings on the pavement, and 34-feet of furrows off the shoulder of the roadway. The vehicle began to roll over prior to leaving the paved surface. 3D simulations were developed to illustrate what actions would have taken place to result in a roll-over accident. The simulations determined that the roll over occurred because of heavy braking with little or no counter steering. If counter steering had been used and pressure had been applied to the accelerator to initially gain control of the vehicle, the roll over would not have occurred.

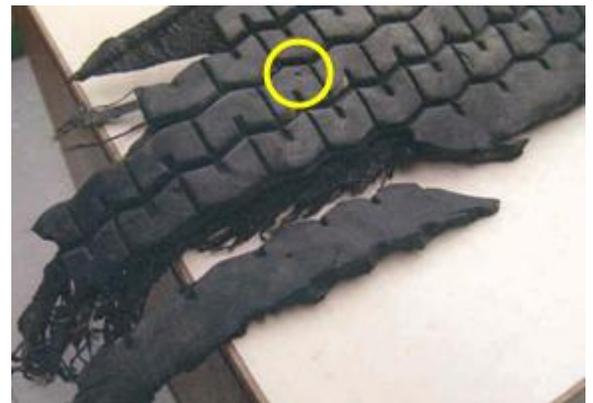
Both front tires were provided to an independent forensic engineering company for analysis. The tires were 12-years old and were found to have good tread depth with no abnormal tread wear, no obvious defects, signs of manufacturing defects, overheating, side-wall flexing, or evidence of puncture repair. The location of failure was very apparent and the entire tread ripped from the tire carcass. One small hole in the tread was noted that **did not** go all the way through the tire. This hole was old, near the point of origin of the failure, and may have allowed moisture into the steel belts of the tire.

Rusted steel belts and pre-accident ply separation were evident, and it was apparent that water had infiltrated the tire. The tire probably failed due to separation between the belts, because water infiltrated into the tread, which then migrated along the steel belts causing rusting and ultimately, failure. Age of the tire and infrequent use with long periods of sitting may have contributed to the failure, which may have been initiated by a small road hazard. The forensic engineering company recommended changing out this type of tire every 8 years.

1. Change out all tires on steering axles that are greater than 8-years old.
2. Provide tire rapid air loss emergency response training to heavy vehicle operators. Consider use of the video provided by the Michelin® Tire Corporation: "The Critical Factor: Maintaining Control in a Rapid Air Loss Situation."
