**Discovery of Contamination Spread at the Plutonium Finishing Plant
during Demolition Activities**

EM-RL--CPRC-PFP-2017-0018

ROOT CAUSE EVALUATION REPORT

March 5, 2018

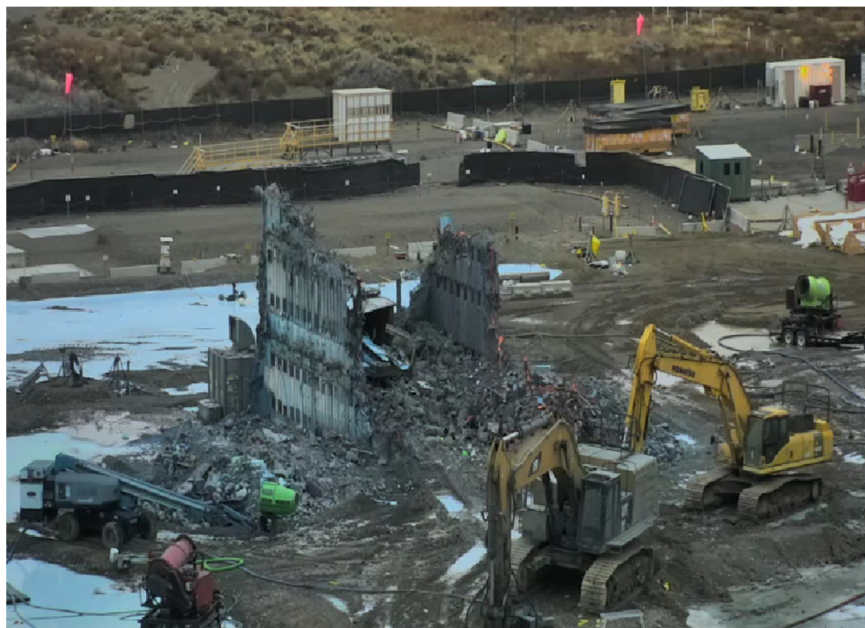
FIGURE 1 - REMAINING PRF STRUCTURE - 12/14/2017

At the time of this event, 236-Z (PRF) had undergone major demolition efforts. The north and south walls and the roof had been completely removed, and the remaining walls were more than 50% removed (Figure 1). Major demolition efforts had taken place on 234-5Z (Figure 2) with the interior of the building open to the outside elements, making it vulnerable to wind conditions. All four walls, east to west and north to south, were open to the environment.

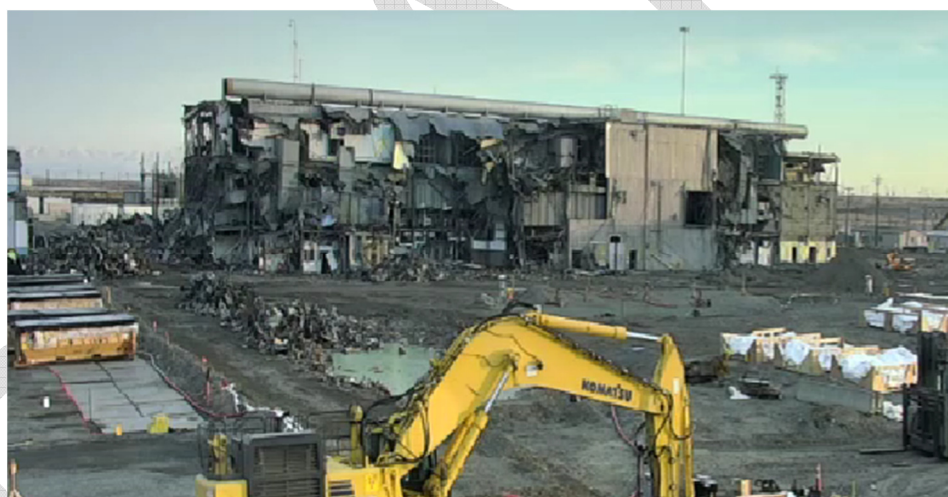
FIGURE 2 - SOUTH SIDE VIEW OF 234-5Z

According to PNNL-20173, demolition of the PRF Canyon represented 98% of all airborne emissions associated with demolishing the PFP complex. PNNL-20173 uses the amount of material available to be emitted in any given week as the basis for dispersion calculations. PNNL-20173 also included assumptions on how long Canyon demolition would occur. The expedited demolition challenged the base assumptions of PNNL-20173. To compensate, the project placed two CAMs (numbered 4 and 4A) in close proximity (within 100 ft) to PRF for Canyon demolition. These CAMs existed well within a 24 derived air concentration (DAC)-hr isopleth from the model, associated with concurrent demolition of the Canyon and Zone 4 of 234-5Z (Figure 2).

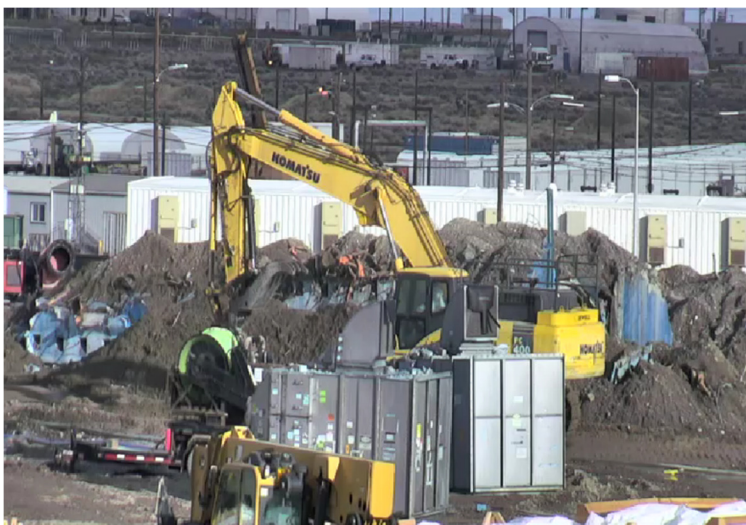
FIGURE 3 – DEBRIS PILES FROM PRF ON 12/17/2017

Surveys identified additional contamination outside of the posted CA. The newly discovered expanded contaminated area was posted to a CA. The PRF debris pile (Figure 3) was covered with soil and soil cement for stabilization.

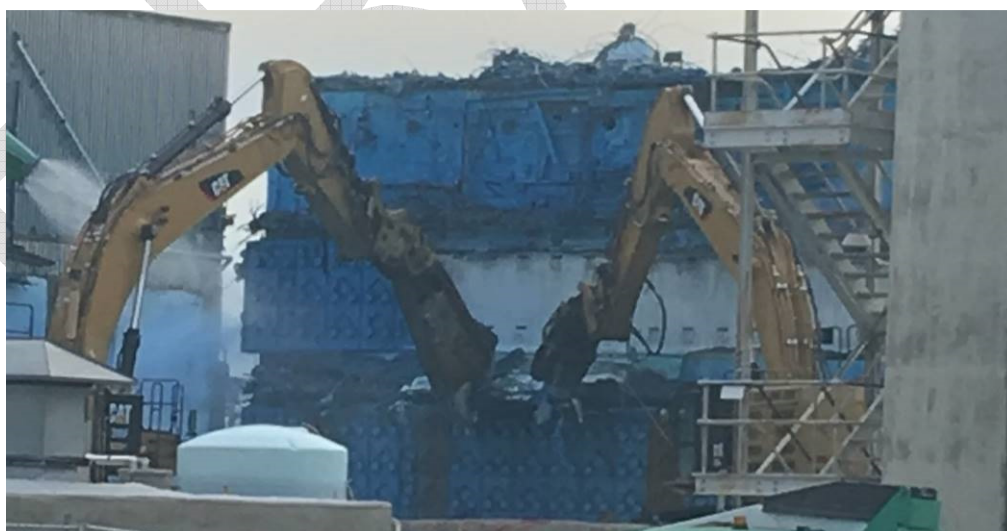
FIGURE 5 - GALLERY GLOVEBOX 2ND WEST, SECTION 3 REMOVAL EFFORTS

PFP Event – EM-RL--CPRC-PFP-2017-0013, Contamination during Gallery Glovebox Removal Demolition Activities, June 8, 2017	
Summary of Event: A CAM alarm that sounded while crews were removing and packaging the third section of Gallery Glovebox 2 nd West from the PRF (Figure 5). Demolition activities were stopped and RCTs began surveys in preparation to egress personnel. Several spots of contamination were found outside of posted radiological areas, the highest reading documented at 12,500 dpm/100 cm ² removable alpha contamination following the alarm. The CAM alarm was in the demolition zone at the Airborne Radioactivity Area boundary, in an area where contamination is expected to exist with the CAM alarm set point at eight DAC-hr.	
Causal Factors:	
AC-01: The work package control set was not adequate to prevent the release and maintain control of contamination.	<p>The controls identified in the work package are noted to be limited by the inputs which are provided. Several issues and potential areas of weakness of the control set were identified:</p> <ul style="list-style-type: none"> • Specific precautions regarding high-pressure streaming or fogging were not called out. • The boundary was not established at a distance far enough from the demolition area. • The method to collect real-time data used for wind limitations was not specified. • The fixative concentration may have been less than adequate. • Additional engineering controls were needed (e.g., ventilation, in regard to total gram value available for release).

AC-02: Water did not keep the particulate contained within the radiological boundary.	<p>The following issues could have contributed to the water not being as effective as expected in isolating particulate to the controlled area (within the boundary):</p> <ul style="list-style-type: none"> • The wind and other weather conditions. • Condition of the gram quantities of material. • Fixative application both before and after demolition.
CC-01: The contamination and airborne radioactivity was not uniformly distributed on the ground and in the air as was anticipated in PNNL-20173.	<p>The contamination was dispersed in a spotty and non-uniform manner beyond the boundary. Actual quantities were a factor of two times what was anticipated from PNNL-20173. The airborne radioactivity was more concentrated, greater than 10 times what was modeled.</p>
CC-02: Fixative did not prevent the material from being propelled into the air as it had not been previously applied to inaccessible areas.	<p>Because the deactivation methods employed did not afford access to the gaskets, glass, and mating surfaces of the gallery glovebox glass, they could not be accessed prior to demolition.</p>

CC-03: The positioning or mode of force of the water may have pushed the contamination past fogging and/or overcame the application.	<p>This event was significantly different in that it is a known fact the CAM alarm was directly related to the removal of the gallery glovebox. Use of the water cannon caused a straight stream of water providing a mode of force. During the demolition activity, several individuals observed the straight stream of water shooting into the jumper receptacles and consideration was given to the fact this could have pushed/dislodged contamination, causing it to become airborne. The fogger also had potential to create a mode of force pushing or dislodging contamination past the suppression efforts.</p>

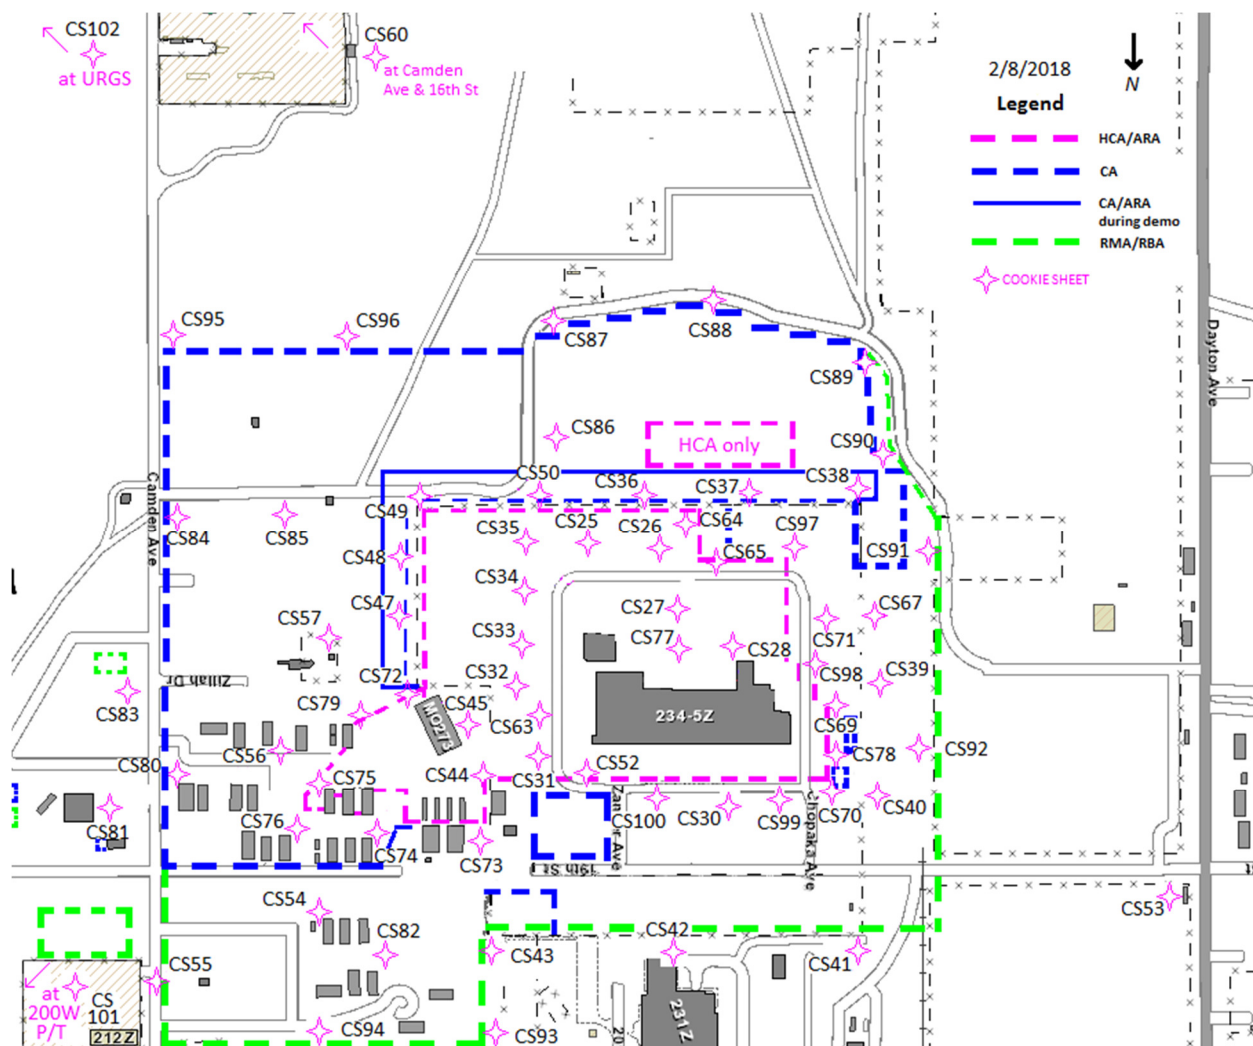
FIGURE 7 - COOKIE SHEET LOCATIONS/BOUNDARIES

The distribution of contamination that crossed the CA boundary was examined and discussed with PNNL Health Physics and Meteorology staff involved in air dispersion modeling for PFP demolition. PNNL staff noted that the contamination deposition was in the form of discrete specks as opposed to plumes of contamination and did not correspond with the airborne radioactivity sample results from the 14 CAMs and 22 air samplers that surround PRF. There are initial indications that this contamination consists of primarily large particles (i.e., specks of contamination that are too heavy to remain suspended in air long enough to be collected on the surface of an air sample filter). The large particles are considered to be non-respirable and fall outside PNNL-20173. The software used in air dispersion modeling does not have the capability to model the deposition location and range of discrete large particles of contamination. The predicted weekly air concentration depicted in Figure 9 assumes respirable particles. The condition of a contamination spread without corresponding airborne radioactivity had not been previously experienced.

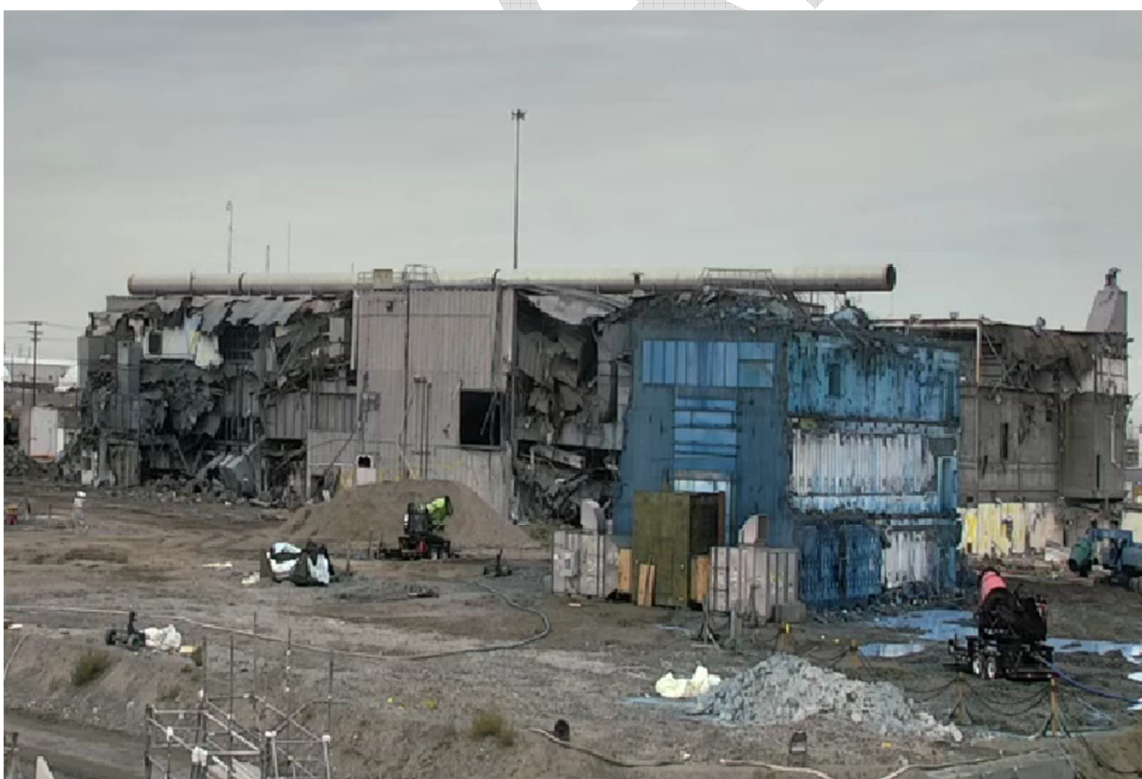
FIGURE 10 - PRF SOUTH WALL SHOWING THE ATTACHED HEPA EXHAUST UNITS (234-5Z SHOWN IN BACKGROUND)

The outcome of the June 8, 2017, event drove the installation of exhausters that were placed at the double doors at the south wall of the PRF Canyon. Due to the removal of the roof, the exhausters were no longer effective; they were no longer in an enclosed area. These exhausters were intended to enhance the ventilation during the gallery glovebox removal, breaching of the Canyon, and removal of the strongbacks, providing a more efficient means of removal (Figure 8).
