# Hanford PUREX Tunnel 2 Stabilization

Current Status of Activities

August 2018

Dan Wood,  
CH2M HILL Plateau Remediation Company  
Chief Operating Officer

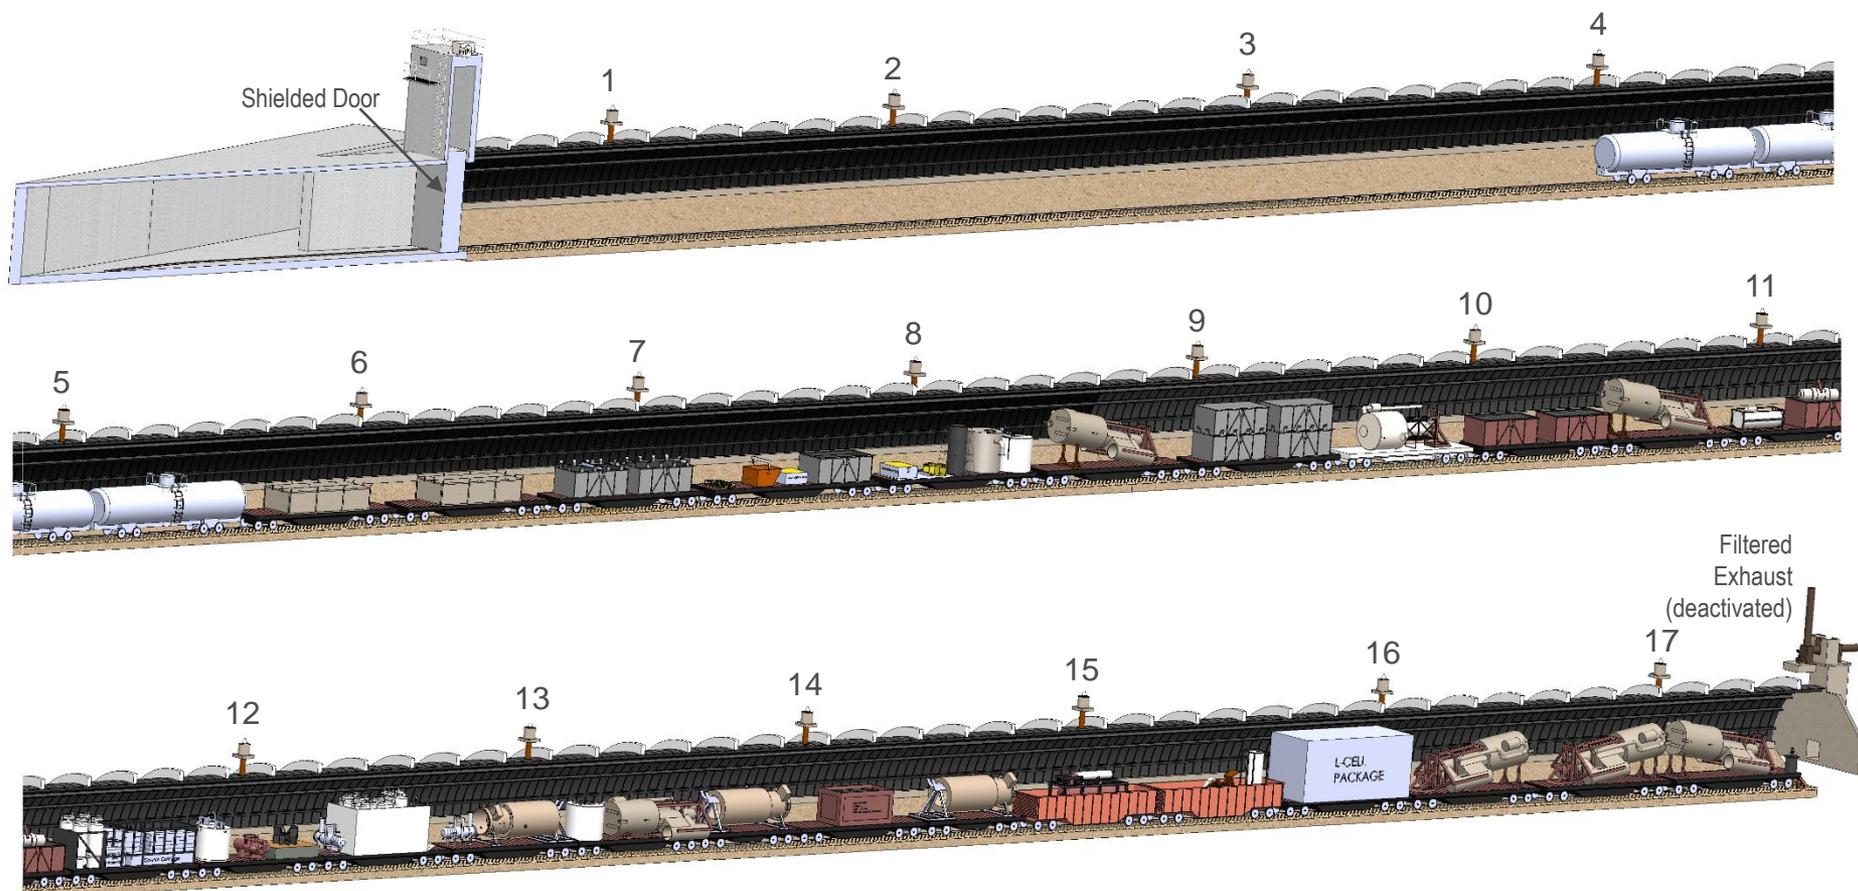
- Exact location of risers and railcars relative to risers confirmed

During grouting, Riser 2 will be connected to a passive HEPA filter  
Risers 3, 5, 8, 11, 14, and 16 are grout insertion points, includes video cameras  
Risrs 4, 7, 9, 10, 12, 15 and 17 will have extra lighting installed  
Risrs 1, 6, and 13 not used

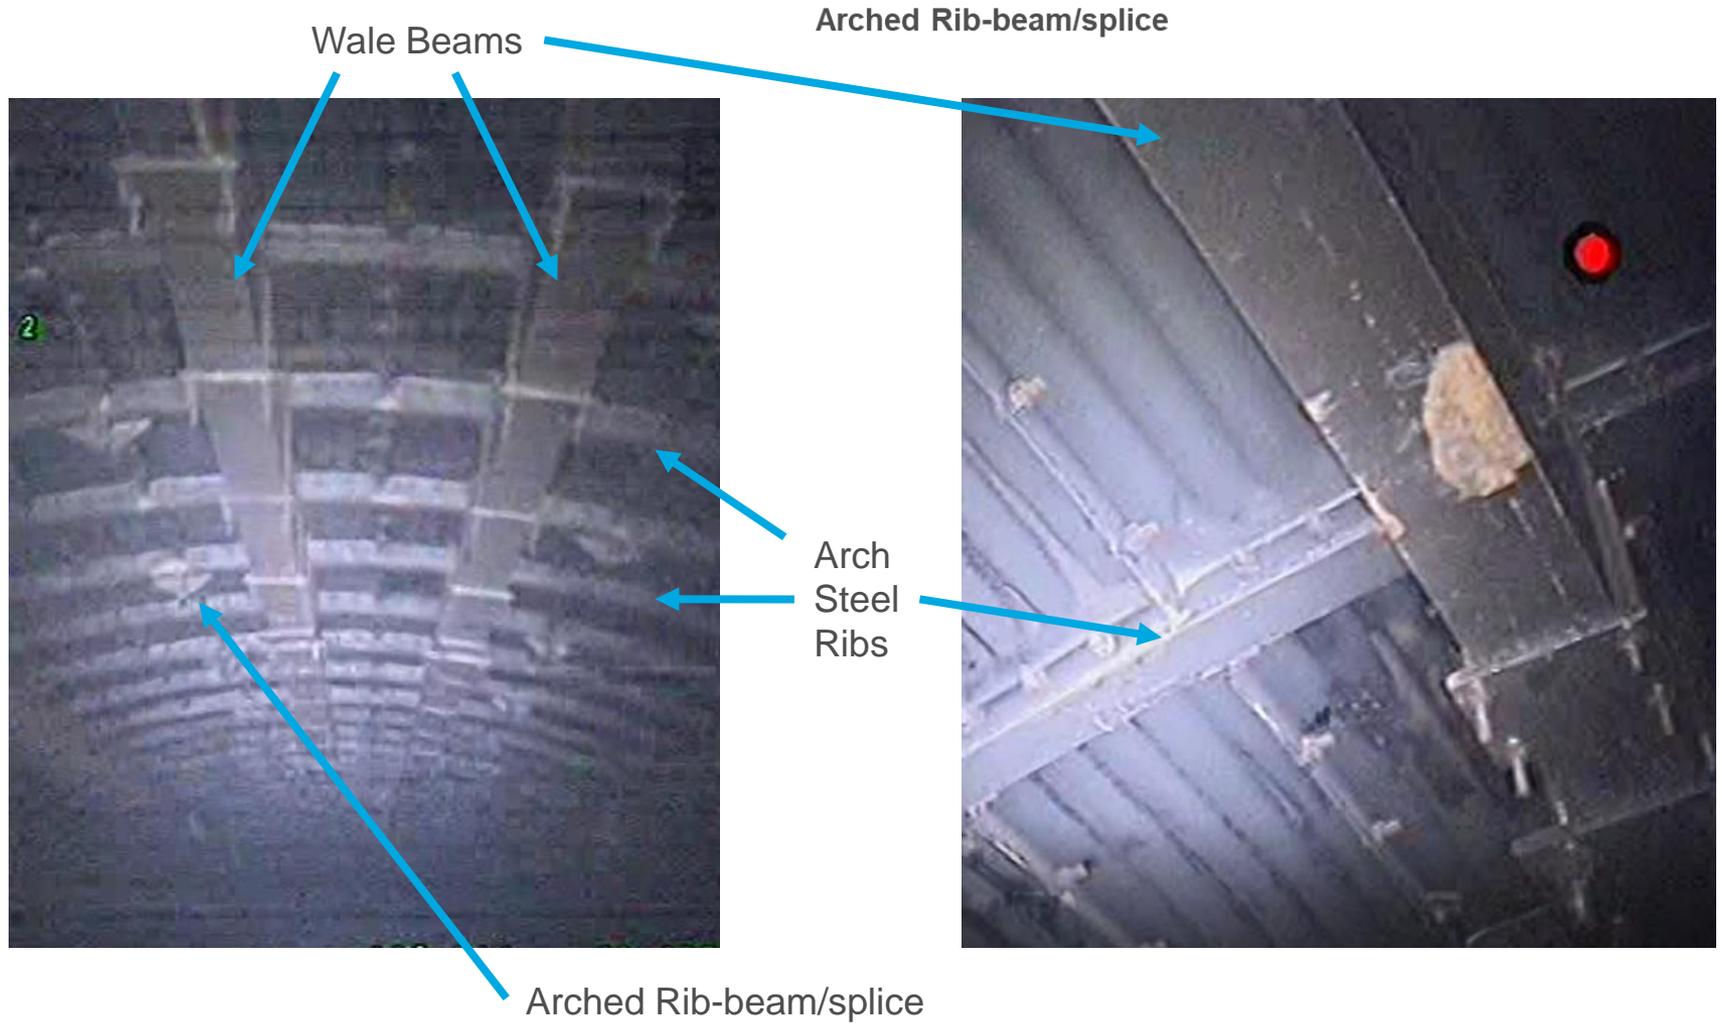
# Investigation – Condition of Structure (Riser 2)

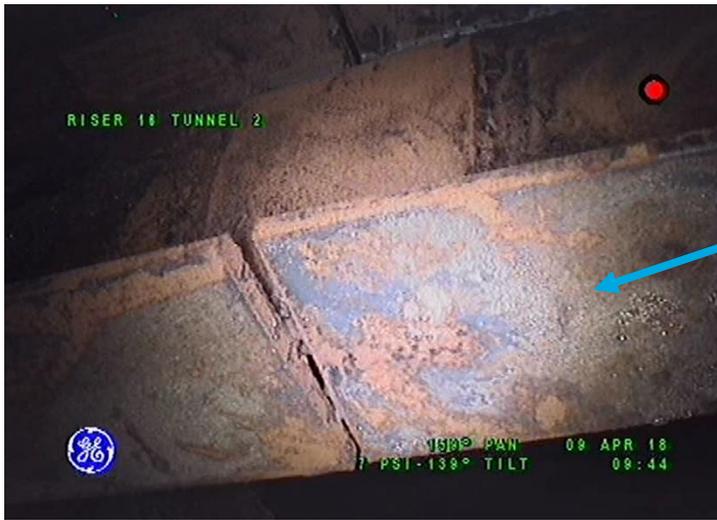
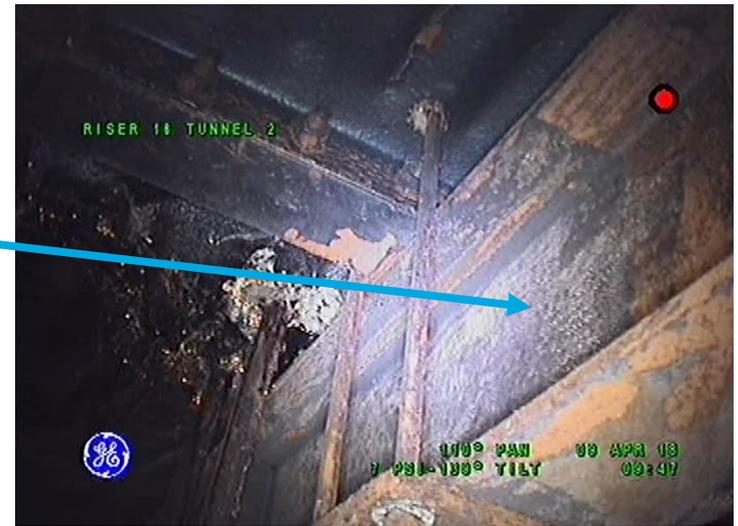
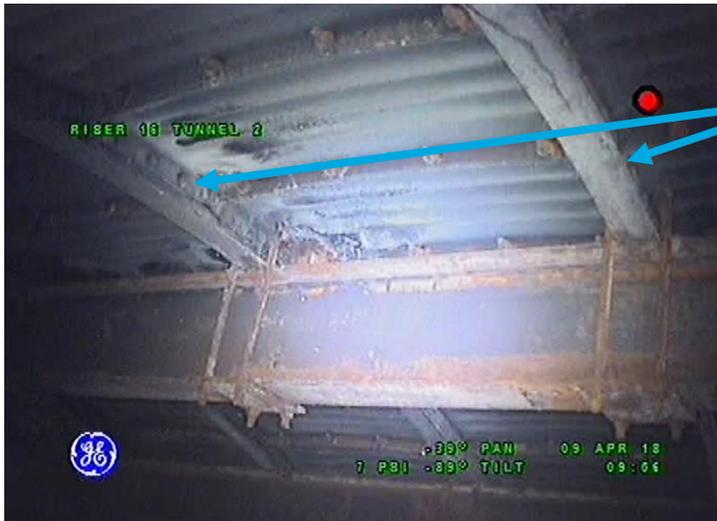
# Investigation – Condition of Structure (Riser 16)

Wale Beams

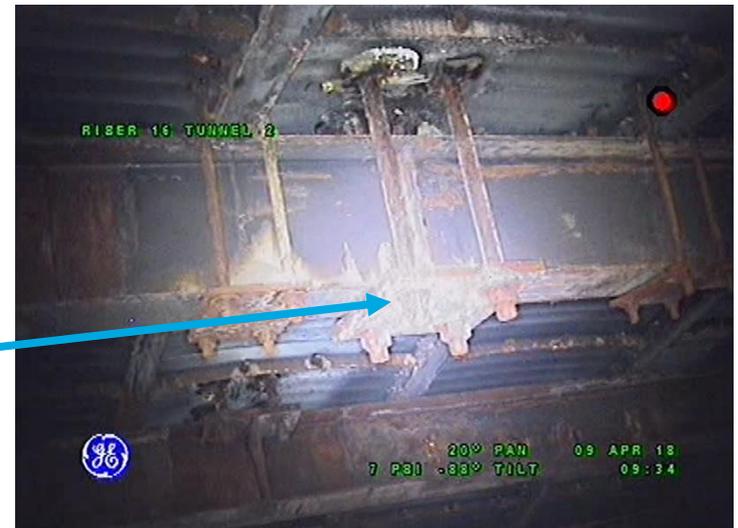
Arch Steel Ribs

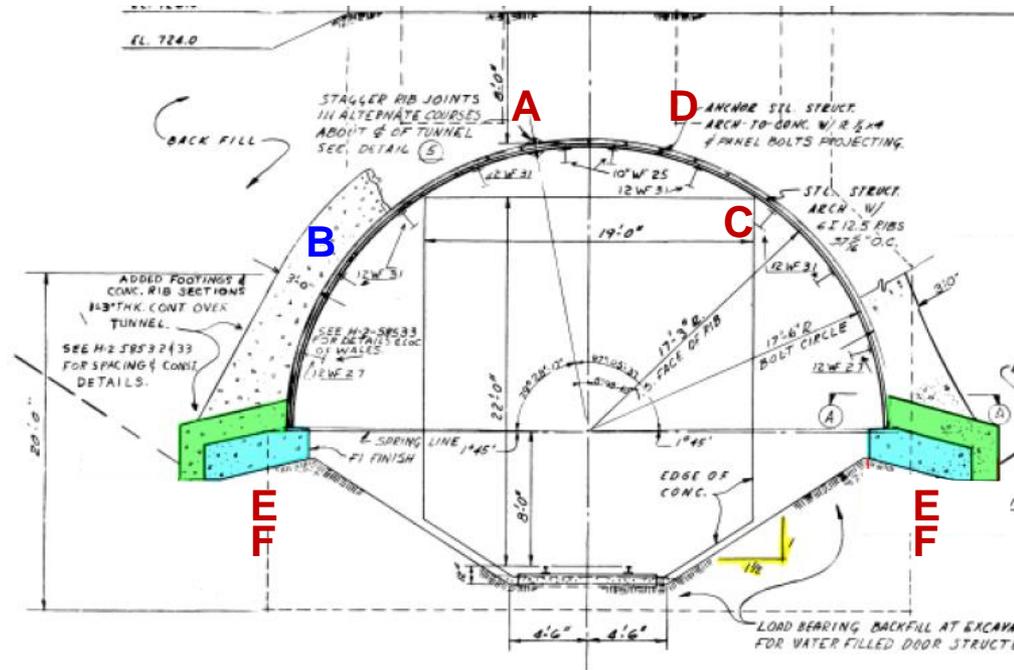
Element*	Max DCR
A: Arched Rib-beam/splice	<b>1.09</b>
B: Concrete Arch Girders	<b>0.59</b>
C: Steel Wale Beams	<b>1.12</b>
D: Wale Beam Anchors	<b>1.04</b>
E: Concrete Footing	<b>1.09</b>
F: Foundation Soil Load	<b>1.03</b>

Loads on multiple structural members exceed building code design capacities; Tunnel 2 has a 'potential high' risk of collapse

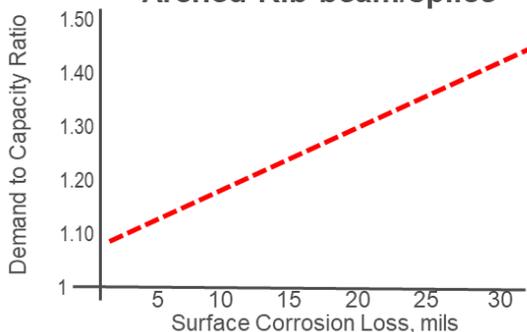
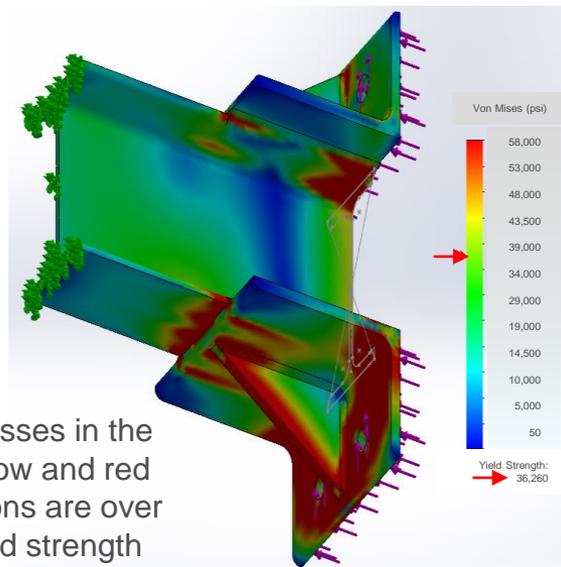
Stresses in the yellow and red regions are over yield strength (DCR > 1.0)

Element*	2017 Max DCR	Updated Max DCR
A: Arched Rib-beam/splice	1.09	1.45**
B: Concrete Arch Girders	0.59	No change
C: Steel Wale Beams	1.12	Indeterminant
D: Wale Beam Anchors	1.04	<b>Suspect</b>
E: Concrete Footing	1.09	No change
F: Foundation Soil Load	1.03	No change

\*\* Based in estimated 1/32" (0.031") loss of thickness,  
at 1/16" (0.063") the DCR could exceed 1.7

Key elements are more overloaded than previously evaluated, the risk of failure is greater

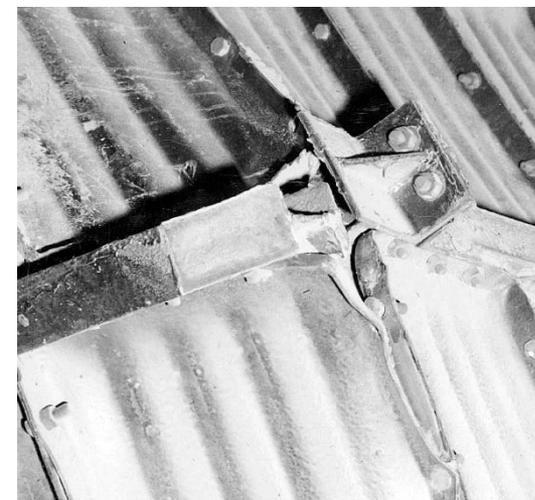
Failed Arched Rib-beam/splice, c. 1963

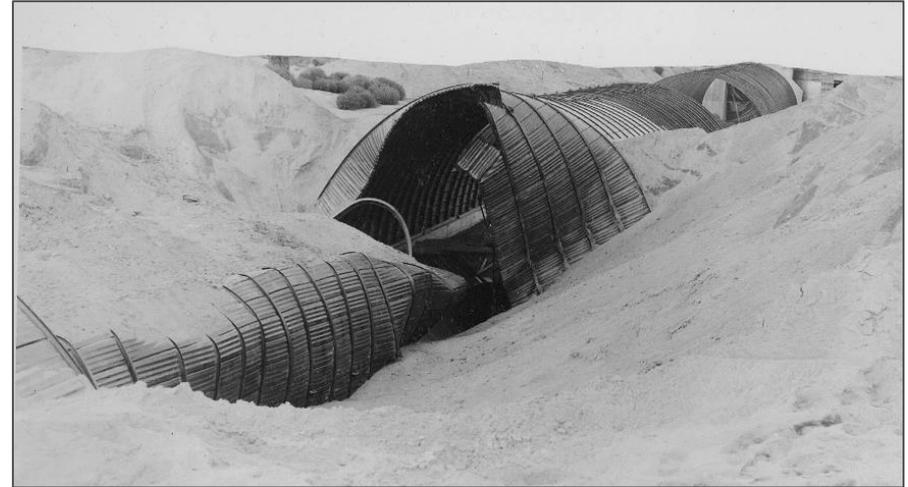
*Tunnel 2 collapse during backfill*
