AY-102 Recovery Project Update

Retrieval Process
Engineering

8/9/2017

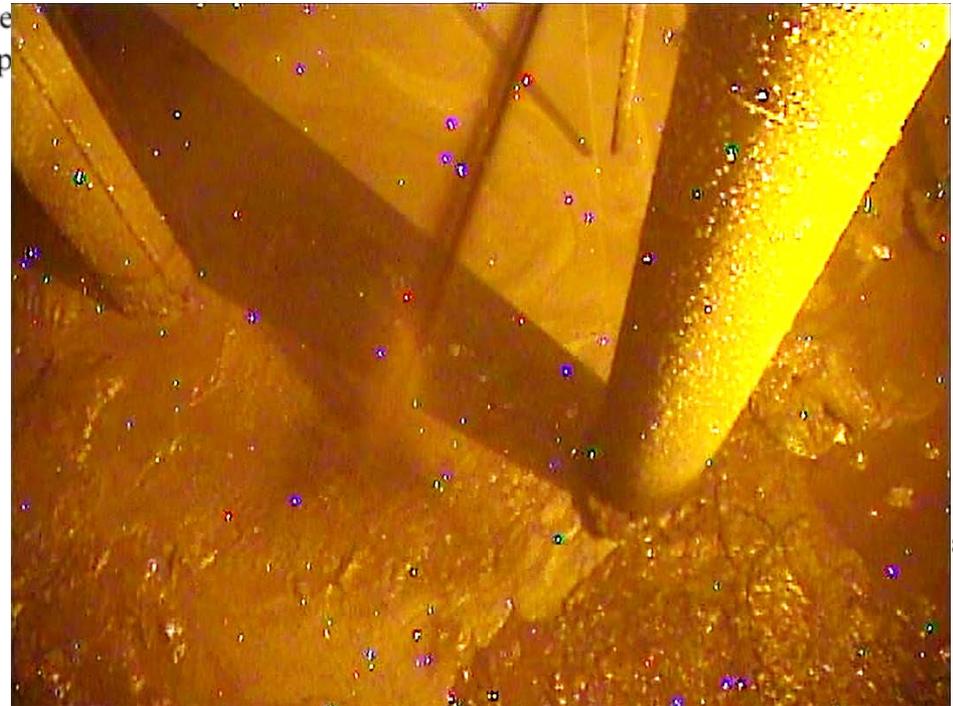
Operation of Sluicer 1 on 4/1
(view from R54 - North Side)

- Annulus level increase was greatest when operating Sluicer 1 in the vicinity below the AY-02B pit
- Annulus level increases were minimized when directing Sluicer 1 away from AY-02B pit
- Leak rate was significantly reduced when operating Sluicer 2
- No indication that waste leaked to environment

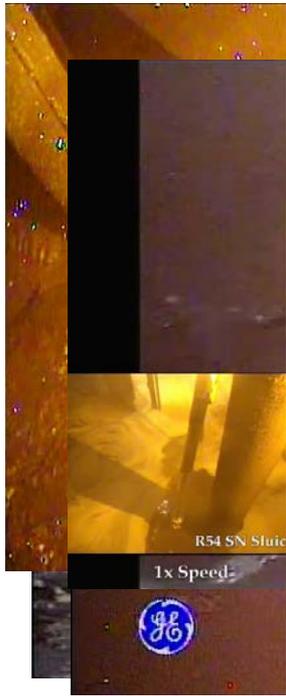
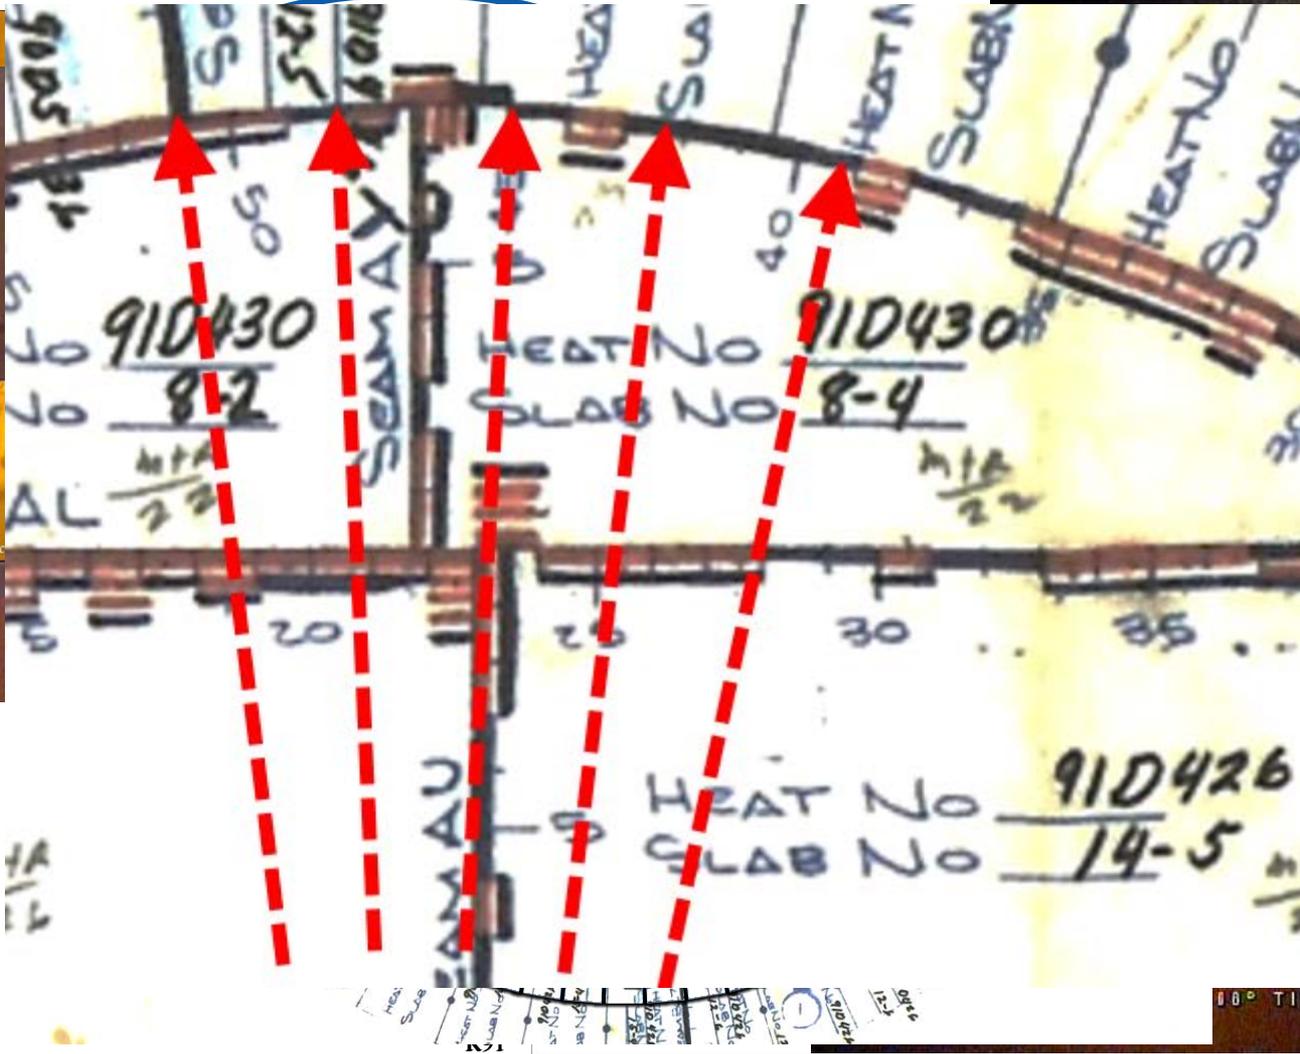
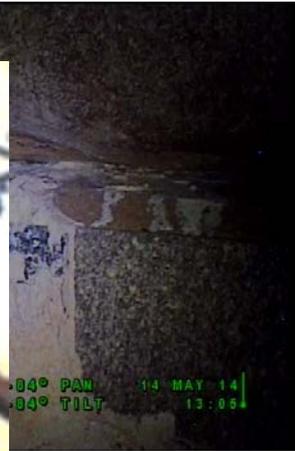
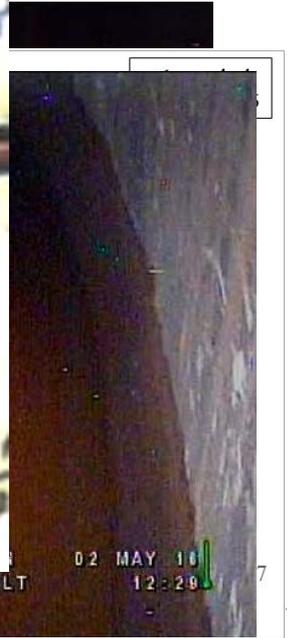
PRIMARY TANK LEAK BEHAVIOR

- **Similar annulus level behavior**
 - Sluicing near suspected leak site resulted in annulus level rise
 - Indication of leakage from one location
- **Residual primary tank solids are mobile**
 - ERSS effective at mobilizing the solids
 - Pump incapable of removing remaining solids
- **Leak Site Cleaning**
 - Last shift focused on clearing solids from suspected leak site
 - High-pressure water, followed by supernate sluicing

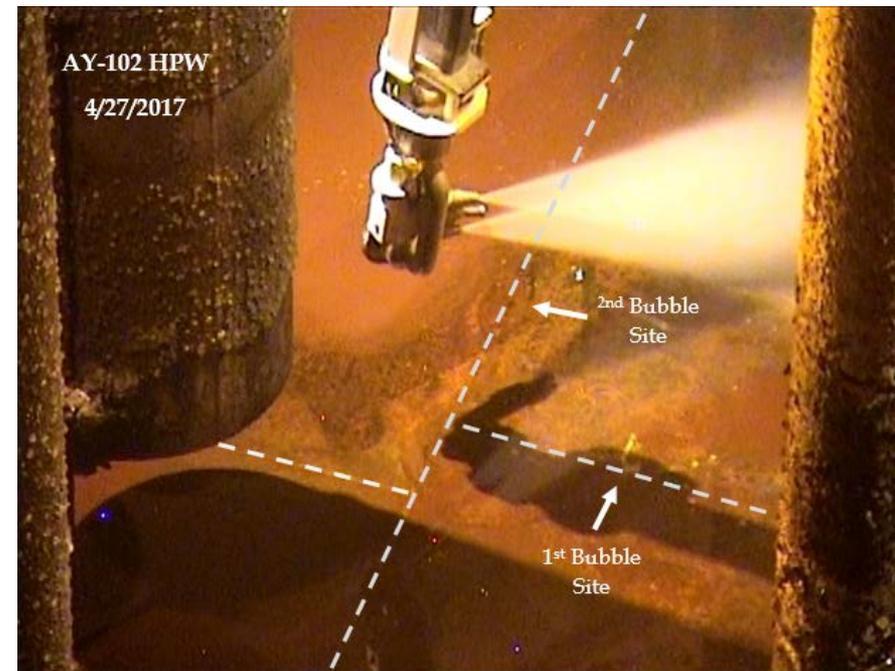
HIGH-PRESSURE WATER OPERATIONS VIDEO

- Applied high-pressure water to the suspected leak site area to further clear residual settled solids in preparation for visual examination
- ~10 gpm at ~5,000 psi discharge pressure
- Nozzle ~1 foot above surface
- Bubbles observed at two sites near perpendicular weld seams
- Provided confirmation of two primary tank failure points

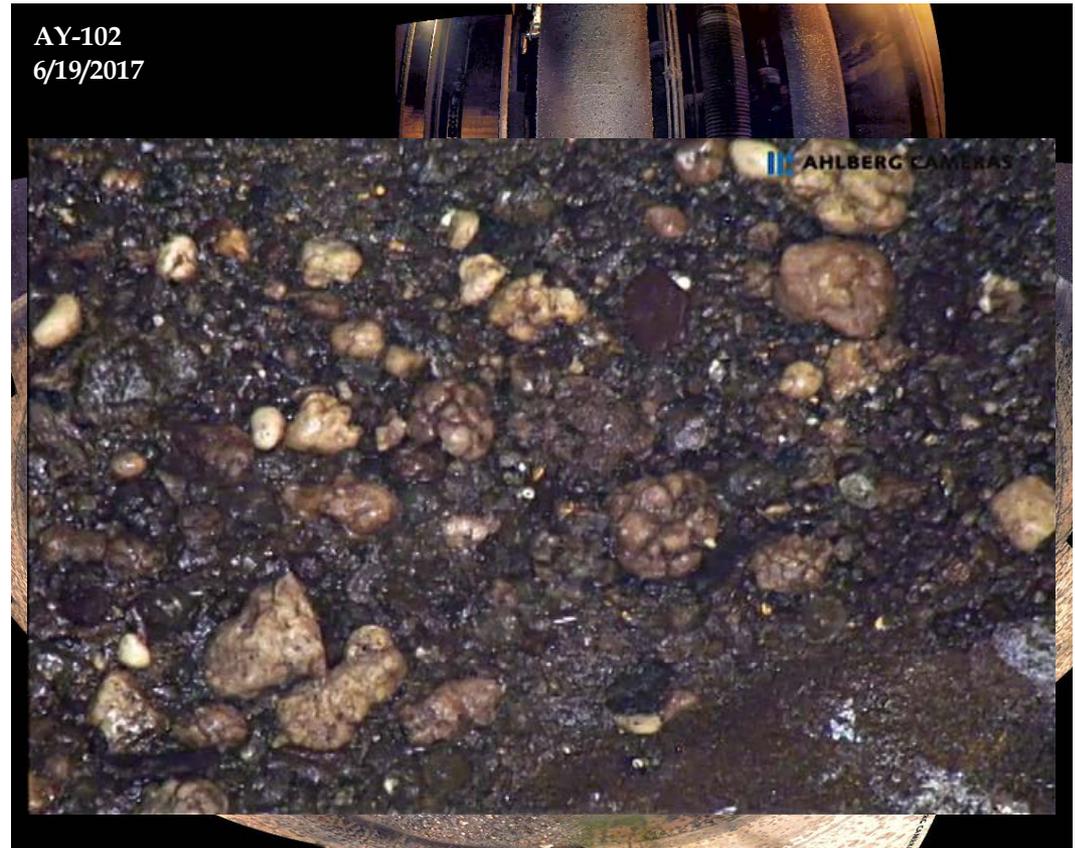
HIGH-DEFINITION CAMERA OPERATION

- High-definition video camera installed on 6/8/2017
- Repositioned in-tank lights and performed initial examination on 6/19/2017
- Enhanced imagery of the residual waste and the two confirmed primary tank leak sites
- Weld seams visible
- Shallow liquid layer remained

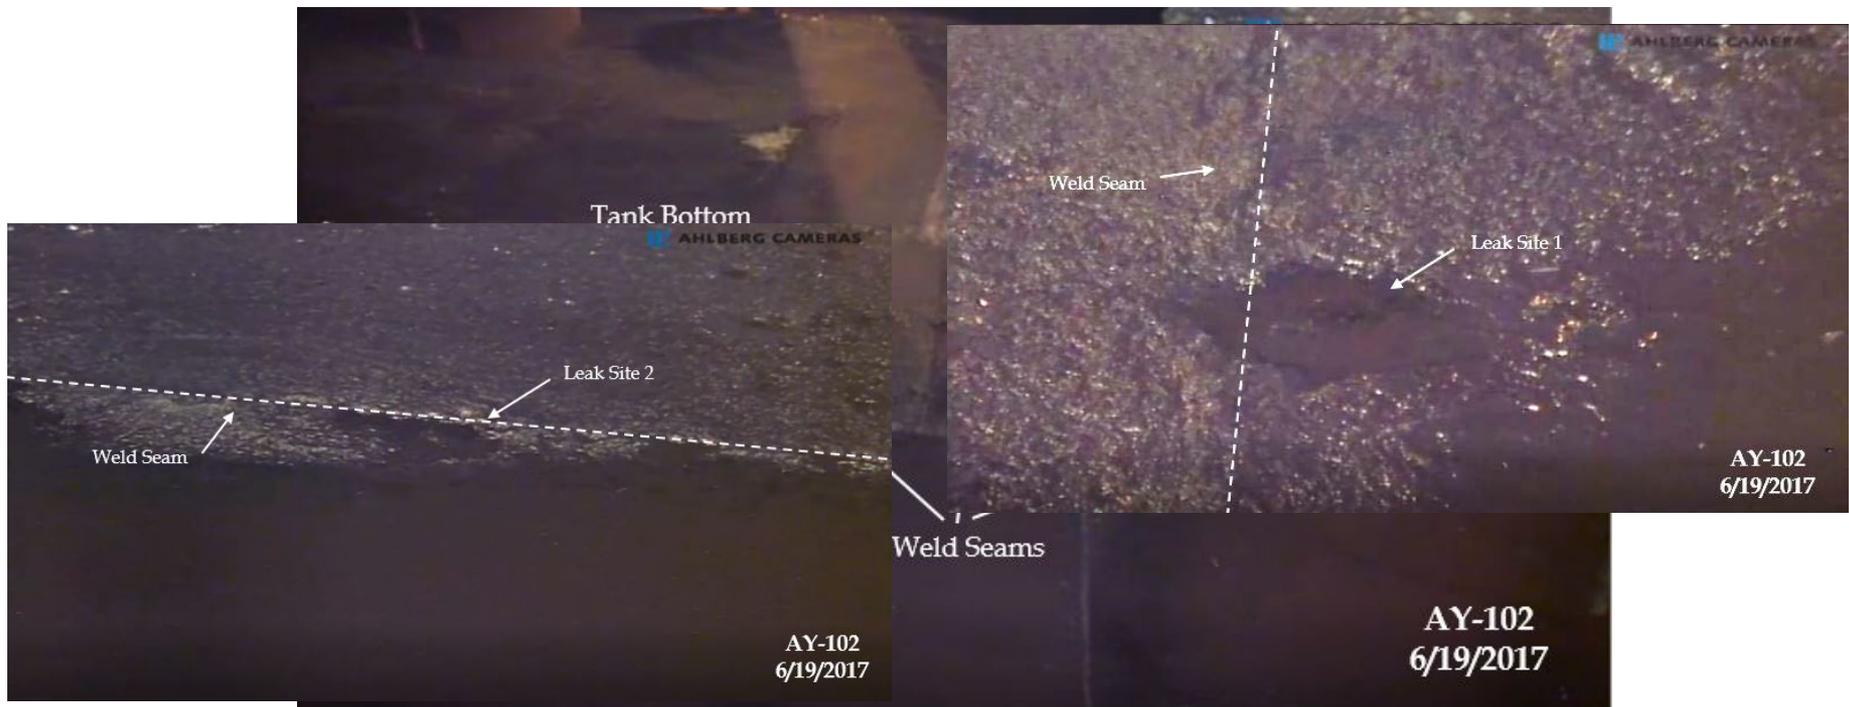
HIGH-DEFINITION VIDEO

- Confirmed leak sites (bubble sites) located within discontinuities along weld seams, appearing as depressions
 - Leak Site 1 appears to be within a ~2-inch-wide area
 - Leak Site 2 appears to be within a ~4-inch-wide area

- Panel of external experts in the field of corrosion (Tank Integrity Expert Panel) reviewed the information to-date.
- Based on tank operational history and post-retrieval examinations, the following opinions were put forth:
 - The metallurgical leak cause appears to be internal pitting corrosion coincident with welds.
 - Corrosion testing of AY-102 early-life waste simulants indicates pitting as a likely degradation mechanism
 - Pitting corrosion due to early-life waste composition would not be localized
 - External corrosion cannot be eliminated as a contributing factor without additional inspection.
 - The inspection to-date does not assure that all leak sites have been identified.
