Department of Energy
Richland Operations Office
P.O. Box 550
Richland, Washington 99352

FREEDOM OF INFORMATION ACT REQUEST (FOI 2010-01517)

09-SED-0041

CONTRACT NO. DE-AC06-08RL14788 – ENGINEERING PROGRAM/PROCEDURES
(S-09-SED-PRC-004)

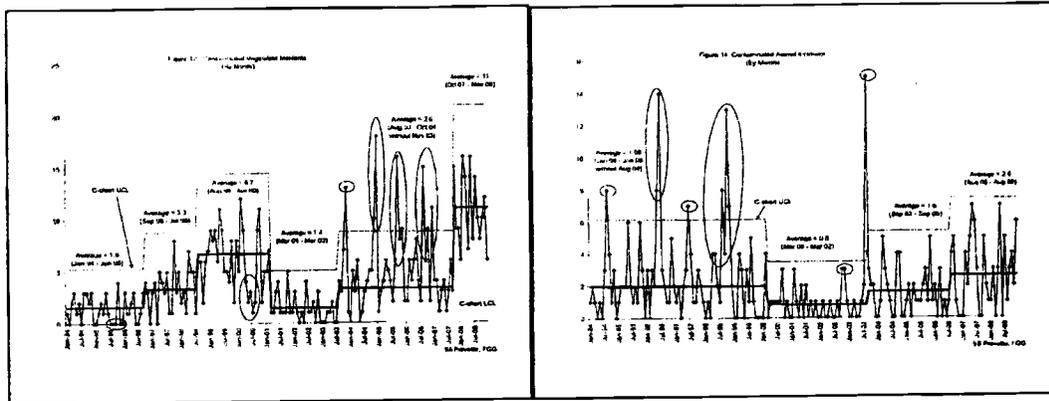
Data shows an adverse trend in the spread of contamination by biological vectors.

- Increases in frequency of contaminated vegetation and contaminated animal incidents have occurred.

Trending has also shown an increase in the contamination levels.

- Less than adequate access to areas for herbicide application in 2005 and 2006 and subsequent inadequate removal of these tumbleweeds resulted in large spreads of contamination.

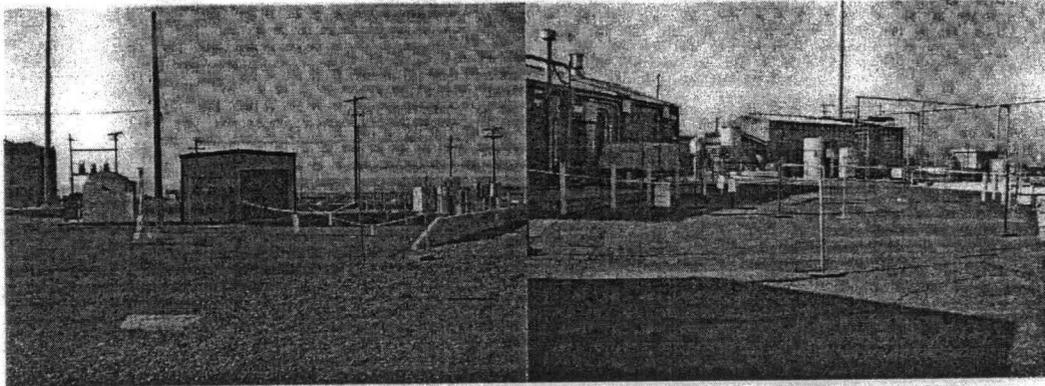
indicated these areas have been expanding over several years due to inadequate control of spread of contamination by biological vectors, but have not all been incorporated into WIDS and thus had not been assigned to a contractor for control and clean-up. Some of the areas have been put into the WRPS monitoring program due to the perseverance of the WRPS (Tank Farms Operations Contractor [TOC]) RCTs.

Examples of these areas are shown below:

SY Farm

241-A

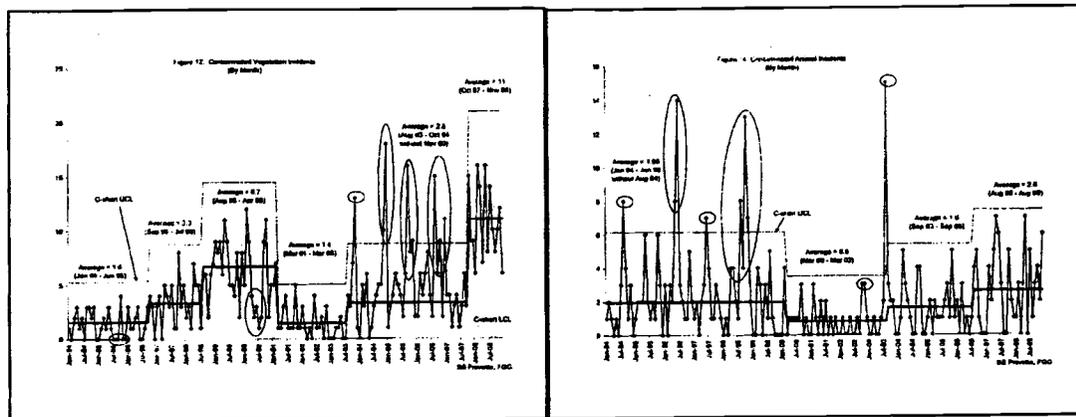
Data shows an adverse trend in the spread of contamination by biological vectors.

- Increases in frequency of contaminated vegetation and contaminated animal incidents have occurred.

Trending has also shown an increase in the contamination levels.

- Less than adequate access to areas for herbicide application in 2005 and 2006 and subsequent inadequate removal of these tumbleweeds resulted in large spreads of contamination.

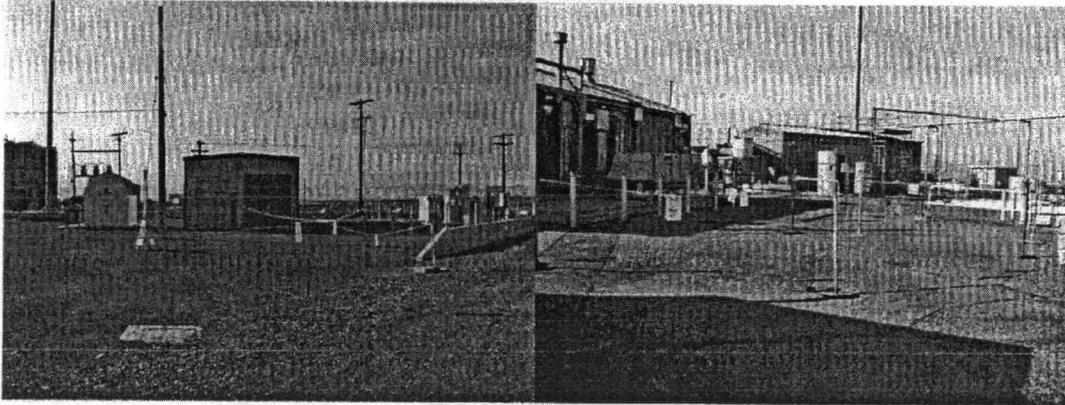
indicated these areas have been expanding over several years due to inadequate control of spread of contamination by biological vectors, but have not all been incorporated into WIDS and thus had not been assigned to a contractor for control and clean-up. Some of the areas have been put into the WRPS monitoring program due to the perseverance of the WRPS (Tank Farms Operations Contractor [TOC]) RCTs.

Examples of these areas are shown below:

SY Farm

241-A

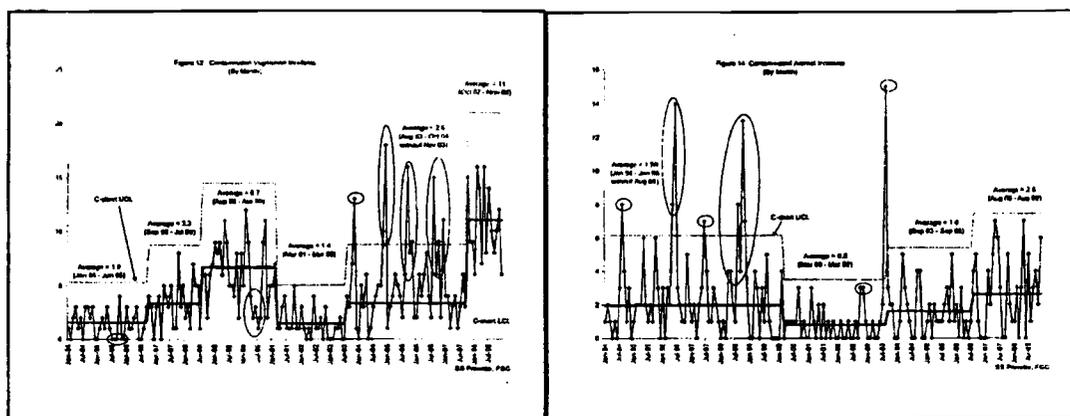
Data shows an adverse trend in the spread of contamination by biological vectors.

- Increases in frequency of contaminated vegetation and contaminated animal incidents have occurred.

Trending has also shown an increase in the contamination levels.

- Less than adequate access to areas for herbicide application in 2005 and 2006 and subsequent inadequate removal of these tumbleweeds resulted in large spreads of contamination.

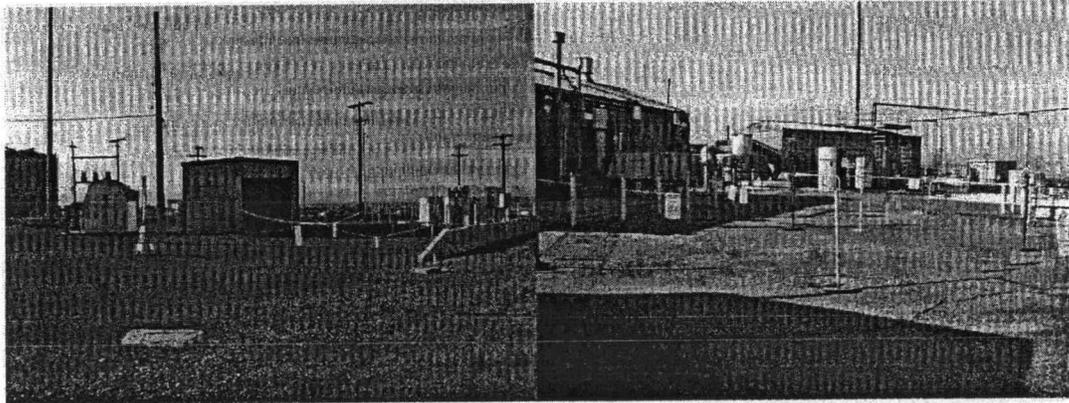
indicated these areas have been expanding over several years due to inadequate control of spread of contamination by biological vectors, but have not all been incorporated into WIDS and thus had not been assigned to a contractor for control and clean-up. Some of the areas have been put into the WRPS monitoring program due to the perseverance of the Washington River Protection Solutions (WRPS) (Tank Farms Operations Contractor [TOC]) RCTs.

Examples of these areas are shown below:

SY Farm

241-A
