13-QAT-0065

CONTRACT NO. DE-AC27-01RV14136 – U.S. DEPARTMENT OF ENERGY (DOE),
OFFICE OF RIVER PROTECTION (ORP) SURVEILLANCE REPORT S-13-QAT-RPPWTP-
004, SURVEILLANCE OF REVIEW OF BECHTEL NATIONAL, INC.'S (BNI) INTERIM
SURVEILLANCE IN RESPONSE TO OFFICE OF INSPECTOR GENERAL (OIG) REPORT
DOE/IG-0863, RECOMMENDATION NUMBER 2

**DOE ORP Quality Assurance Team's Review of BNI's Interim
Surveillance, 24590-WTP-SV-QA-12-113, in Response to Office of
Inspector General Report DOE/IG-0863, Recommendation Number 2**

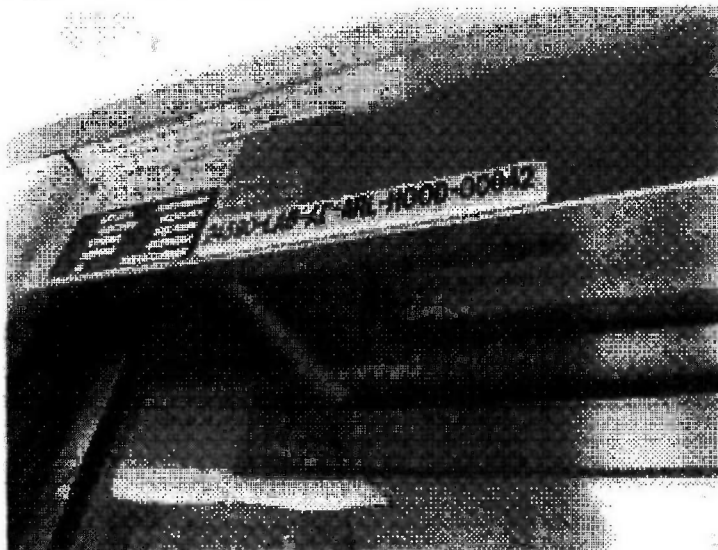
Figure 1. Fume Hood 24590-LAB-AE-ARL-HOOD-00042

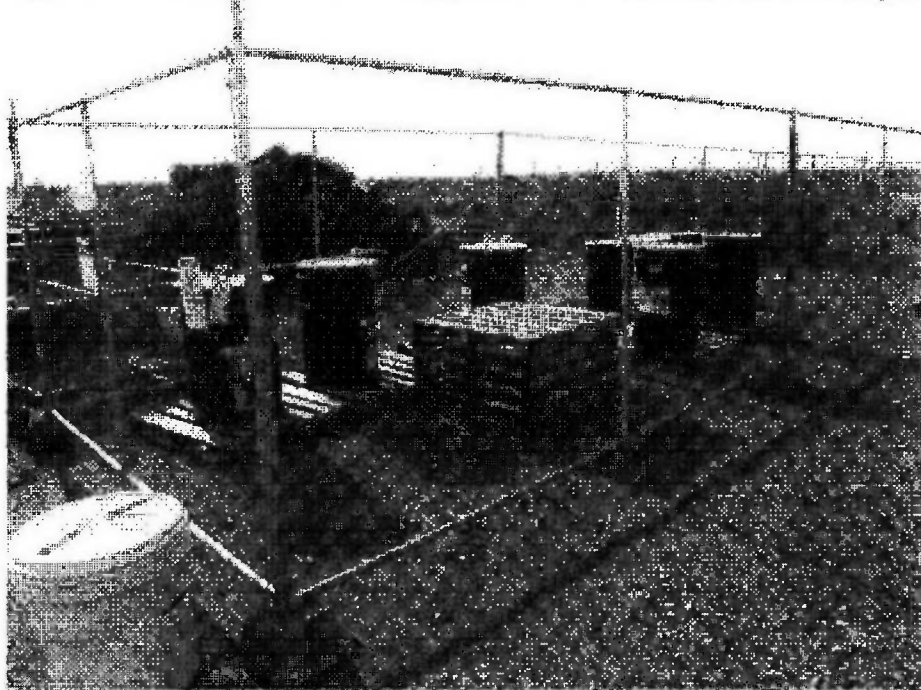
Figure 1. Five 55-Gallon Drums on Pallets in Hazardous Waste 90 Day Accumulation Area.

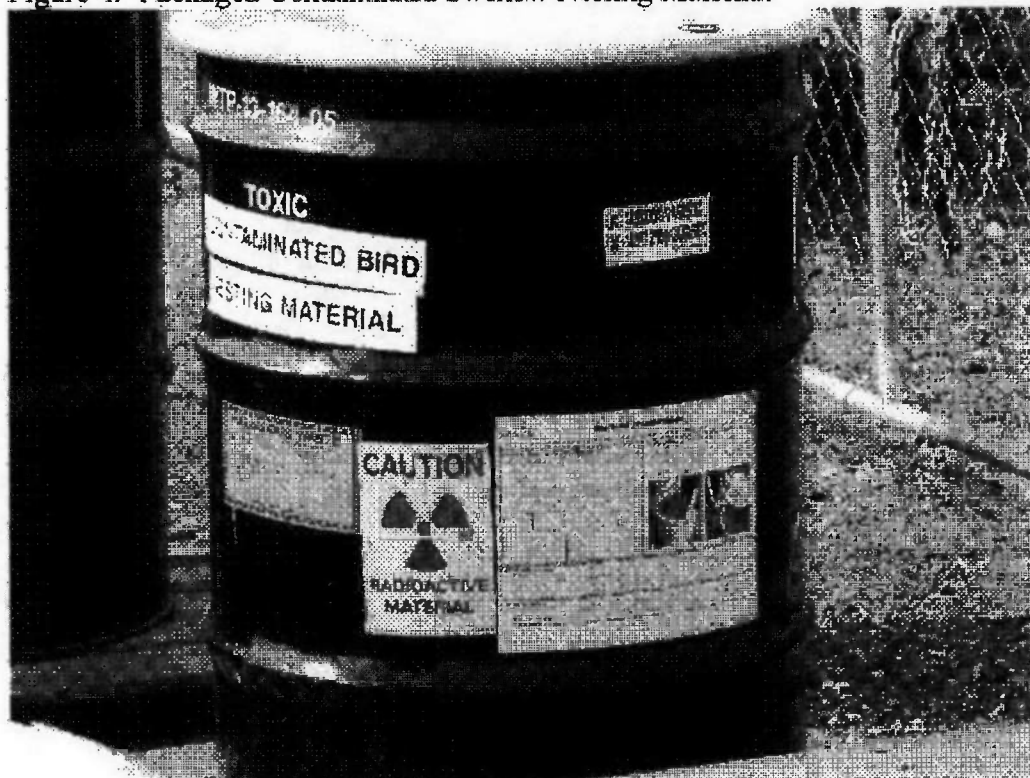
Figure 4. Packaged Contaminated Swallow Nesting Material.

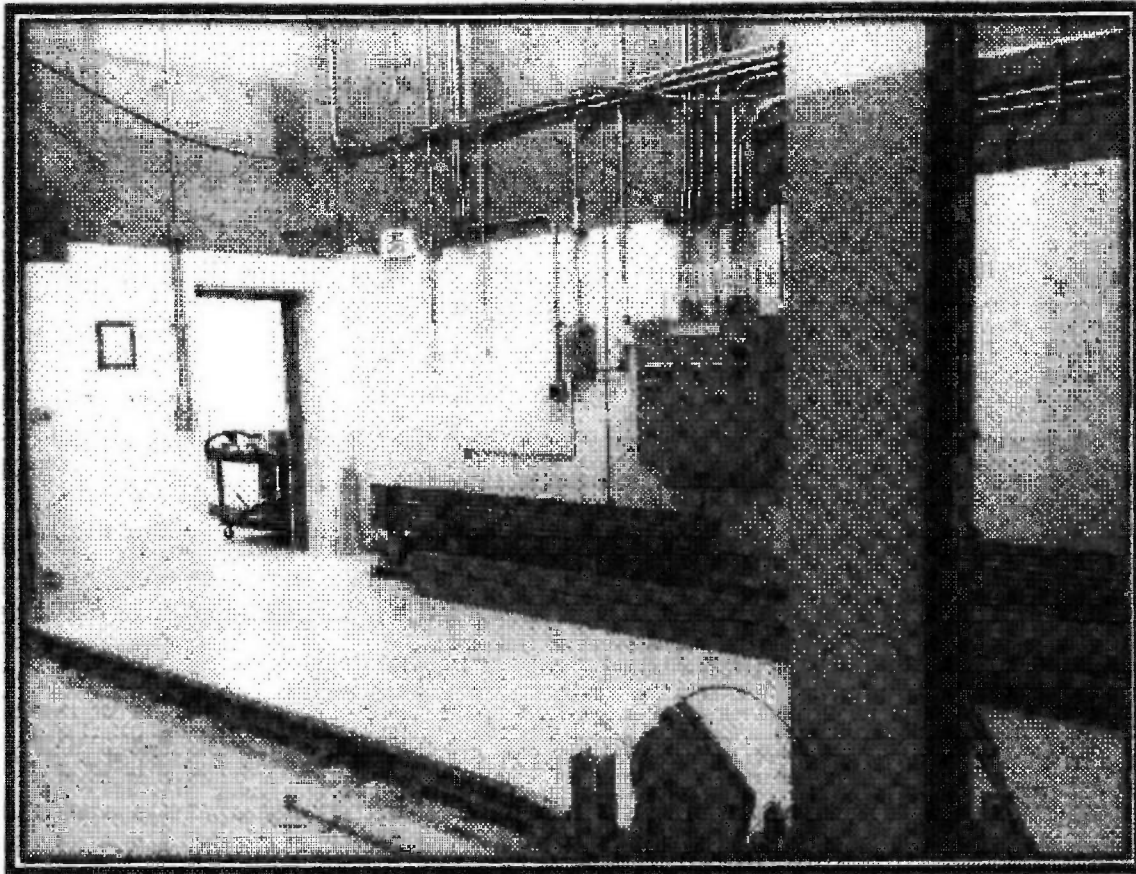
- Electrical panels and local operating stations are unnecessarily located inside a C3 (Contamination Area). Locating operating stations and electrical panels inside C3 areas increases worker dose during routine and maintenance activities, increases generation of radioactive waste (e.g., coveralls, swipes, and decontamination supplies, and results in costly maintenance due to use of personal protective equipment, use of contamination control supplies, and added personnel (Operators and Radiological Control Technicians [RCT])).

Electrical panel and Local Operating Panel in C3 LAW Bogie Maintenance Room

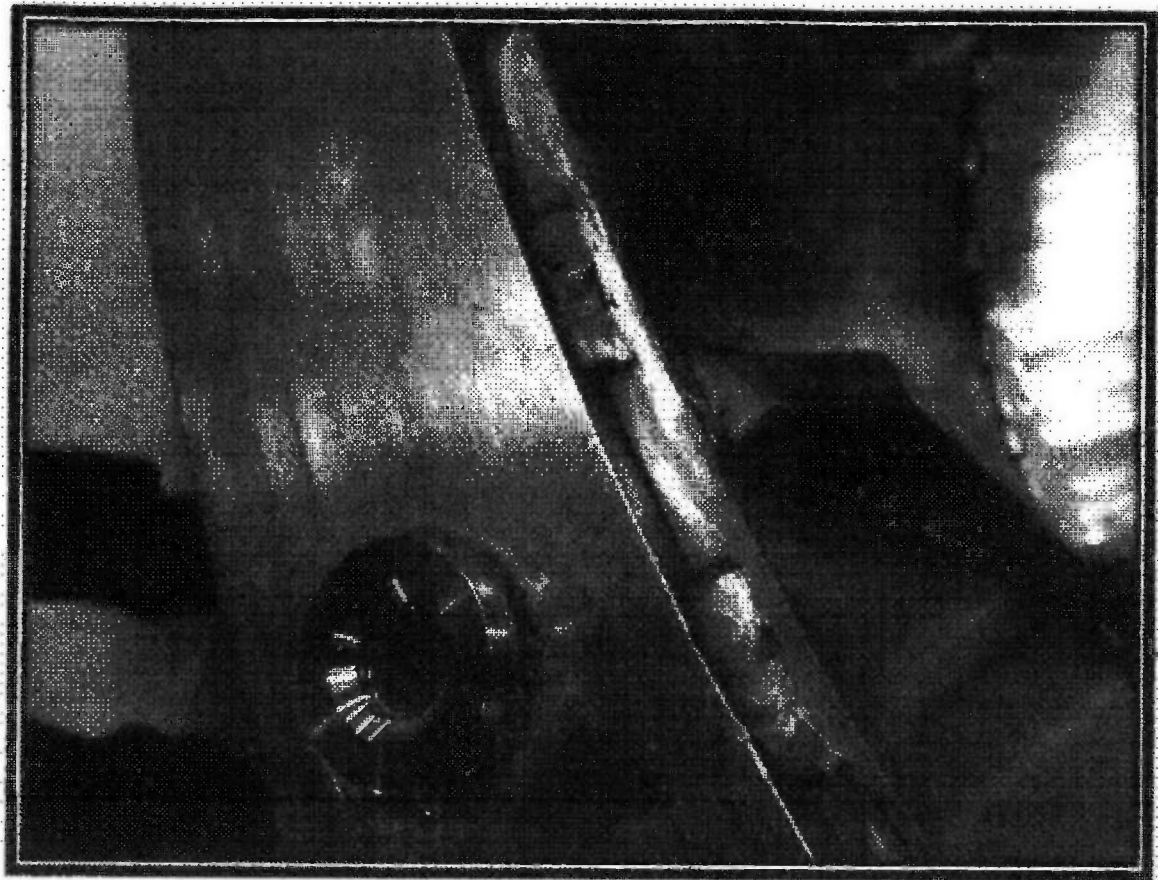
- The LAW container holder is designed to be inserted into the LAW melter cave turntable. The container holder has the potential to become contaminated. However, the container holder was not designed and fabricated in a manner to ease decontamination. Welds inside the holder are not continuous and provide nooks and crevices that will be difficult to decontaminate.

LAW Container Holder Weld Detail Showing Nooks and Crevices
