DOCUMENT NO. RHO-CD-1076

DATE September 1980

STRUCTURAL EVALUATION OF THE PUREX NO. 1 BURIAL TUNNEL

G. R. Silvan

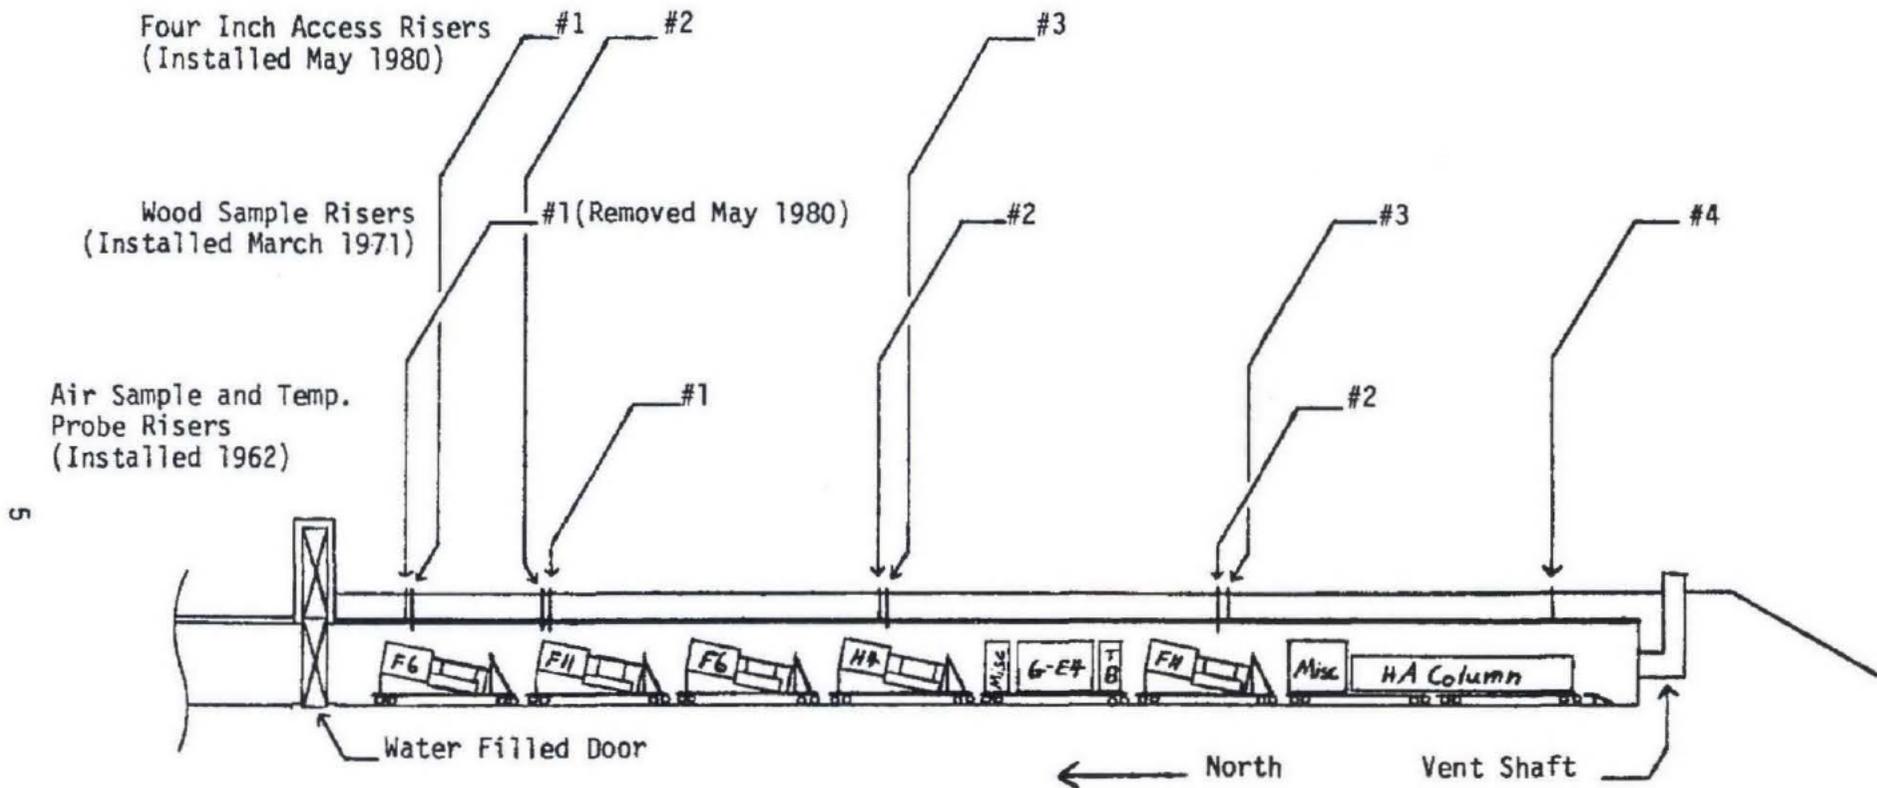
FIGURE 2: PUREX NO. 1 BURIAL TUNNEL

The core sample locations are as follows (see fig. 2):

Location Number 1: Approximately 18 feet south of the water filled door and 4 feet east of the tunnel centerline.

Location Number 2: Approximately 54 feet south of the water filled door and 4 feet west of the centerline.

Location Number 3: Approximately 154 feet south of the door and 4 feet east of the centerline.

Locations one and two were selected because they were the areas that appeared to have received the largest amount of radiation exposure, and location number three was selected as a reference.

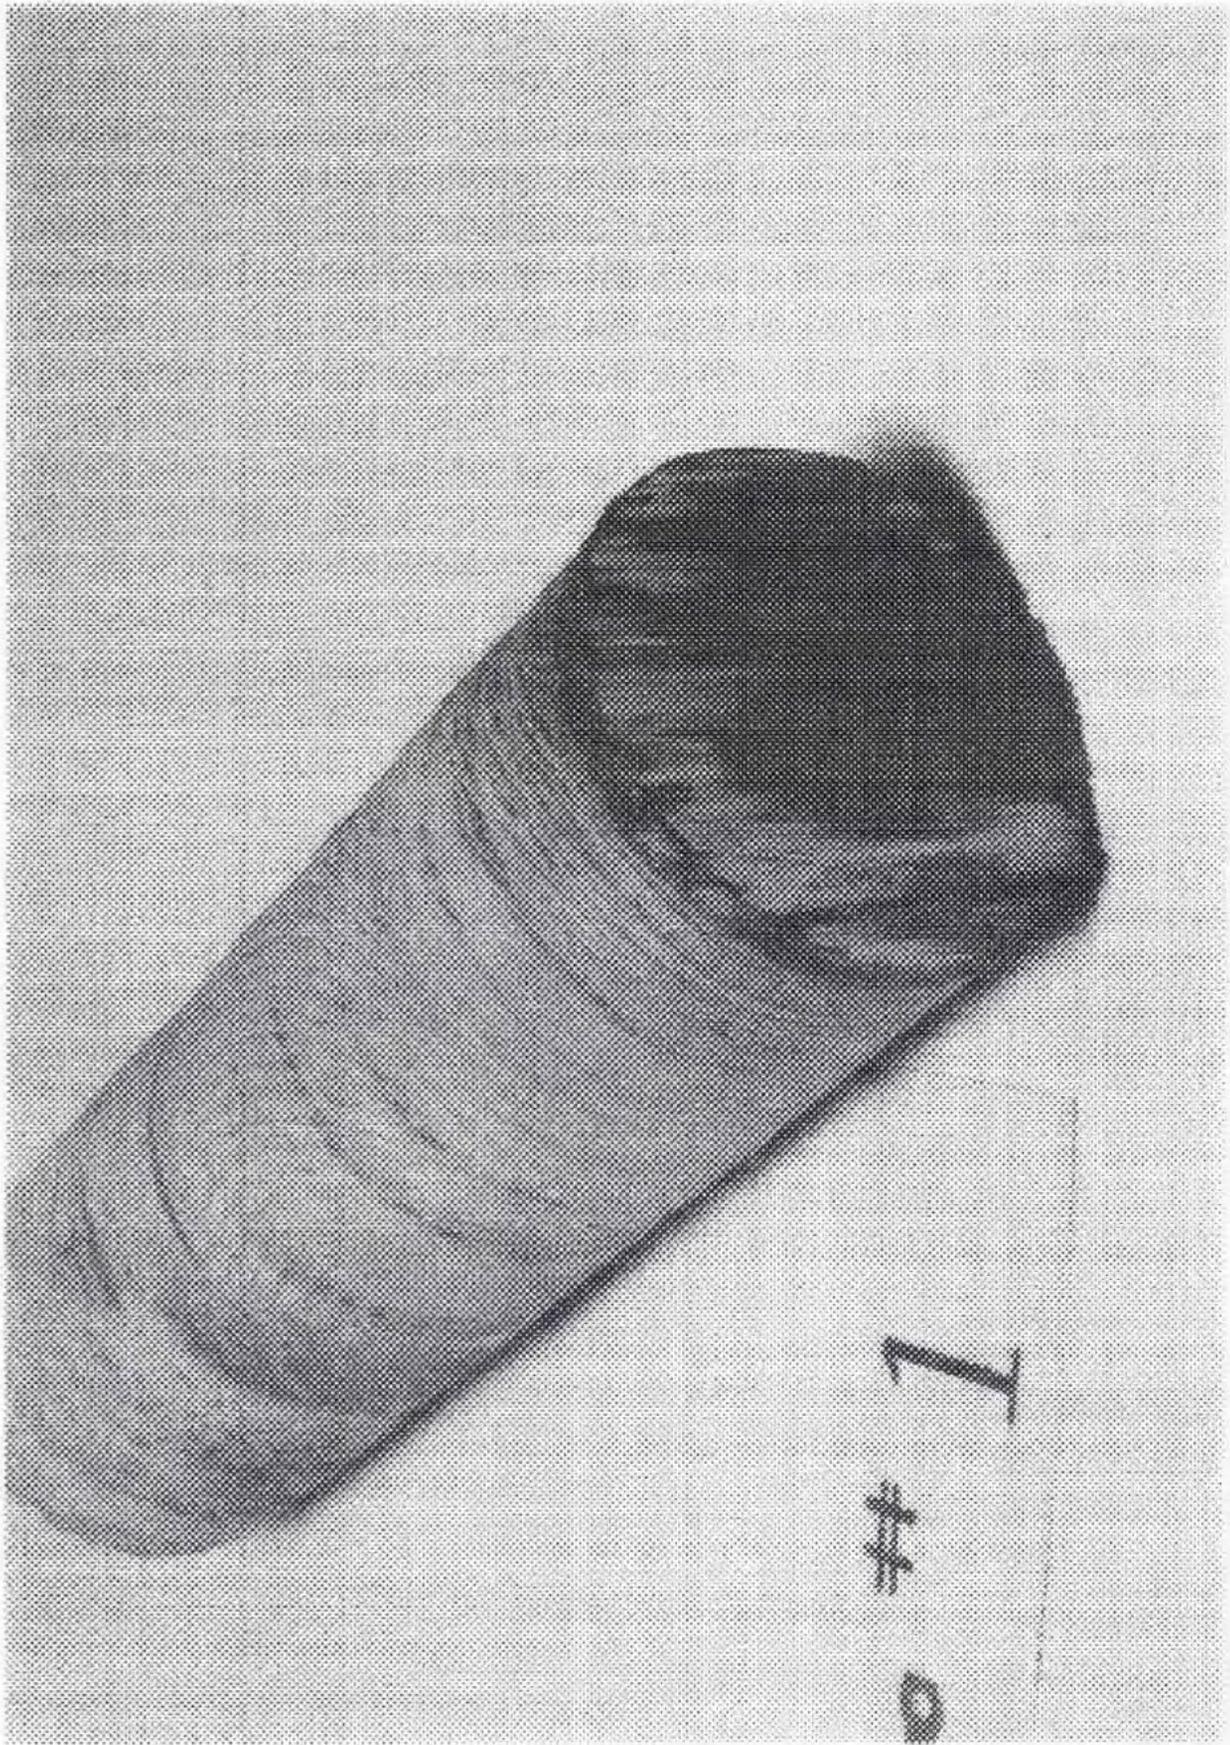
Figure 10: Core Sample, Location No. 1

Core Drilling. Because of low radiation exposure, location number three was chosen to be sampled first and core drilling began on Tuesday, May 13. High winds and problems with the stainless steel saw teeth getting dull too fast forced the operation to be suspended for the day, and the core drilling was completed the next morning. To eliminate the need for constant sharpening, the number of saw teeth on the hole saw was cut in half, and carbide tips were attached to the remaining teeth. After the hole saw was modified, core samples from locations one and two were obtained without difficulty. All core sampling was completed on Friday, May 16. The wood cores are shown in figures 10 through 12. The cores appear blackened on the ends because the timbers had been creosote treated before use.

All three samples have a specific gravity higher than the industrial, and since modulus of rupture is roughly proportional to specific gravity<sup>(12)</sup>, they should all have a higher than average modulus of rupture. This is true with sample number three and the control sample but not true with samples number one and two, and would suggest that these timbers may have been weakened by an environmental influence. The probable cause of this loss of strength will be discussed later in greater detail. In any case, all of the samples fall within the acceptable range for modulus of rupture and the wood in the burial tunnel can be assumed to be compatible with present day douglas fir (see letter in appendix).

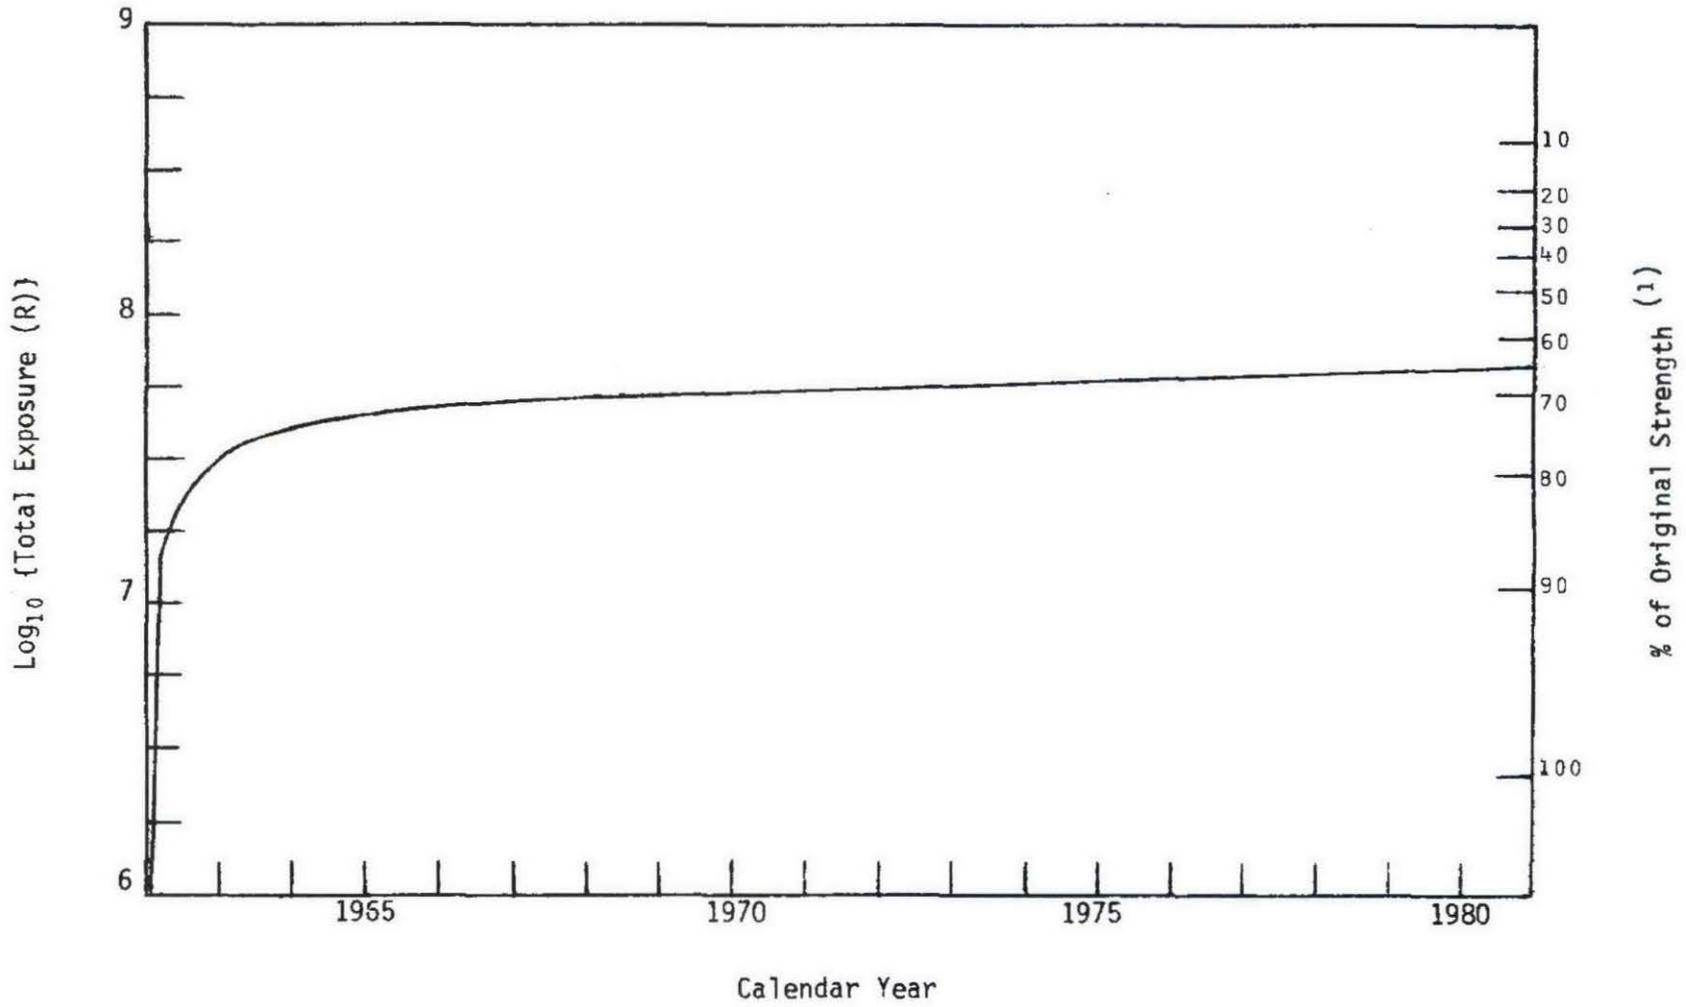
FIGURE 13: WORSE CASE EXPOSURE PROFILE

Radiation. Several locations in the tunnel have been exposed to large amounts of gamma radiation due to the presence of the failed process equipment in the tunnel. Studies have shown that large amounts of gamma radiation can lower the strength of wood.<sup>(1)</sup> The results of the core sample tests bear this out. Samples number one and two which have received large dose of radiation are noticeably weaker than sample number three even though they are similar quality wood. Fortunately, even though the wood has been weakened, it is still within allowable strength limits. A worse case radiation profile has been prepared (see appendix) and is shown in figure 13. The most severe effects

of the gamma radiation occur in the first three years and the effects gradually tapered off thereafter. Radiation is not expected to be a major factor in any future weakening of the tunnel.
