Five-Year Surveillance Report for the 105-DR Safe Storage Enclosure

Program/Project: Long Term Stewardship

Date Published
October 2016

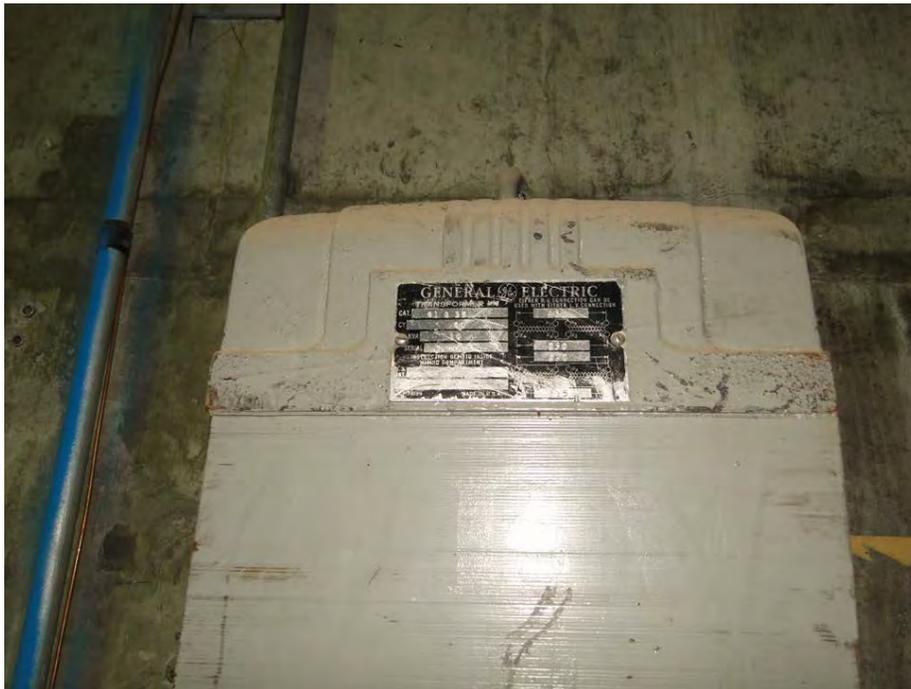
Figure 9. Dry Transformer in 105-DR.

Two dry transformers were observed in 105-DR SSE. Figure 9 shows one of the transformers. Both transformers were in good conditions and were not leaking. No action regarding the transformers is planned.

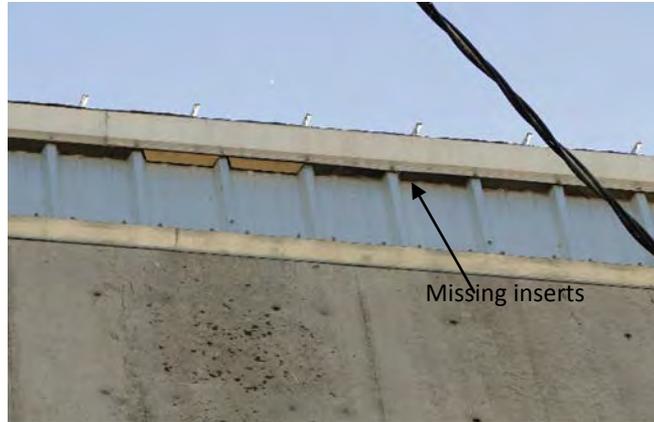
Figure 11. Missing Inserts between Metal Roof and Walls.

2. Inserts between metal roof and metal wall are missing which can allow biological intrusion. There are several instances of the missing inserts (see Figure 11).

A screening project has been initiated to place screens over the openings and install foam inserts where needed. 105-DR houses a maternal colony of bats; they are anticipated to move out in September or October. The work to install the screens will be performed once LTS receives clearance from MSA Environmental Monitoring and Environmental Surveillance.

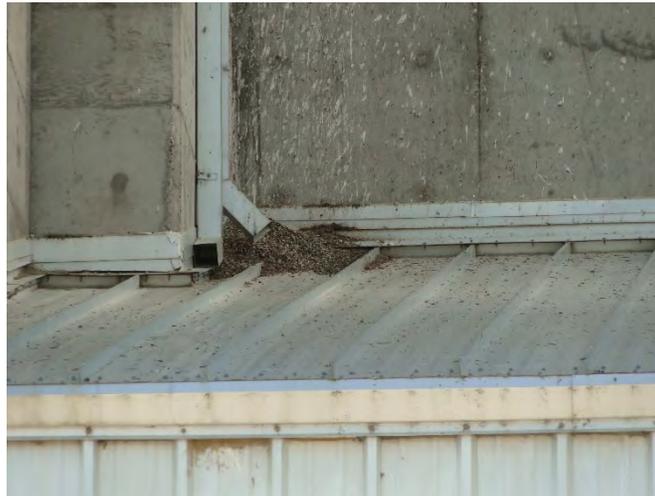
Figure 12. Photo of Roof Showing Accumulated Bird Droppings.

3. Bird droppings are accumulating on the steel roof, as shown in Figure 12. There is a potential for roof corrosion.

Roof areas where droppings are present will be observed during the annual exterior inspection of 105-DR. If further concerns are identified, the necessary actions will be taken following the annual inspection.

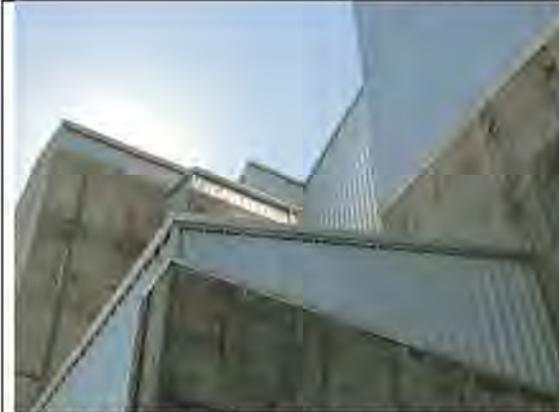
DSC04131 Inserts between metal roof and metal wall are missing in several locations. A few at higher elevations could be seen to be missing from north side of building. Same issue was observed in 2012 inspection.

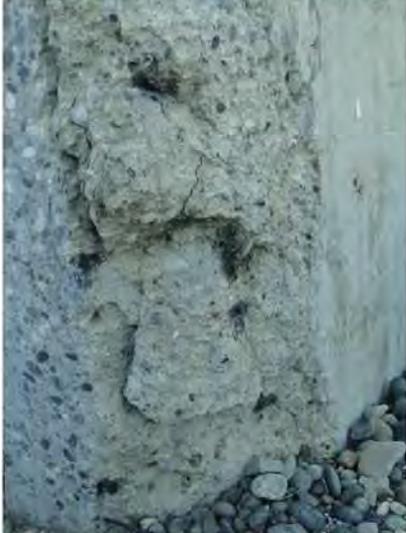
<p data-bbox="266 921 703 999">DSC04135 Northwest corner of front face. Spalling of concrete on corner, no change from 2012 inspection.</p>

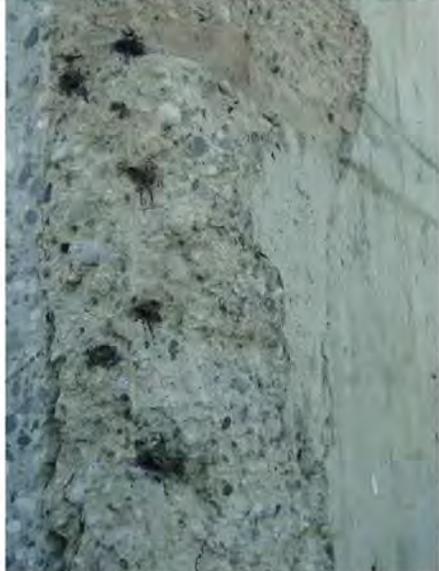
<p data-bbox="727 959 1349 1016">DSC04136 Northwest corner of front face. Spalling of concrete on corner, no change from 2012 inspection.</p>

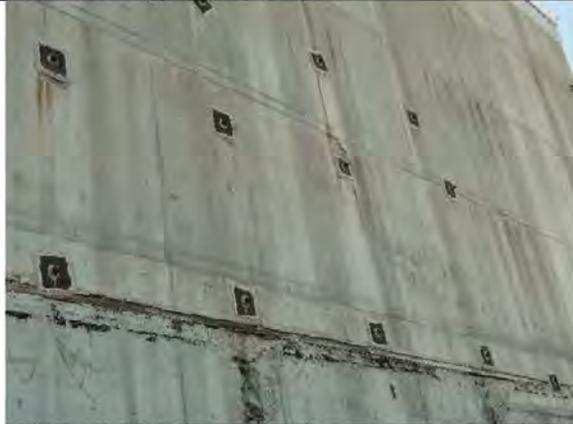
<p data-bbox="727 1442 1294 1520">DSC04137 Wall plates are showing corrosion. Rust color is running down wall between plates. No change from 2012 inspection</p>

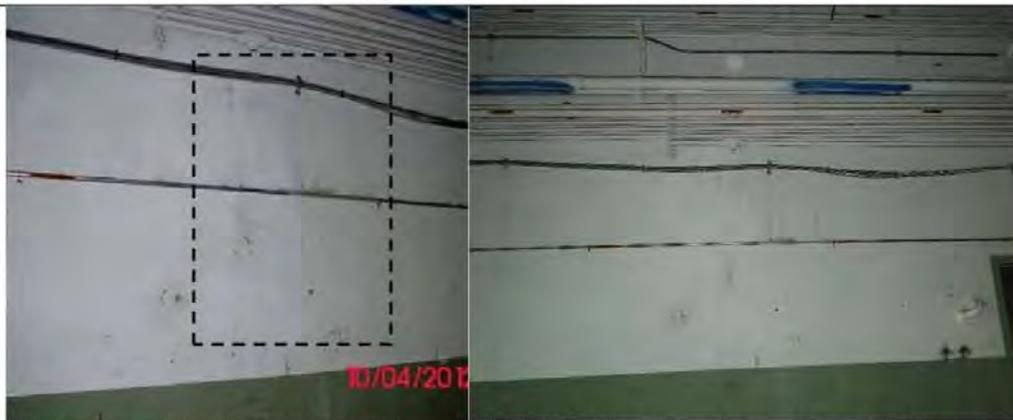
DSC04221 Moisture intrusion was observed in this area on 2012 inspection. No moisture was observed.

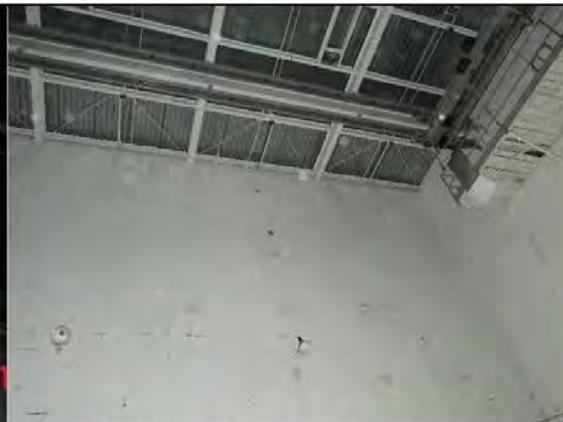
DSC04225 2012 inspection observed "discoloration and corrosion". 2016 walkdown concluded that corrosion was very minimal.

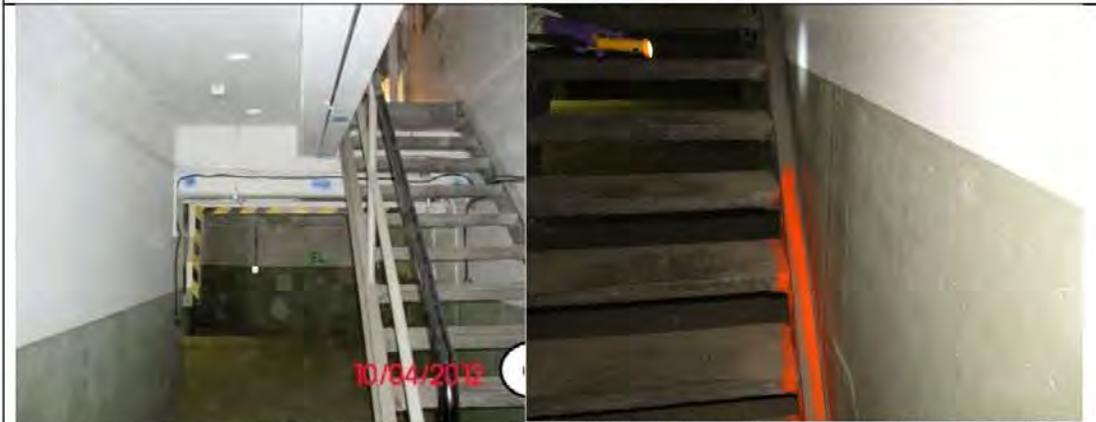
DSC04193 – Stairs to -9' appear stable, 2016 team could not replicate instability.

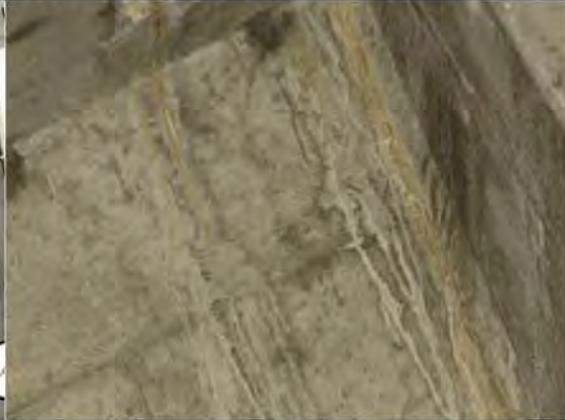
DSC04179 Discoloration/staining on concrete was noted in the 2012 walkdown. Staining still exists, looks the same as in 2012.

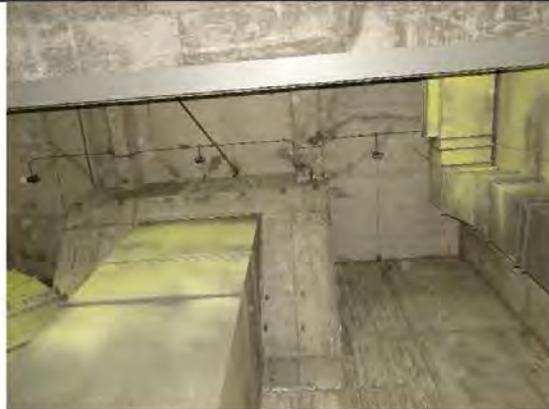
DSC04181 Discoloration/staining on concrete was noted in the 2012 walkdown. Staining still exists in 2016, looks the same as in 2012.

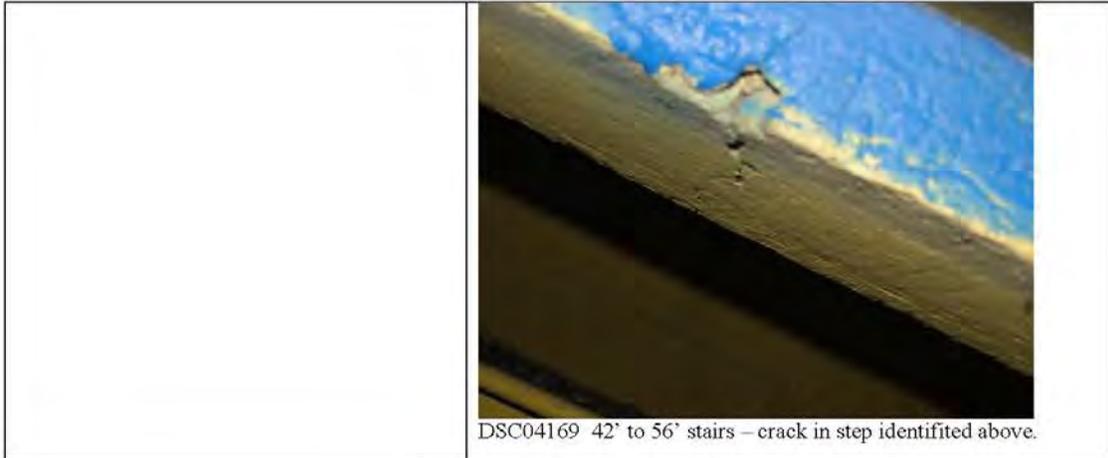
DSC04169 42' to 56' stairs – crack in step identified above.

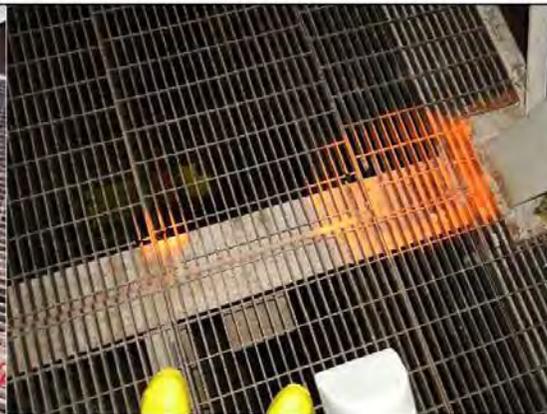
DSC04145 grating minor damage

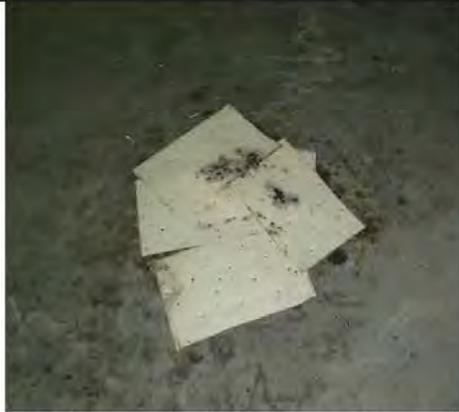
DSC40227 Absorbent pads on floor of front face along north wall (2 locations). Leakage appears to be very slow.

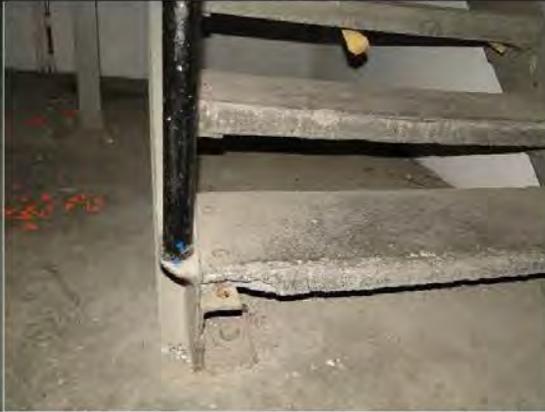
DSC40186 Bottom stair of the south staircase to the +13' Elev. shows spalling and deterioration.

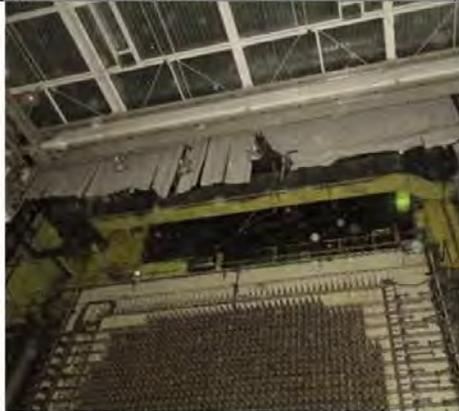
DSC40198 Bats present above front face work area, large amount of bat guano on the floor.

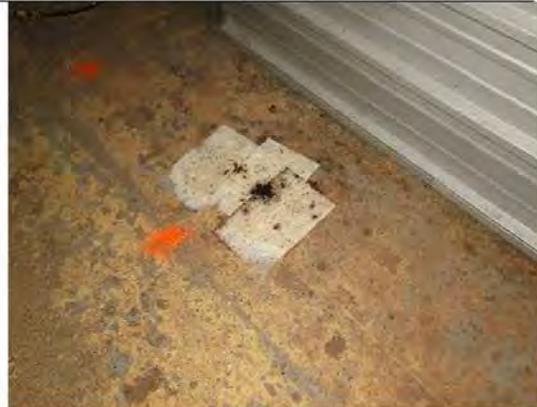
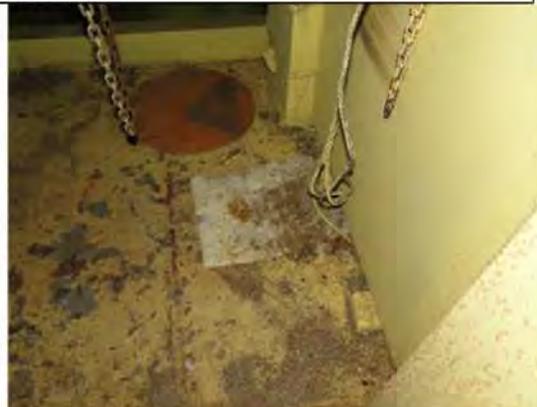
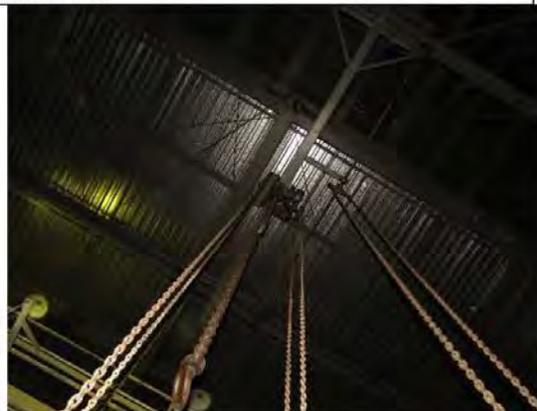
Three winches are leaking from above the 42' 4 5/8" level. Two areas with absorbent pads are located on the floor on the northwest side of floor. One area with absorbent pads is located on top of the top hat. Leakage appears to be very slow in all cases.

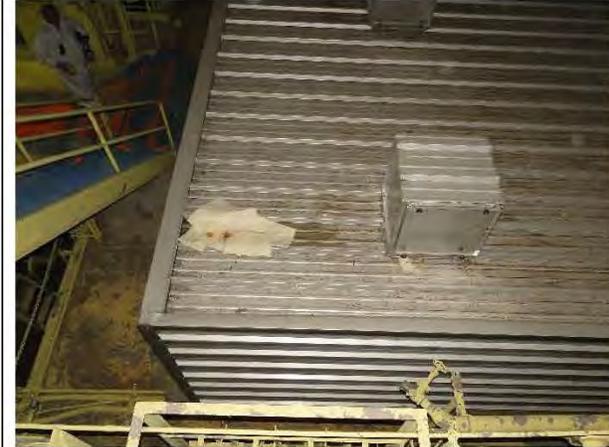
DSC04162 – Drip absorbant pad on top hat, adjacent to 42' to 56' stairs.
