**ADDITIONAL INFORMATION TO SUPPORT REQUEST FOR TEMPORARY
AUTHORIZATION TO IMPLEMENT THE CLASS 3 PERMIT MODIFICATION REQUEST
FOR THE PUREX STORAGE TUNNELS CLOSURE UNIT GROUP 19 TO ALLOW
INTERIM CLOSURE ACTIVITIES FOR PUREX STORAGE TUNNEL 2**

CHPRC-03811
Revision 0

PUREX Tunnel 2 Visual Inspection Results

Date Published
August 2018

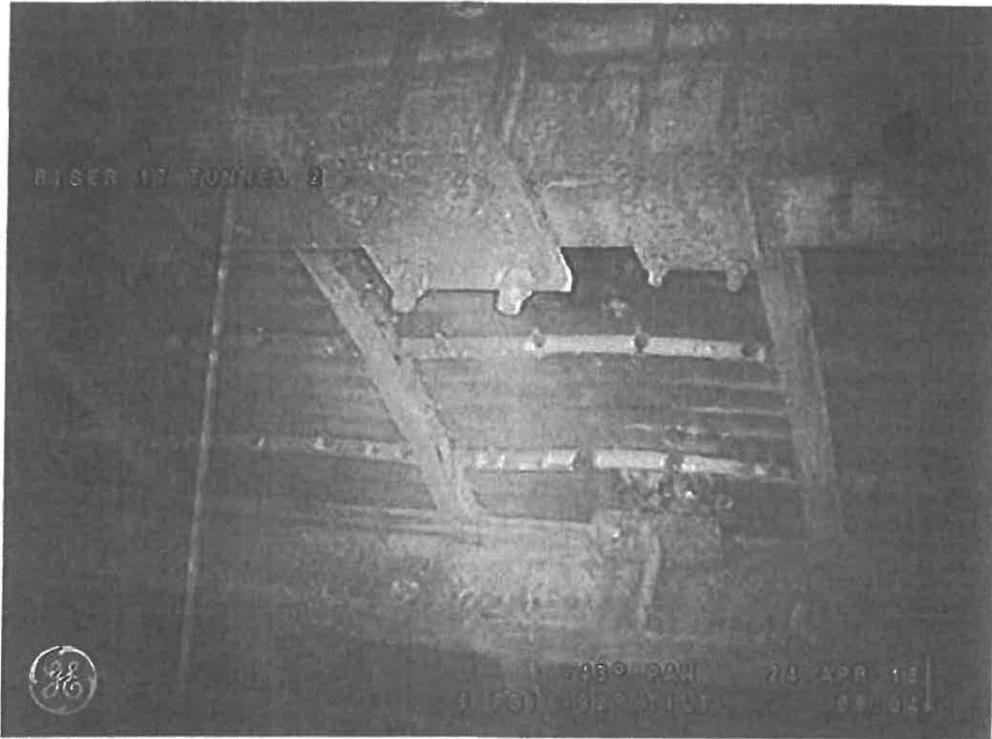
Between February 2018 and April 2018, video inspections were performed of the interior of the tunnel. The inspections confirmed that the interior steel configuration matched the details shown on the construction drawings. During the visual inspections close attention was paid to the steel members and connections. The visual inspections found significant corrosion at the south end of the tunnel (refer to Figures 1 and 2), while the north end did not have the same level of corrosion (refer to Figure 3).

Figure 1, Wide view of structural steel members near South end of Tunnel 2

The corrosion in the South end of the tunnel on the bolts and threads which extend to the external concrete support ribs is a concern. Corrosion at threaded connections is a common cause of failure in general industry. The concrete support ribs, wale beams and the bolted connections were specifically installed to prevent the collapse of the tunnel (after earlier designs without these features failed during backfill). The Engineering Evaluation identified several overstressed structural support members and connections. The presence of significant corrosion means the structure is weaker than analyzed.

The conclusion of the evaluation of the visual inspections indicates PUREX Tunnel 2 is weaker than analyzed and grouting should proceed as soon as possible.

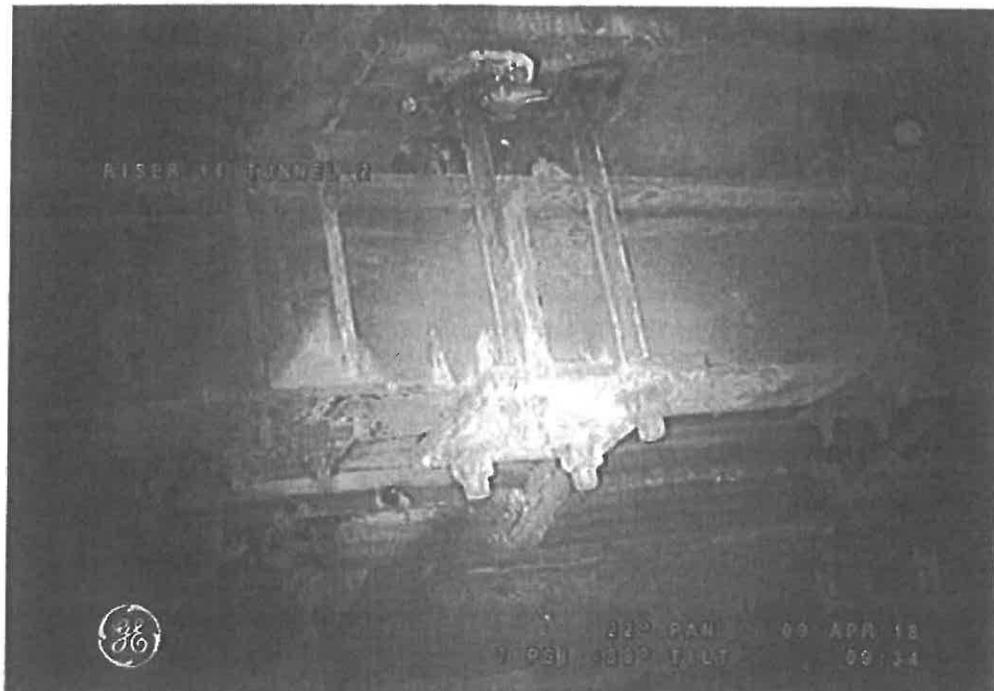
Figure 2, Close up of structural (bolted) connections in the South end of Tunnel 2

If one of the connections to the concrete ribs failed, the load would shift to other connections increasing their overstressed conditions and likely causing failure. The failure could be a localized collapse. However, the shifted loads could create a failure sequence, commonly called a "zipper" effect, leading to a failure larger than that experienced in Tunnel 1 (the collapse would expand until overburden could not be supported by adjacent members). In addition, dropping structural steel components present a greater threat to the waste containers/equipment stored in Tunnel 2 (as compared to the wooden timbers used in Tunnel 1).

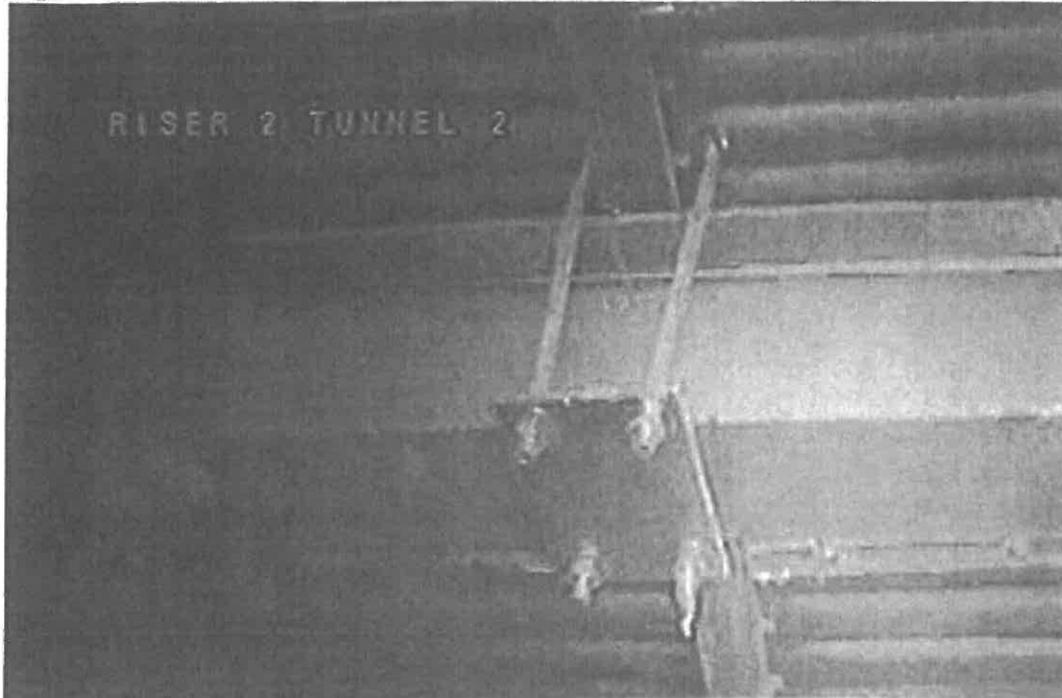
Figure 3, Example of structural steel conditions in North end of Tunnel 2
