# 241-AN Tank Farm Construction Extent of Condition Review for Tank Integrity

**Abstract:** This report provides the results of an extent of condition construction history review for the 241-AN tank farm. The construction history of the 241-AN tank farm has been reviewed to identify issues similar to those experienced during tank AY-102 construction. Those issues and others impacting integrity are discussed based on information found in available construction records, using tank AY-102 as the comparison benchmark. In the 241-AN tank farm, the fifth double-shell tank farm constructed, tank bottom flatness, refractory material quality, post-weld stress relieving, and primary tank bottom weld rejection were improved.

Date Published  
January 2014

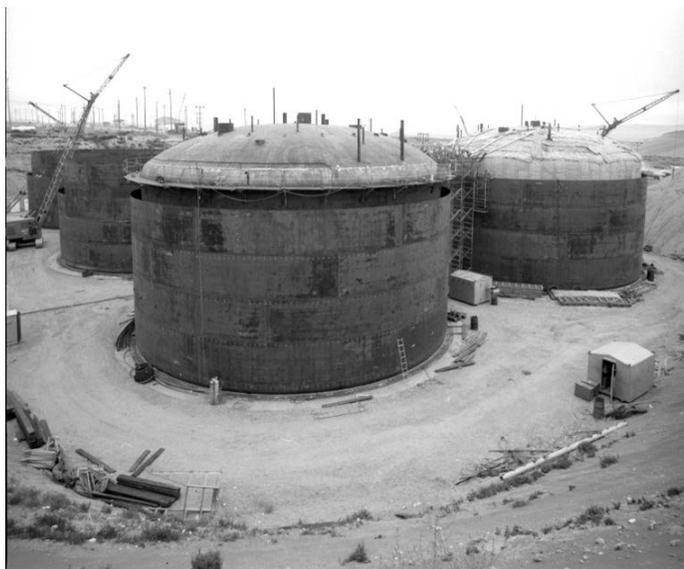
**Figure 4-14. Tank AN-104 (right) during Post-Weld Stress Relieving (Photo 83472-13) (Taken 9/21/1978)**

Although the construction specification specifies a stress relief temperature of 1100° F, dome deformations in tank AW-101 due to stress relieving at 1100° F triggered a change in the stress relieving procedure (see RPP-RPT-55981, *241-AW Tank Farm Construction Extent of Condition Review for Tank Integrity*, for details). To prevent similar dome distortions in tank AW-102 during stress relieving, the requirement was changed to a soak temperature of 1000° F for three hours (see App. Figure B-2). Dome distortions due to stress relieving in tank AW-102 were significantly less severe than those in tank AW-101 (see App. Figure B-3), so the new requirement became procedure for the remaining 241-AW tank farm tanks and all of the 241-AN tank farm tanks.

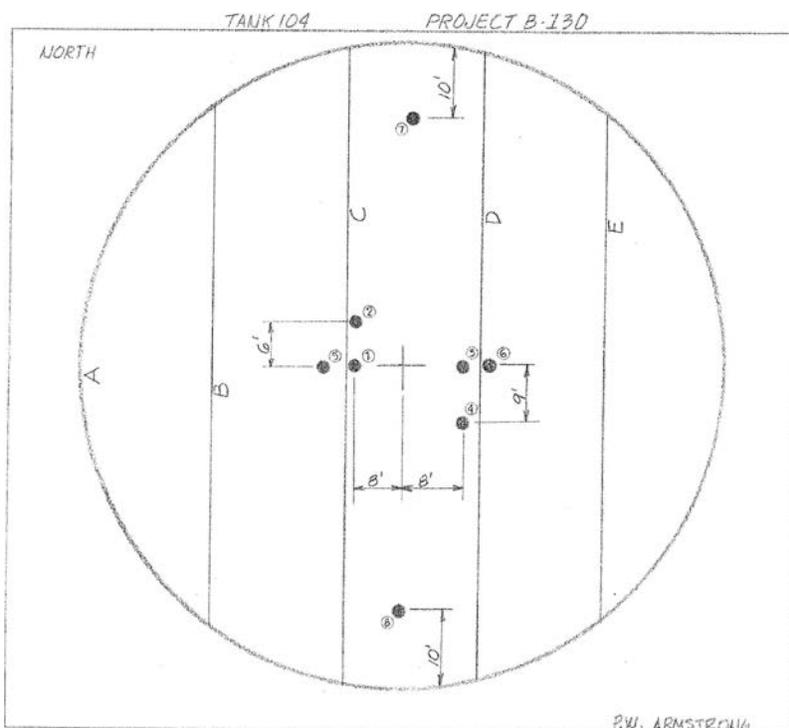
**Figure 5-1. Tank AW-104 Drilled Refractory Drill Sequence and Location**

Lite Wate 70 (LW70) was the refractory material utilized in the 241-AN tank farm tanks. A void between the secondary liner bottom and refractory was found near the center of tank AN-104. Holes were drilled in the refractory and pourable grout was used to fill the void. The holes were then filled with LW70, and the refractory was accepted.

HOLE #2 ~ VOID 5/8"  
 HOLE #2 ~ VOID 1/2"  
 HOLE #3 ~ VOID 1/4"  
 HOLE #4 ~ VOID 0"  
 HOLE #5 ~ VOID 0"  
 HOLE #6 ~ VOID 0"  
 HOLE #7 ~ VOID 0"  
 HOLE #8 ~ VOID 0"

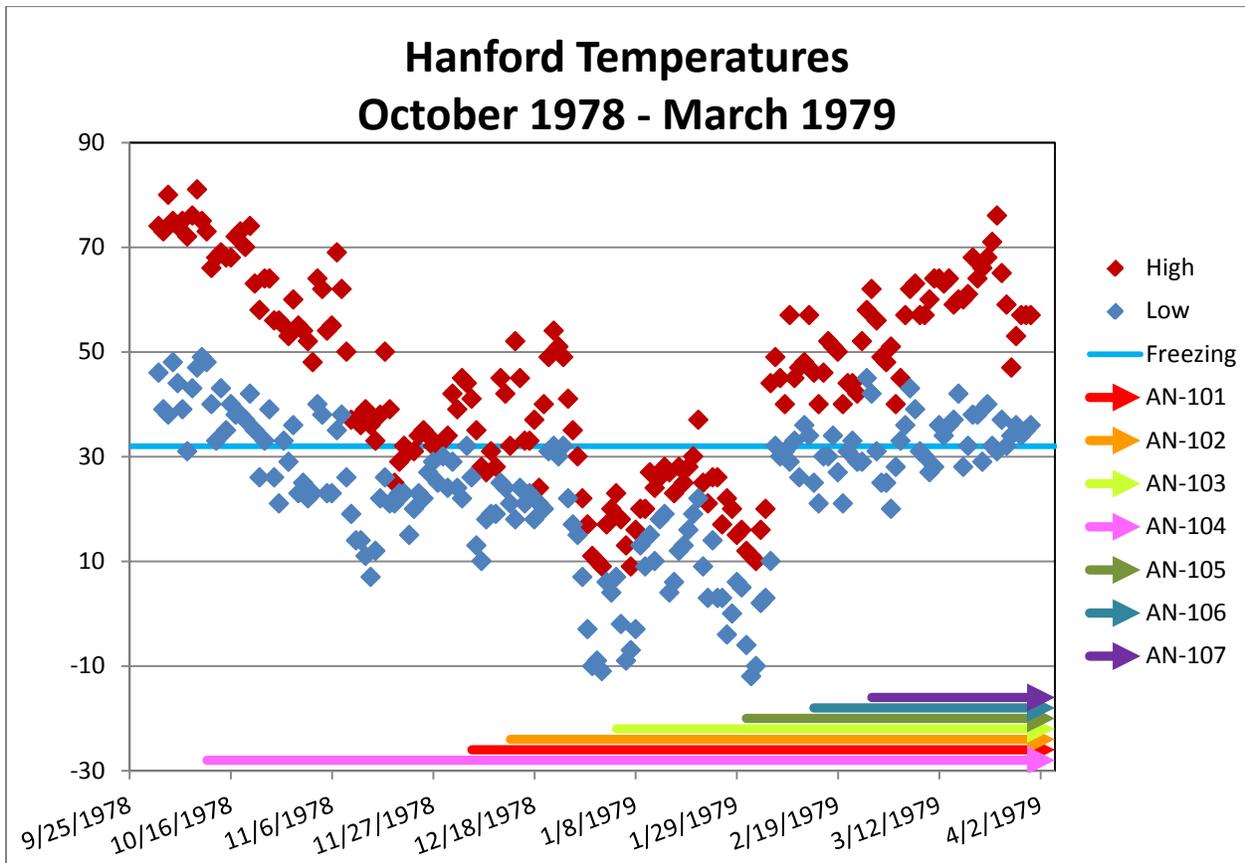
**Figure 5-2. Hanford Temperatures (October 1978 through March 1979) and Periods When Tanks Were Filled with Water**

The author of the January 8 inspection report adds that, because the temperature had been around 0° F for approximately two weeks prior to his inspection, any small leaks might have been frozen and not visible. This issue was not addressed in any available documentation. Temperature data from the Hanford Meteorological Station show that the area experienced temperatures below freezing for approximately five weeks in the winter of 1978-79. Five of the tanks in the 241-AN tank farm were partially or completely full of water during this time. Once the hydrostatic test water was added, it remained in the tanks for several months so that it could be used to support the dome concrete pour. Figure 5-2 shows the minimum and maximum temperatures at Hanford from October 1978 through March 1979, as well as a bar showing the period when each tank in the 241-AN tank farm was filled with water during and following the hydrostatic testing. Tanks AN-101 through AN-104 remained full of hydrostatic test water during a period of time where temperatures were consistently below freezing.

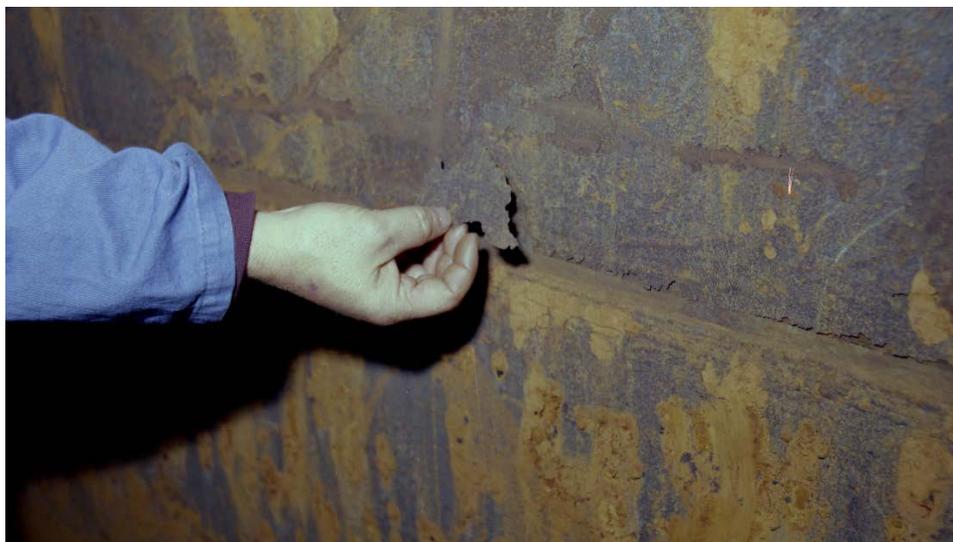
**Figure 5-3. Mill Scale Discovered in Tank AN-107 (Photo 093266-31cn)  
(Taken 10/20/1980)**

1. *"The majority of the tank is corroded to some extent and is covered with loose red/orange/brown oxide which is expected to be  $Fe_2O_3$  or one of its hydrated forerunners,*
2. *In many locations the corrosion products have formed tubercles [sic] or "puff ball" structures (particularly true of the lower three feet on the wall),*
3. *The scale over and to each side of the welds, particularly the vertical welds, is loose, and*
4. *The surface surrounding the localized corrosion on the tank bottom still appears to be a well-adherent layer of mill scale."*

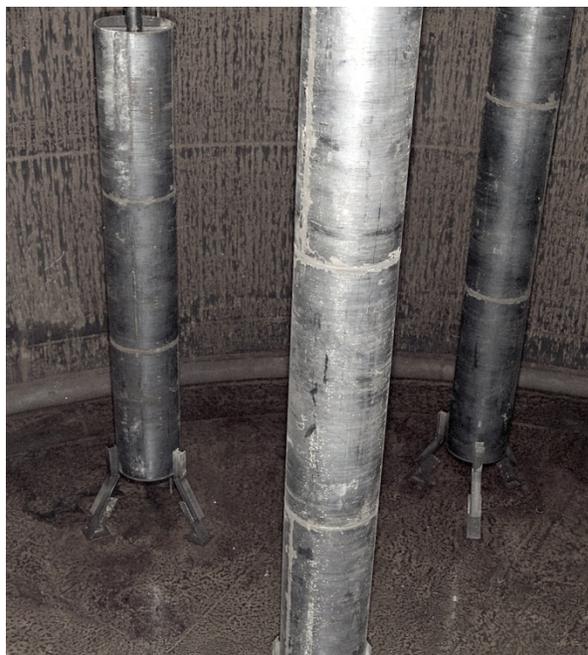
**Figure 5-4. Rust and Pitting on the Tank Bottom and Walls of Tank AN-107. (Photo 94572-43) (Taken 8/26/1980)**

It is believed that tank AN-107 was the only tank in the 241-AN tank farm to be inspected following the pump-out of water. Based on the amount of time that other 241-AN tank farm tanks contained raw water, it is hypothesized that all tanks in the 241-AN tank farm would have similar rust and pitting (shown in Figure 5-4) as a result.

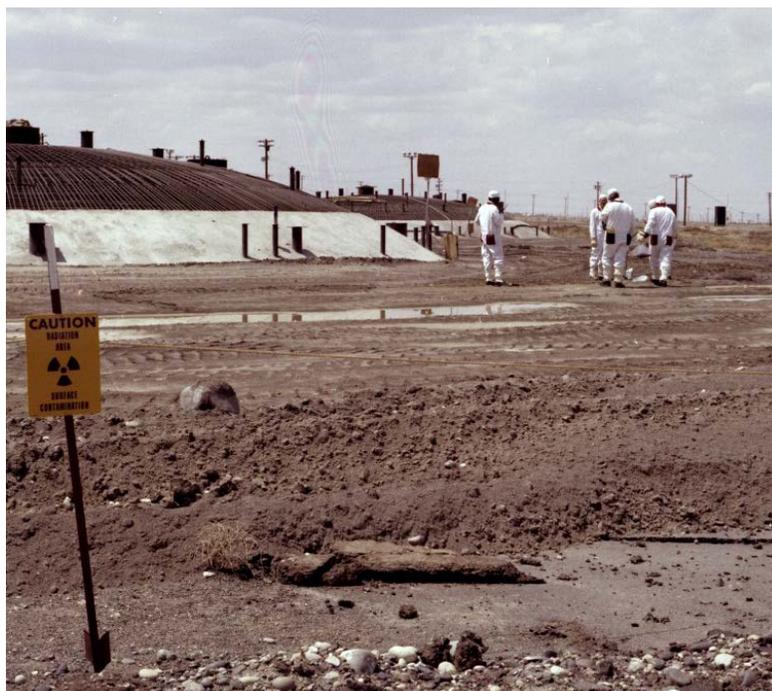
**Figure 5-5. Removing Contaminated Soil from the 241-AN Tank Farm (Photo 87008-2) (Taken 6/14/1979)**

During backfill operations for the 241-AN tank farm, additional backfill material was being obtained from a borrow area to the east of the 200-East perimeter fence, north of crib 216-A-24, and south of a ditch. The subcontractor was excavating approximately 100 ft. north of the fence surrounding the crib at a depth of approximately 15 ft. On June 13, 1979, moisture in the soil was encountered which was later discovered to be contaminated material. Some of this material had already been transported and placed in the tank farm along the north side. The material was placed between 33 ft. and 66 ft. north of tank AN-107 and tank AN-104 with some spillage from the scrappers in between the tanks and along the haul road. A crew dressed in protective clothing is seen removing contaminated backfill from the 241-AN tank farm in Figure 5-5.

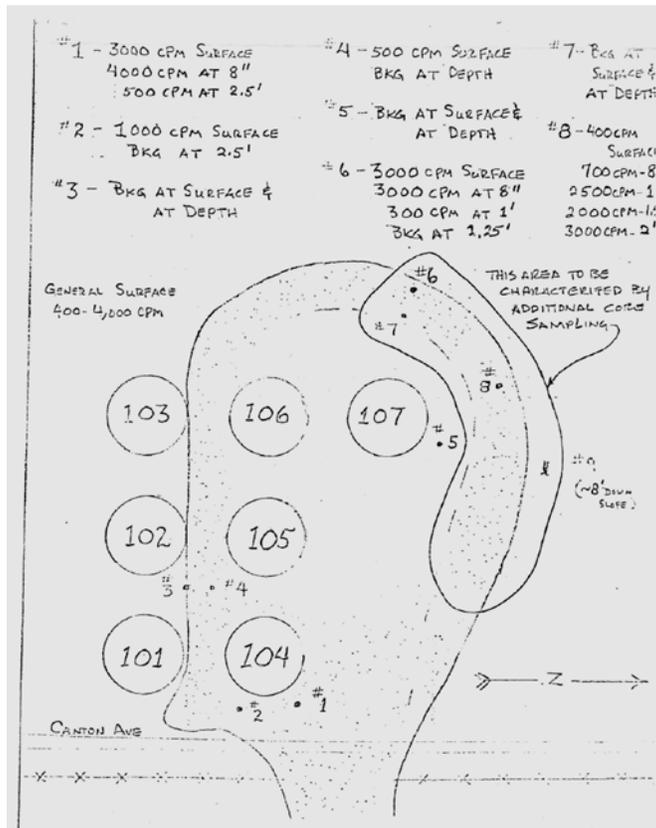
Figure 5-7. 241-AN Tank Farm Contaminated Backfill Core Sample Results

As a result of the action taken to address the contaminated backfill within the 241-AN tank farm, localized areas of contamination likely still exist in the north region of the farm. Figure 5-6 shows the tank farm location relative to designated borrow area and identifies the key landmarks discussed within the description of the occurrence. Figure 5-7 shows core sample results from around various regions of the farm and provides an overview of the level of contamination discovered.

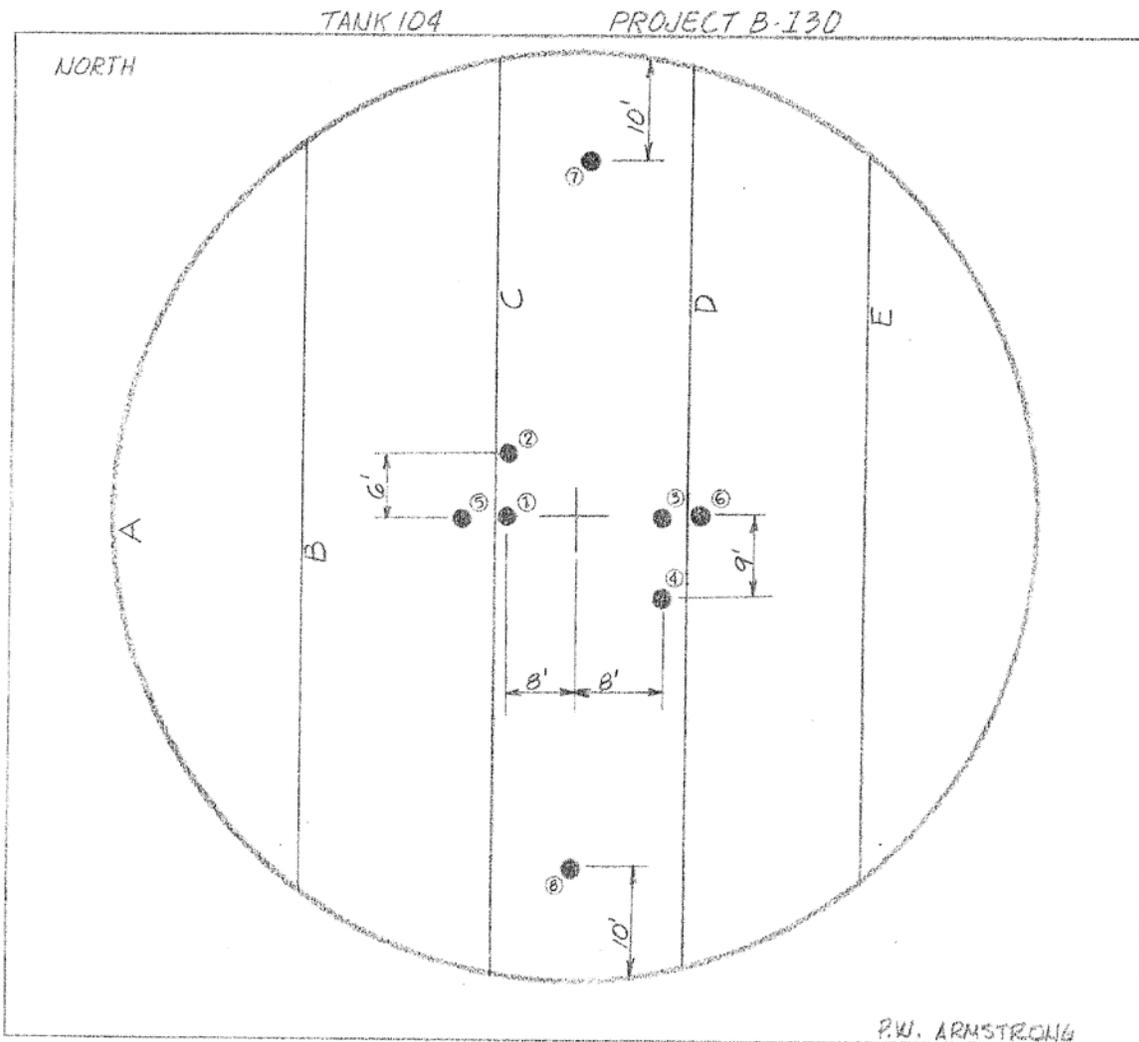
- HOLE #1 ~ VOID 5/8"
- HOLE #2 ~ VOID 1/2"
- HOLE #3 ~ VOID 1/4"
- HOLE #4 ~ VOID 0"
- HOLE #5 ~ VOID 0"
- HOLE #6 ~ VOID 0"
- HOLE #7 ~ VOID 0"
- HOLE #8 ~ VOID 0"

CORE DRILLED (8) ONE INCH HOLES FOR INSPECTION. THE VOID BETWEEN THE BOTTOM OF THE INSULATING CONCRETE AND TOP OF SECONDARY, STEEL TALK BOTTOM IS AS FOLLOWS:
