PROJECT CAI-816
NEW PRODUCTION REACTOR
STEAM GENERATORS
MECHANISMS AND CAUSES OF TUBING FAILURES

MECHANISMS AND CAUSES OF TUBING FAILURES

N REACTOR STEAM GENERATOR 3B
MATERIAL 304 STAINLESS STEEL

"N" REACTOR STEAM GENERATORS 2A & 4A - MATERIAL - 304 STAINLESS STEEL TUBING

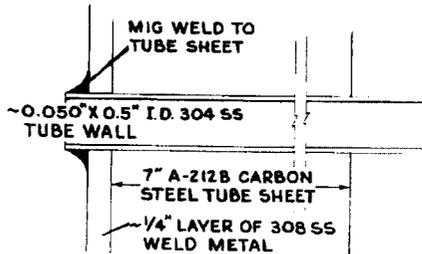
The stress corrosion observed in this case was immediately adjacent to the weld which attached the 304 stainless steel tube to the tube sheet. A cross section of the tube-to-tube sheet geometry is given in Figure 1. Because of the fabrication history of these steam generators, a pronounced stress gradient exists in the vicinity of the tube mouth as axial and hoop stresses. An idealized sketch of the stress distribution is given in Figure 1. The stresses resulted from the tube being rolled into the carbon steel sheet, welded in place, then the entire vessel was subjected to a heat treatment to stress relieve the welds in the carbon steel. This heat treatment at 1125-1150 F for 6-10 hours relieved the weld stresses, but it also thoroughly sensitized the 304 stainless steel by precipitating the carbides and generated severe residual stresses because of the dissimilar coefficients of thermal expansion of carbon and stainless steels. The calculated stresses are well above the elastic limit of the 304 stainless steels so that it is highly probable that there is a high level of residual stress near the tube mouth, decaying rapidly to values near zero within the first 0.5-1.0 inch. Therefore, the first requirement for stress corrosion is known to exist in all the steam generators.

CROSS SECTION OF TUBE JOINT

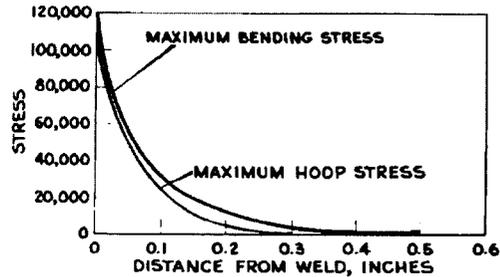
CALCULATED STRESS DISTRIBUTION IN TUBE AFTER HEAT TREATMENT

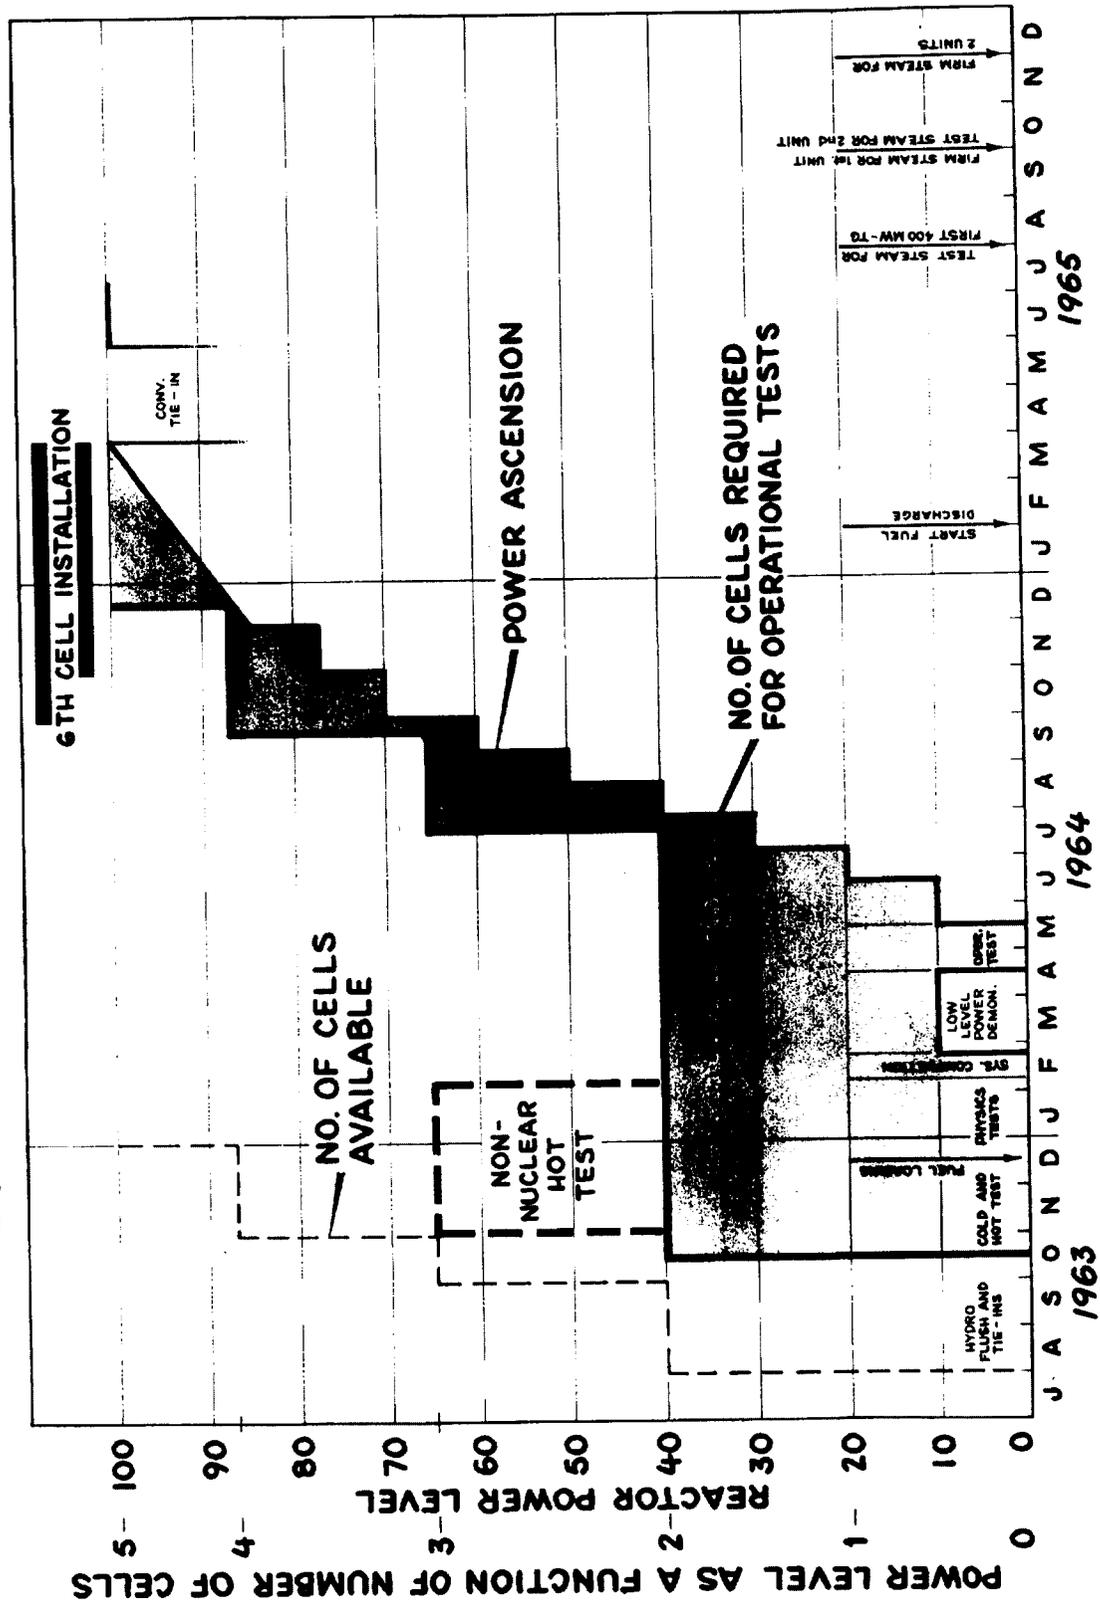
EFFECT OF STEAM GENERATOR OUTAGE ON REACTOR STARTUP

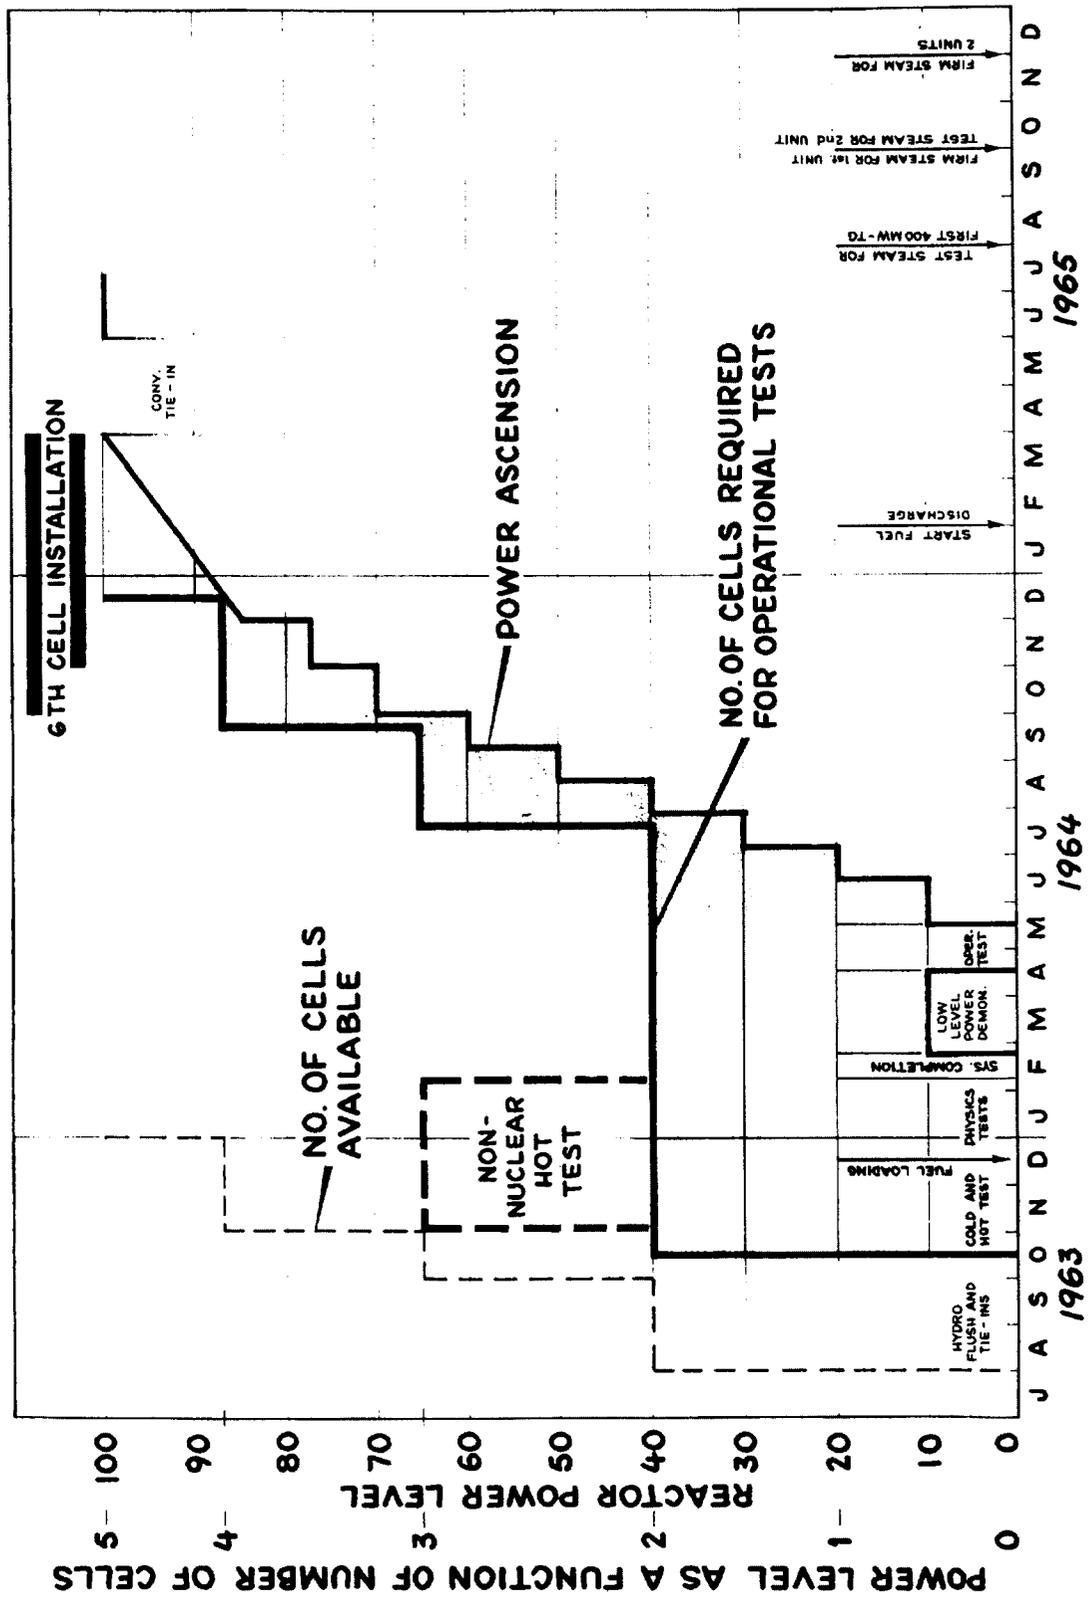
EFFECT OF STEAM GENERATOR OUTAGE ON REACTOR STARTUP
