Locating the Source of a Chromium Groundwater Plume at the Hanford Site

Scott W. Petersen, Fluor Hanford, Inc.

Christopher Murray, Pacific Northwest National Laboratory

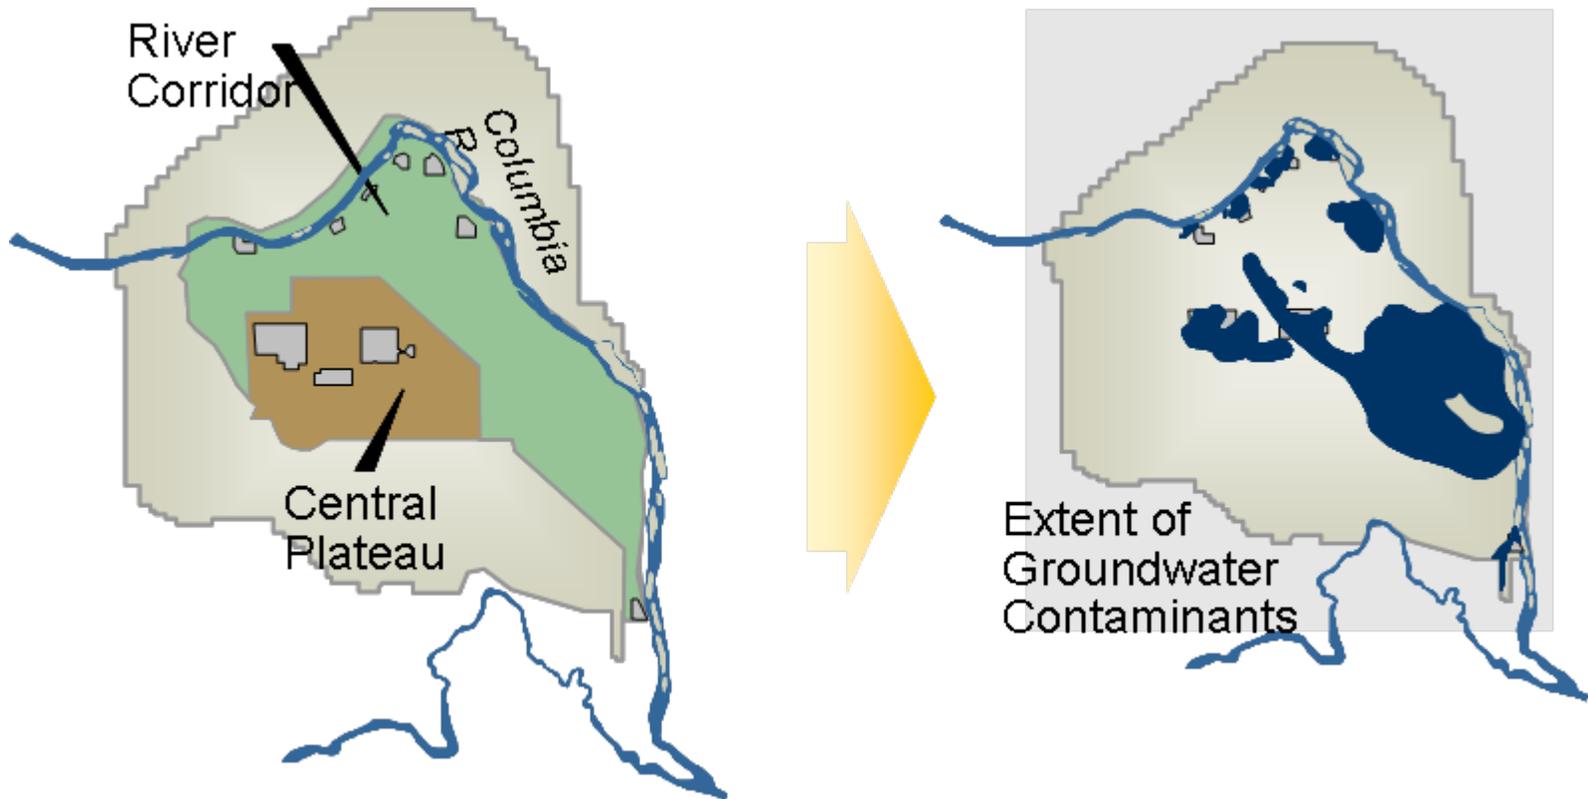
Current Extent of Groundwater Contamination

- Approximately 80 square miles of groundwater contaminated above drinking water standards
- Contaminants from 100/300 Areas and PUREX reach Columbia River

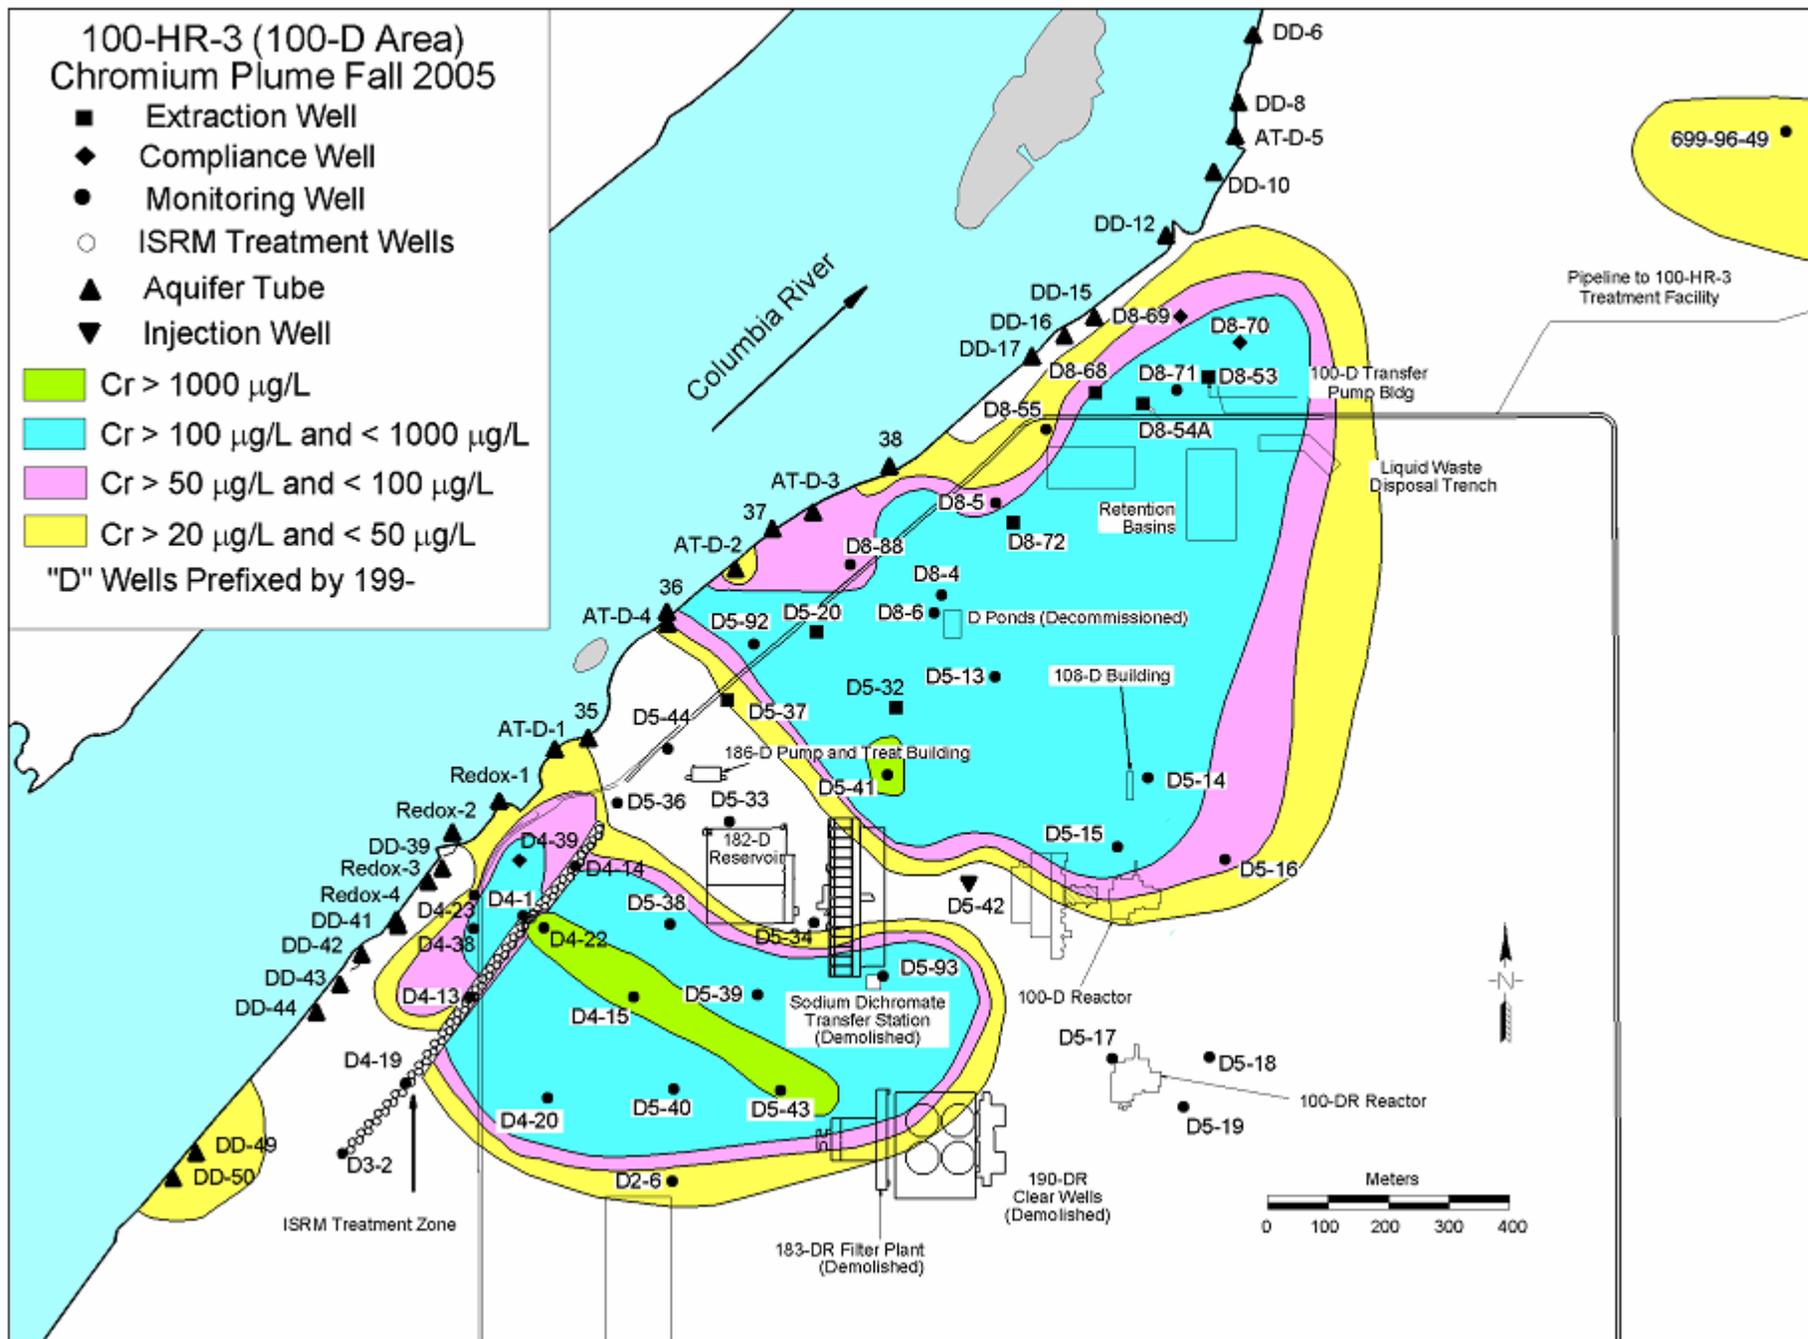
100-HR-3 (100-D Area) Chromium Plume Fall 2005

- Extraction Well
- ◆ Compliance Well
- Monitoring Well
- ISRM Treatment Wells
- ▲ Aquifer Tube
- ▼ Injection Well

- Cr > 1000 µg/L
- Cr > 100 µg/L and < 1000 µg/L
- Cr > 50 µg/L and < 100 µg/L
- Cr > 20 µg/L and < 50 µg/L

"D" Wells Prefixed by 199-

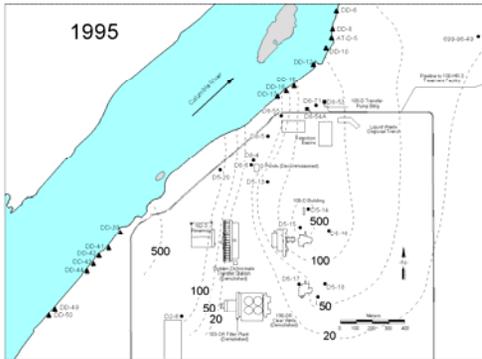
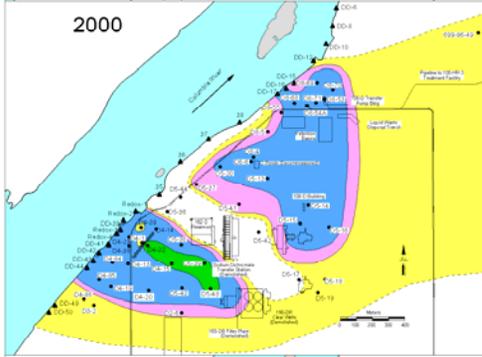
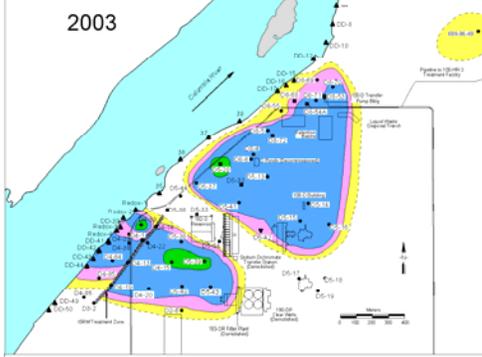
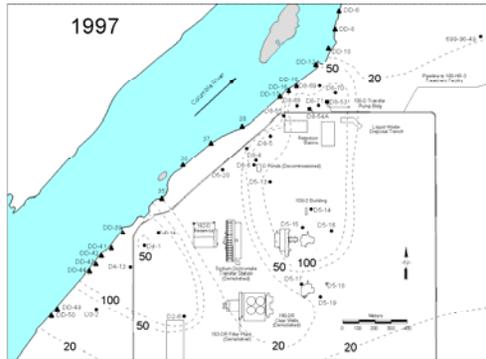
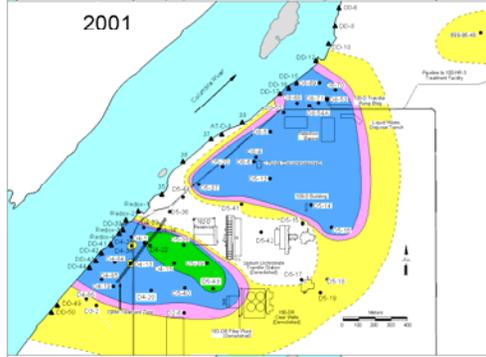
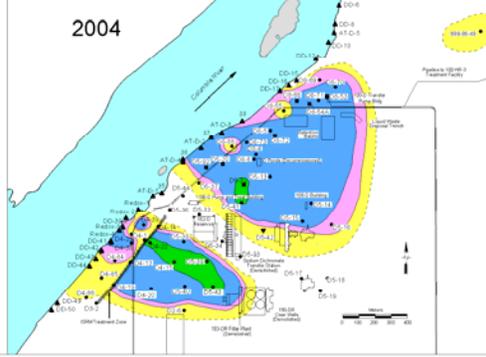
**100-HR-3 (100-D Area)
Chromium Plume
Fall 1995 to 2005**

- Extraction Well
- ▼ Injection Well
- Monitoring Well
- ▲ Aquifer Tube

- Chromium > 1000 µg/L
- Chromium > 100 µg/L and < 1000 µg/L
- Chromium > 50 µg/L and < 100 µg/L
- Chromium > 20 µg/L and < 50 µg/L
- Chromium < 20 µg/L

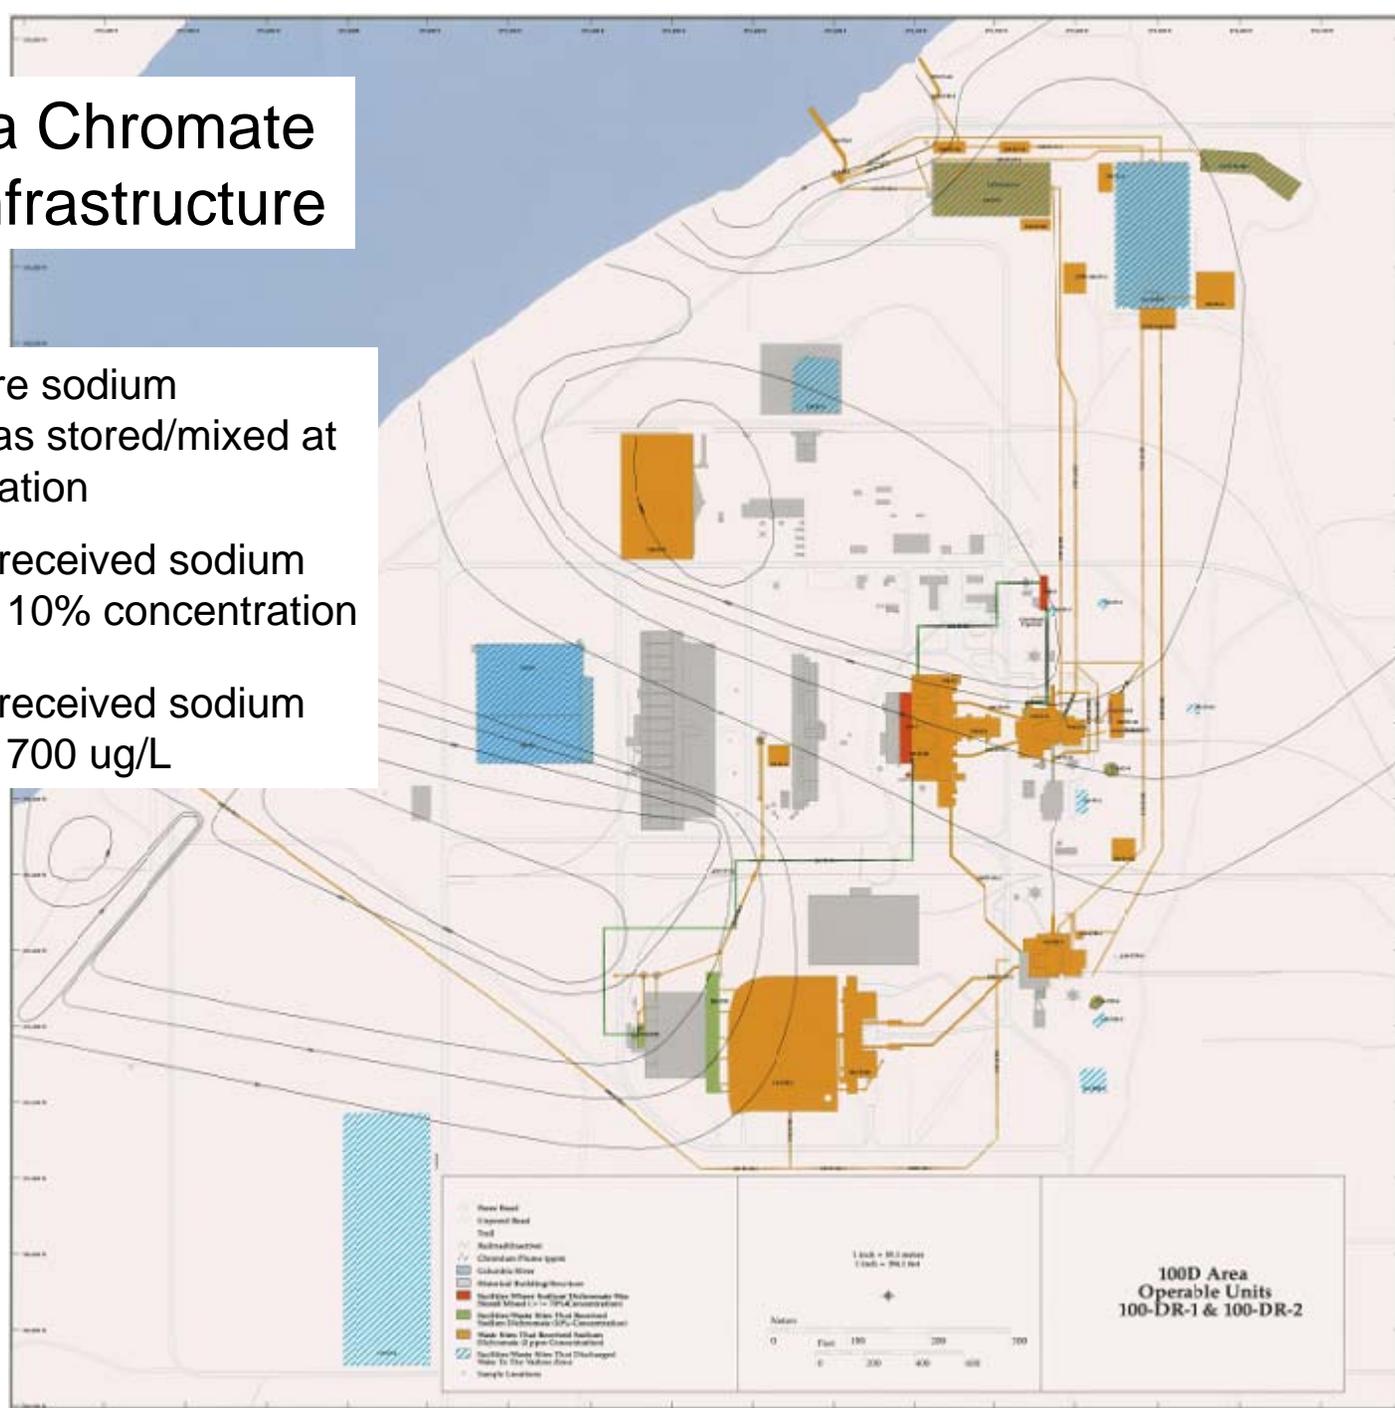
100-D Area Chromate Handling Infrastructure

Facilities where sodium dichromate was stored/mixed at 70% concentration
-

Facilities that received sodium dichromate at 10% concentration
-

Facilities that received sodium dichromate at 700 ug/L

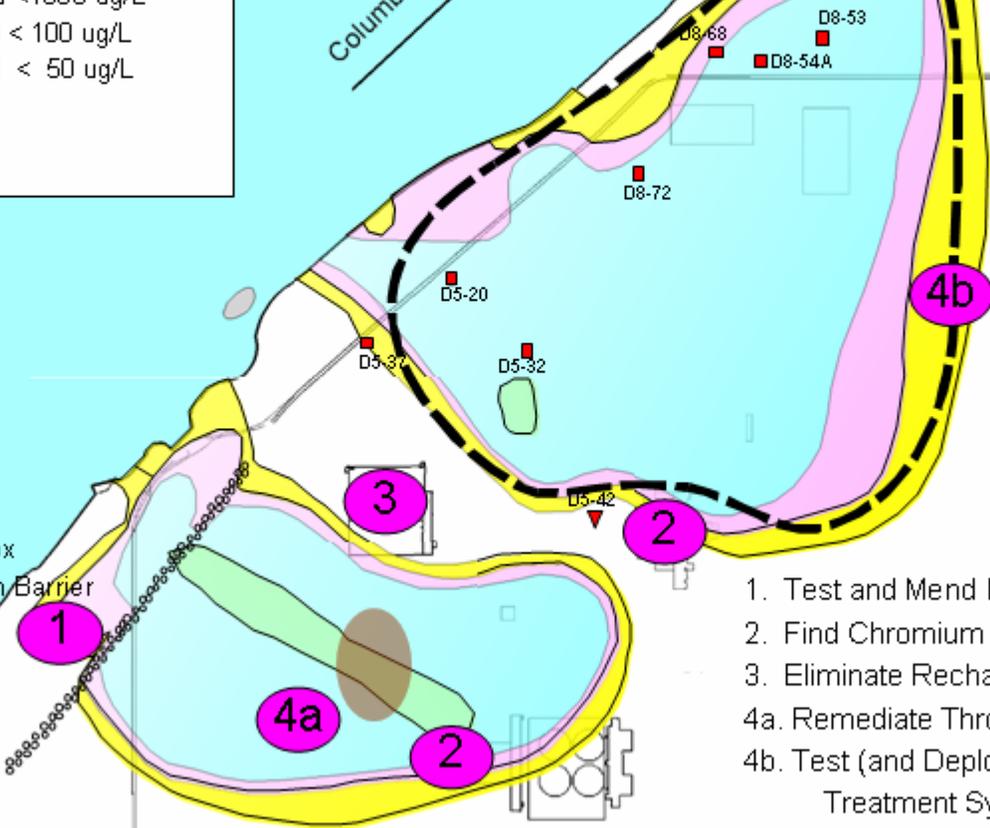
100-HR-3 (100-D Area)
Chromium Plume Fall 2005

- Extraction Well
- ▼ Injection Well

- Cr > 1000 ug/L
- Cr > 100 ug/l and <1000 ug/L
- Cr > 50 ug/L and < 100 ug/L
- Cr > 20 ug/L and < 50 ug/L

In Situ Redox Manipulation Barrier

1. Test and Mend ISRM Barrier
2. Find Chromium Source
3. Eliminate Recharge
- 4a. Remediate Through Biostimulation
- 4b. Test (and Deploy) Electrocoagulation Treatment System

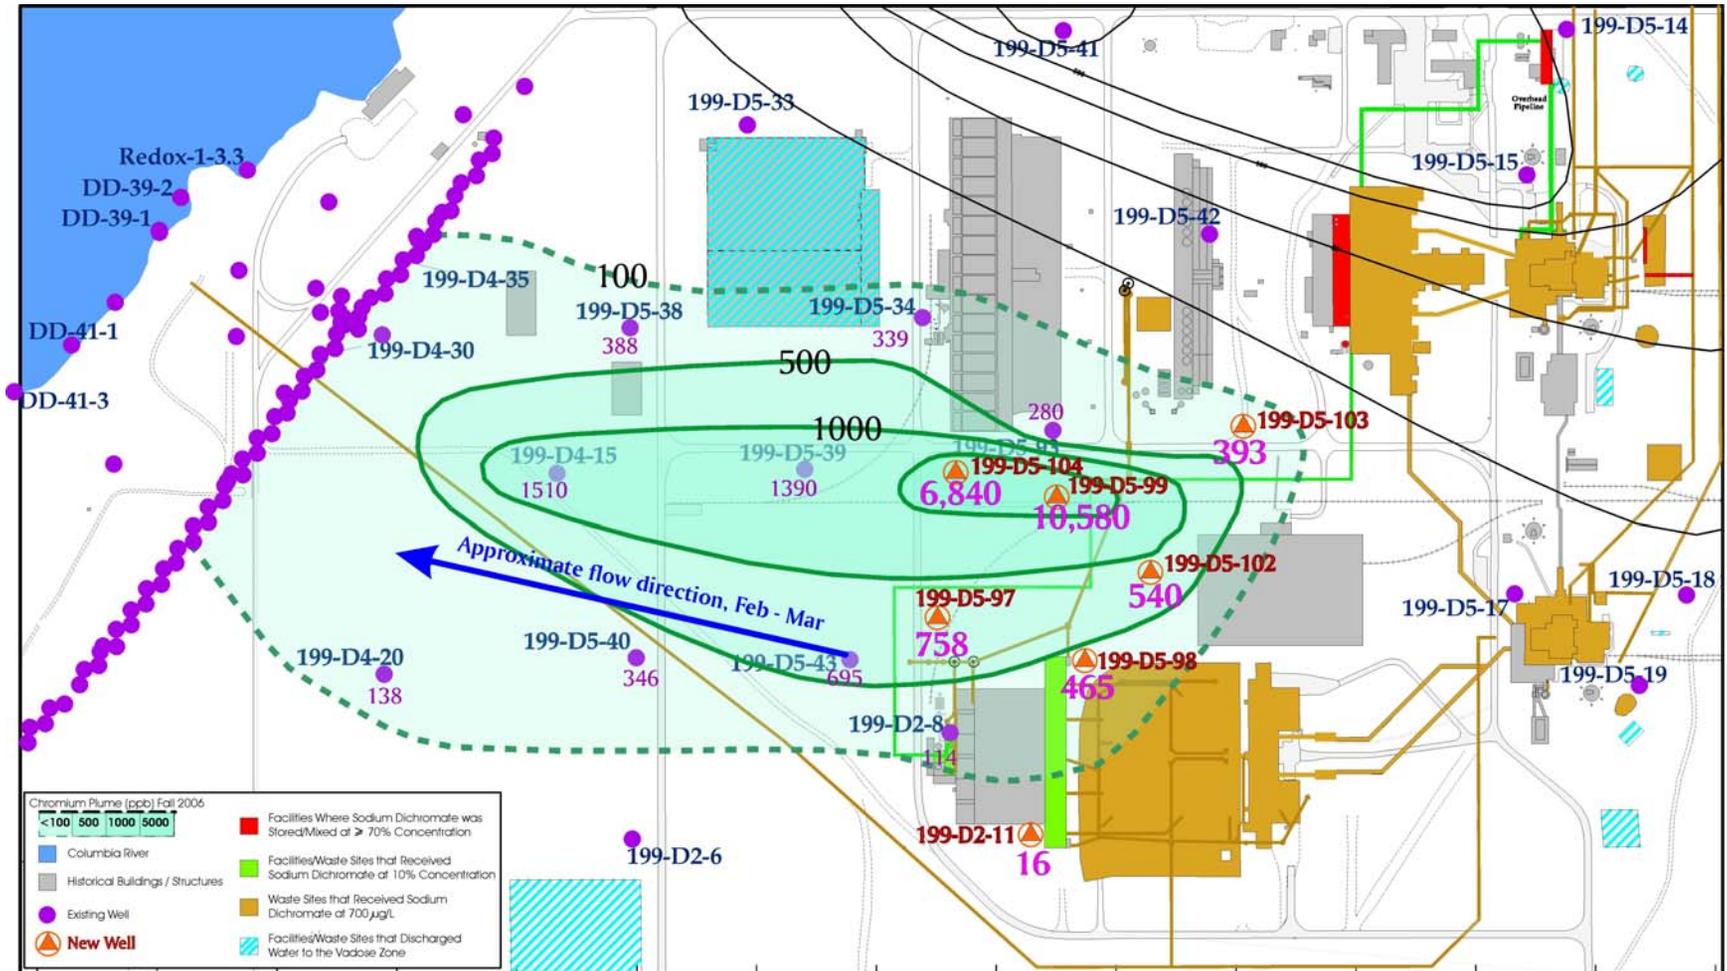
Initial Results from the Chromate Source Investigation Project

Hexavalent chromium values in parts per billion (ug/L)

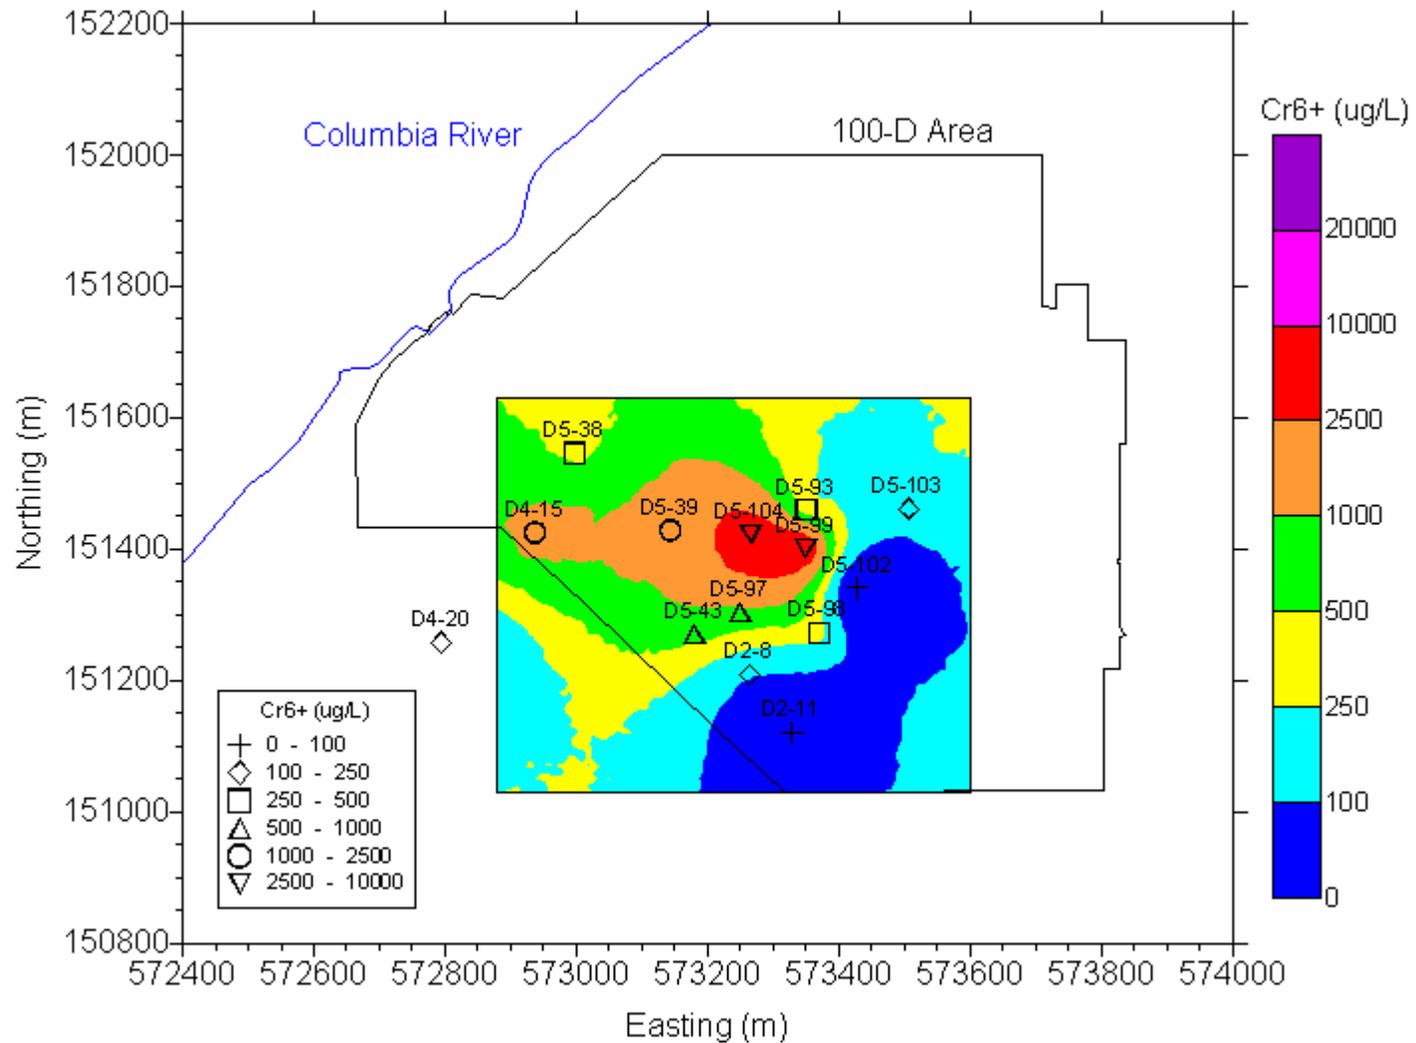
Geostatistical Realization, Median Simulated Value Based on 1,000 Simulations

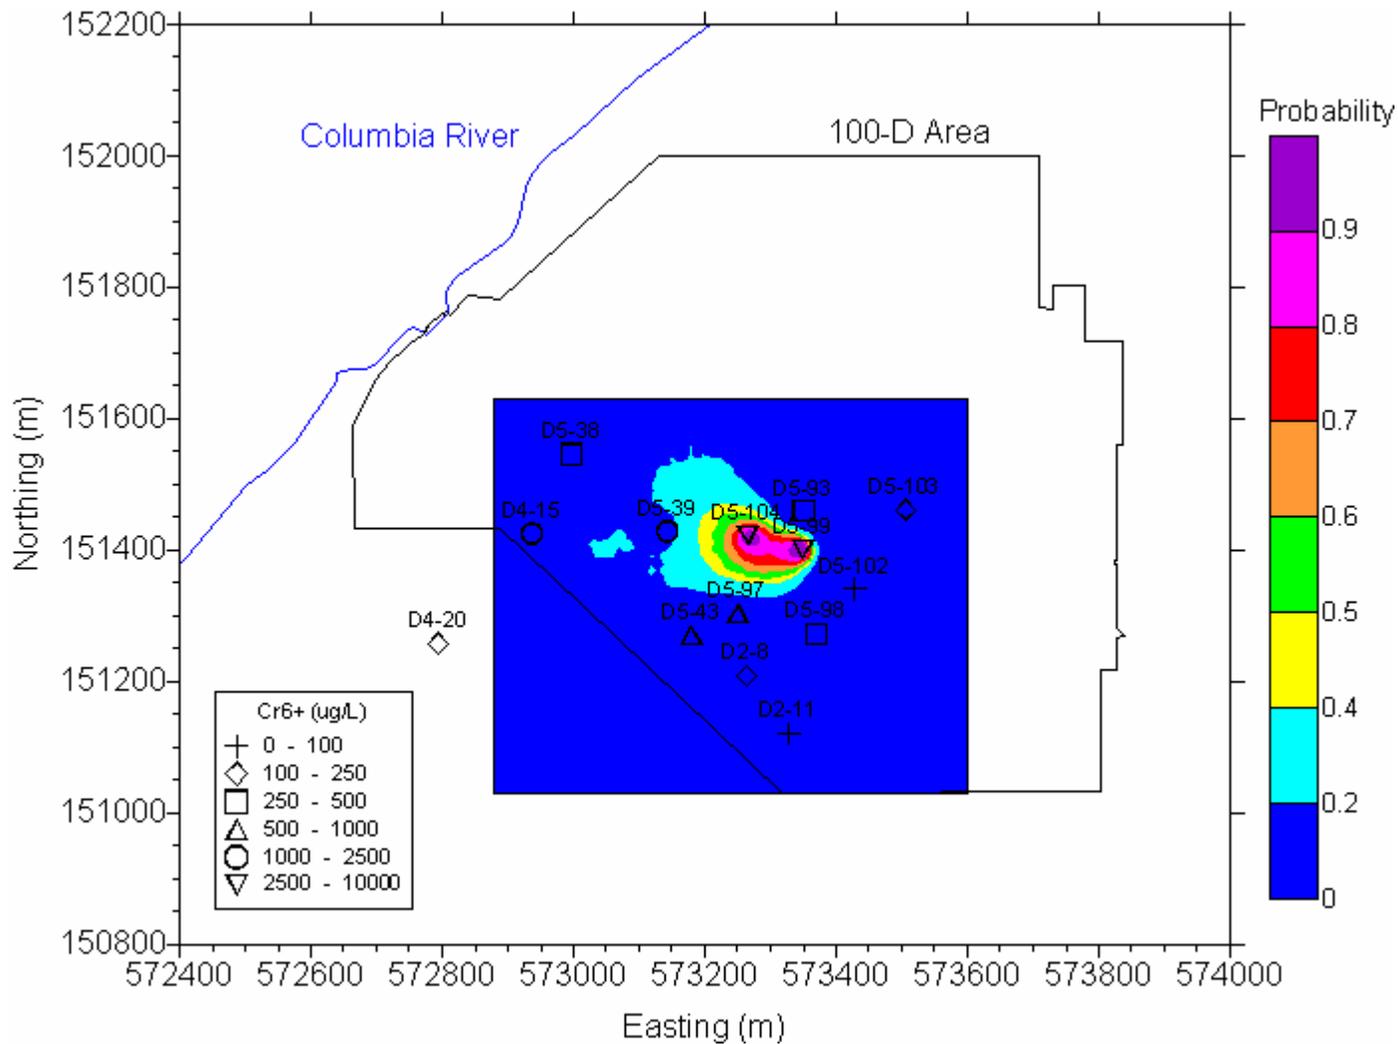
Geostatistical Realization, Probability of Exceeding 2,500 ug/L Based on 1,000 Simulations
