CONTRACT NO. DE-AC06-96RL13200 - 2004 FINAL INSTITUTIONAL CONTROLS (ICs)  
ASSESSMENT REPORT, DOE/RL-2004-56-Rev. 0

# 2004 Site Wide Institutional Controls Annual Assessment Report for Hanford CERCLA Response Actions

DOE/RL-2004-56  
Revision 0

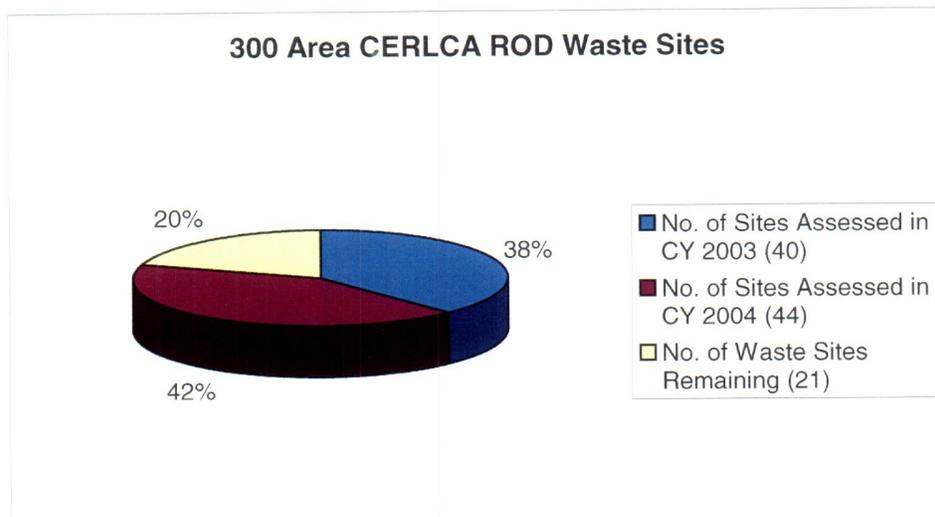
**Figure 1-1. Summary of 300 Area CERCLA ROD Waste Sites**

Figure 1-1 summarizes the 300 Area CERCLA ROD waste sites that were evaluated in the 2003 and 2004 IC Assessment process.

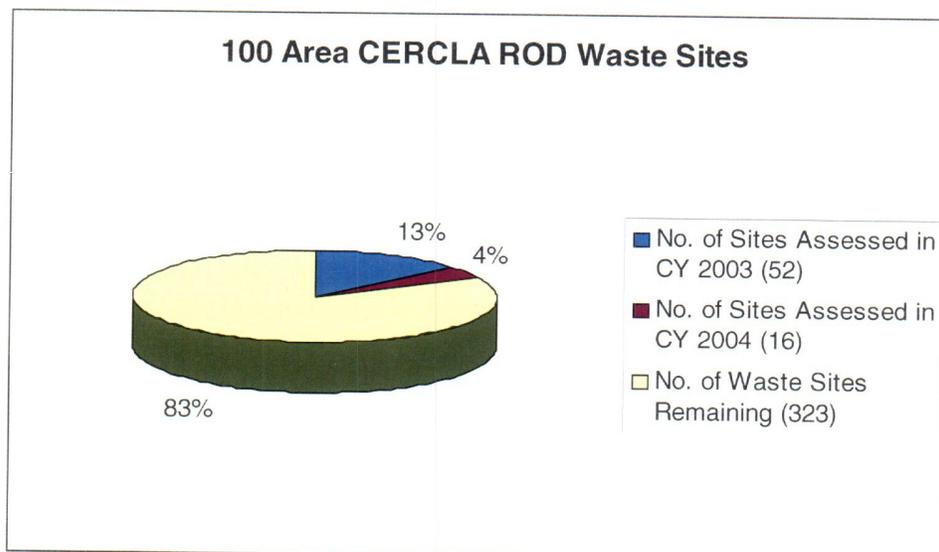
**Figure 1-2. Summary of 100 Area CERCLA ROD Waste Sites**

The 100 Area physical assessment evaluated waste sites located within the 100-BC-1, 100-BC-2, 100-DR-1, 100-DR-2, 100-FR-2, 100-HR-1, 100-HR-2, and 100-KR-2 OUs. Figure 1-2 summarizes the 100 Area waste sites evaluated in the calendar years 2003 and 2004. Only those waste sites identified in a CERCLA ROD, consistent with the Sitewide IC Plan, are included. To date, there are 394 waste sites identified in the 100 Area CERCLA RODs, of which, a total of 68 (17%) waste sites have been physically assessed.

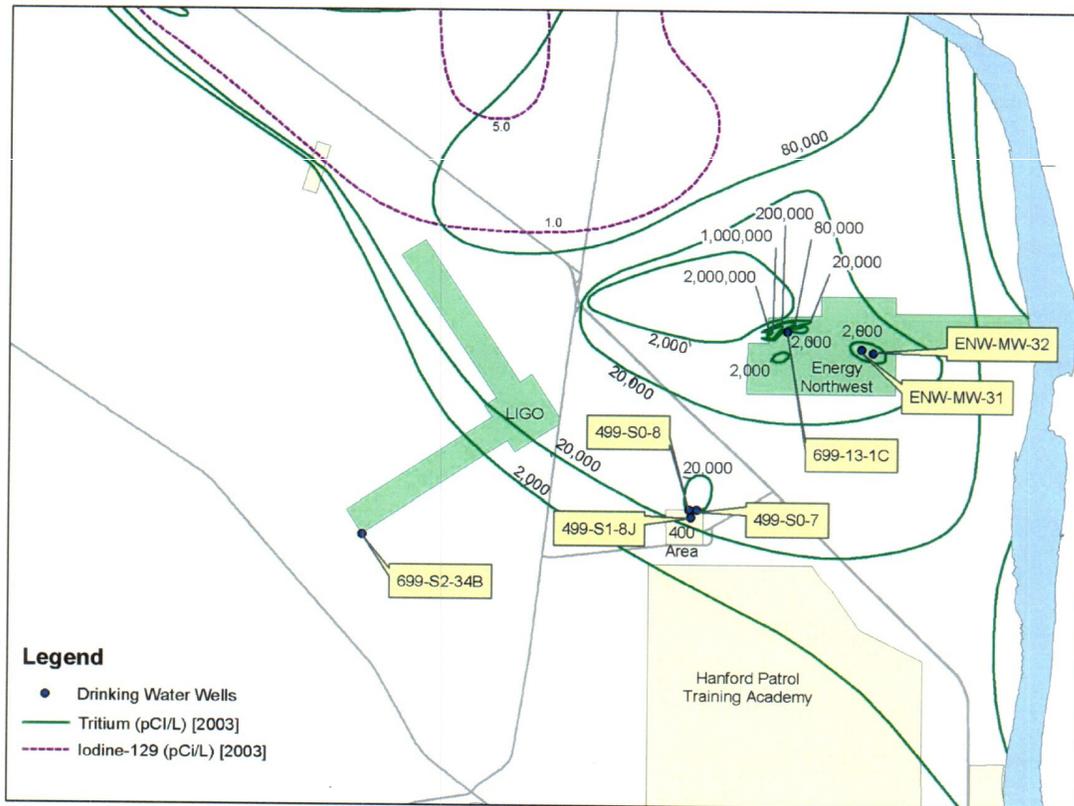
**Figure 4-1. Drinking Water Supply Well Locations**

Overall, this assessment found that there were a total of 14 water supply wells (Table 4-1) either used previously or currently in use. FHI manages six wells, PNNL manages one well, Energy Northwest has five wells, and LIGO has two wells. Of these 14 water supply wells, seven are used for drinking water. Five of the six wells managed by FHI are located in well houses. Access to these well houses is controlled. Three of the six FHI-managed wells are located in the 400 Area (Appendix C, Figures 15-17). These three wells supply drinking water to Fast Flux Test Facility complex and are classified as Group A non-transient non-community (NTNC) public water systems with a groundwater source. The water system is governed by WAC 246-290. All monitoring program plans are developed and all sampling is performed in accordance with the WAC or 40 CFR 141. Only one of the three drinking water wells (499-81-SJ) is used actively at the 400 Area. The other two are backup wells that are only used for short periods of time, if needed while the primary well is out of service for routine maintenance. Two other FHI-managed wells are located at the Waste Encapsulation and Storage Facility (WESF) in the 200 Area. In the event of loss of the raw water pressure to WESF, these wells will be

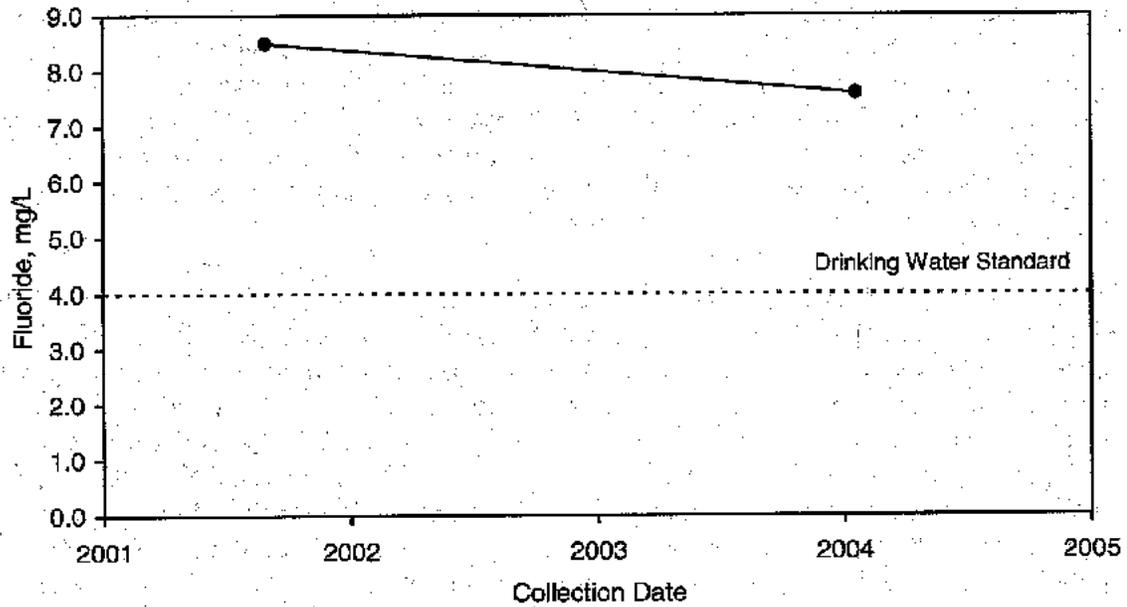
**Figure 4-5. 699-S2-34B Fluoride Level (prior to treatment)**

LIGO has one water supply well under a "Public Water System" operating permit from the State of Washington. Well No. 2 (699-S2-34B) is used as the source of water supply for domestic water, fire water, landscape irrigation, etc. This well was drilled in 1994 and placed in use in 1997. It is 1,941 ft deep according to the well log. The identity number for Well No.2 is AHA157, B8101, Hanford well name 699-S2-34B. This well has administrative control processes/procedures in place, i.e., lock and within control, and adequate signs and barriers to ensure their protection. LIGO provides drinking water samples to the WDOH on a monthly basis. These samples, which are representative of drinking water quality, are taken after the water is treated using reverse osmosis. The well is also sampled by DOE prior to treatment and analyzed for Hanford sitewide constituents including tritium, iodine-129, and major ions (specifically for nitrate). Total dissolved constituents are very high in the well; however, no Hanford-derived contaminants are observed. The water prior to treatment exceeds the maximum contaminant level (4,000 ug/L) for fluoride (Figure 4-5), which occurs from natural sources in the deep confined aquifer. The most recent value, from a sample collected in

January 2004, was 7,600 ug/L. However the level of fluoride is below the drinking water standard after treatment.

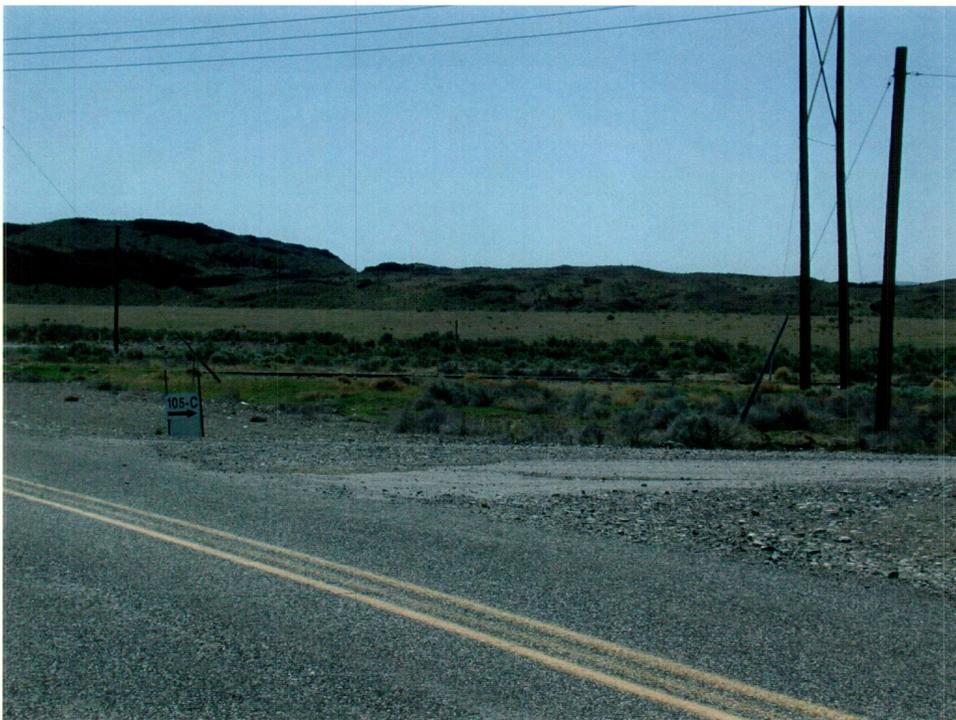
**Figure 2. Alternative Access Road to 100-B/C Area Waste Sites – No Warning Signs Posted on Road.**

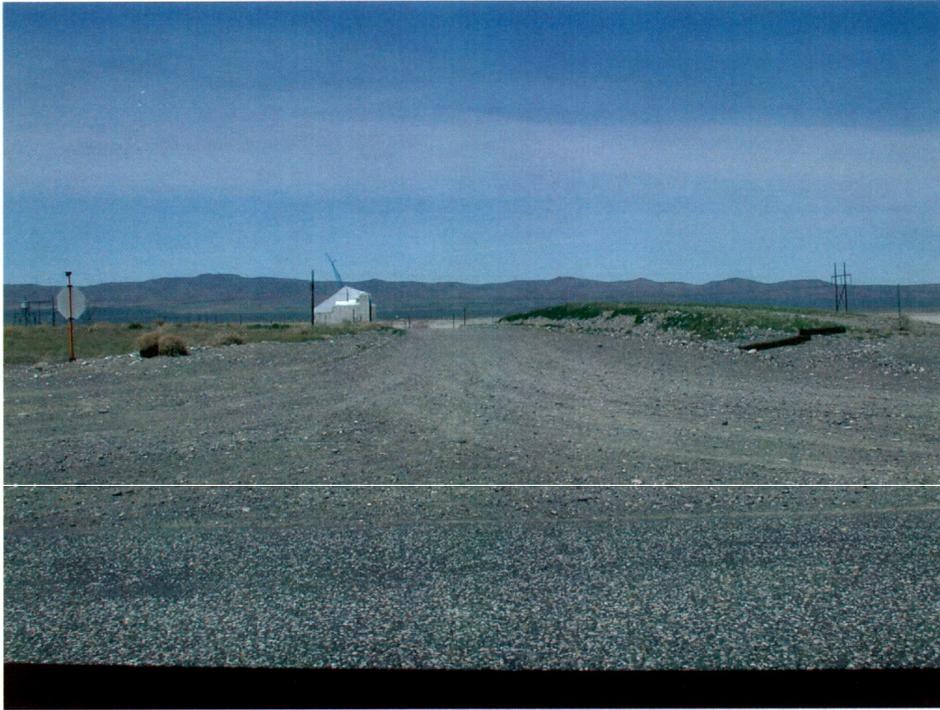
**Figure 3. Alternative Access Road to 100-D Area Waste Sites – No Warning Signs Posted on Road.**

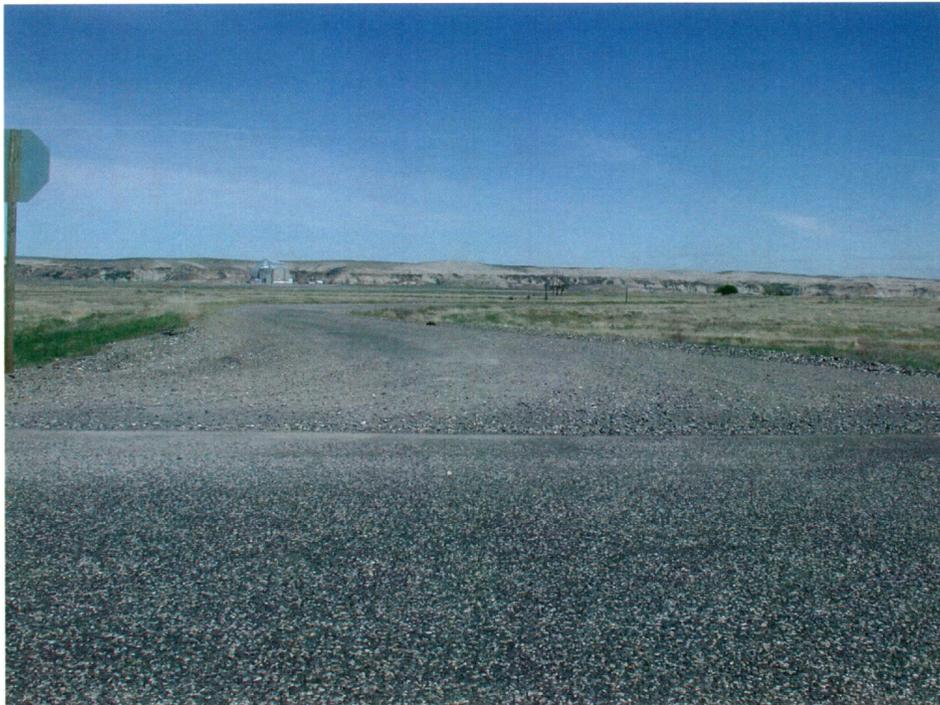
Warning signs were not found at the secondary access roads from Route 4 to waste sites located in the 100-F Area. Warning signs were requested at the entrance to the access roads (see Appendix C, Figure 4). **The warning signs were installed on June 11, 2004; no further actions are required.**

**Figure 4. Alternative Access Road (from Route 4) to 100-F Area Waste Sites – No Warning Signs.**

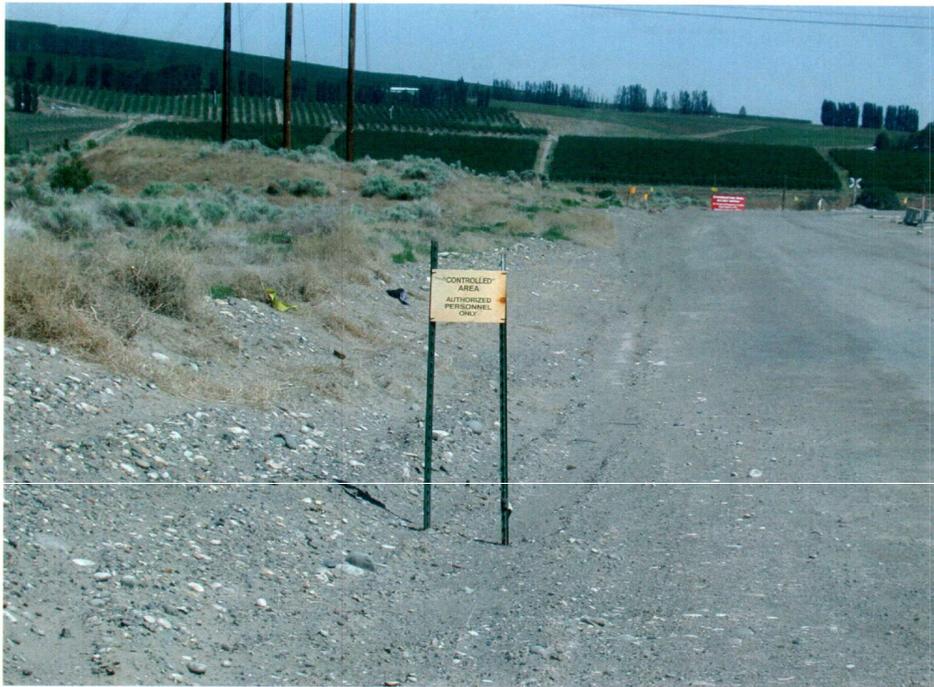
**Figure 5. Warning Sign Posted Along Alternative Access Road to 300 Area Waste Sites (Near 300-7 and 300-8 Waste Sites).**

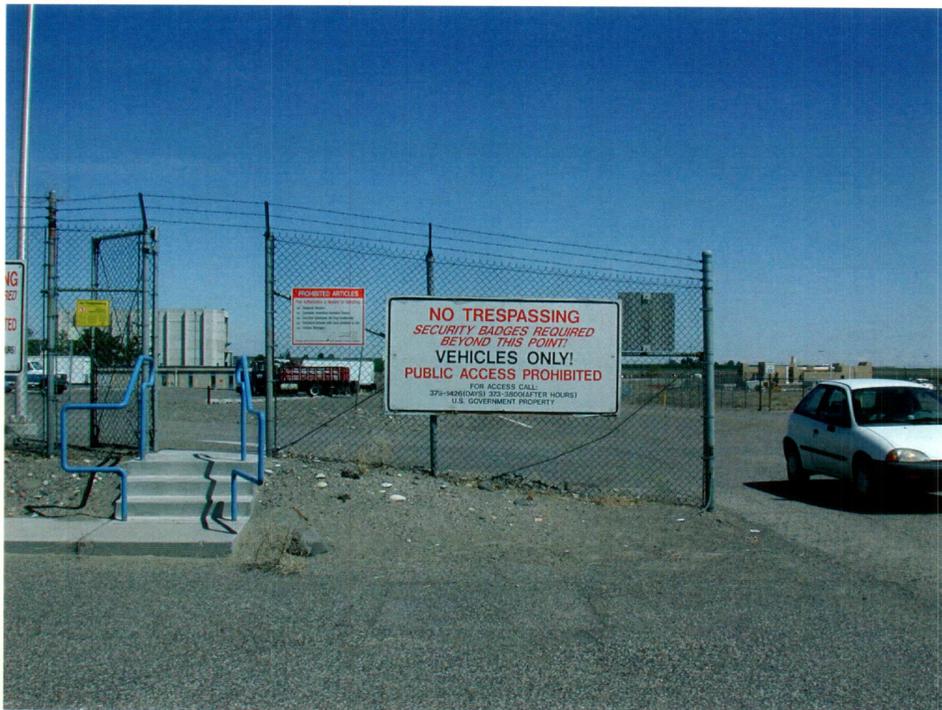
**Figure 6. Warning Signs at 300 Area Main Industrial Complex Entrance.**

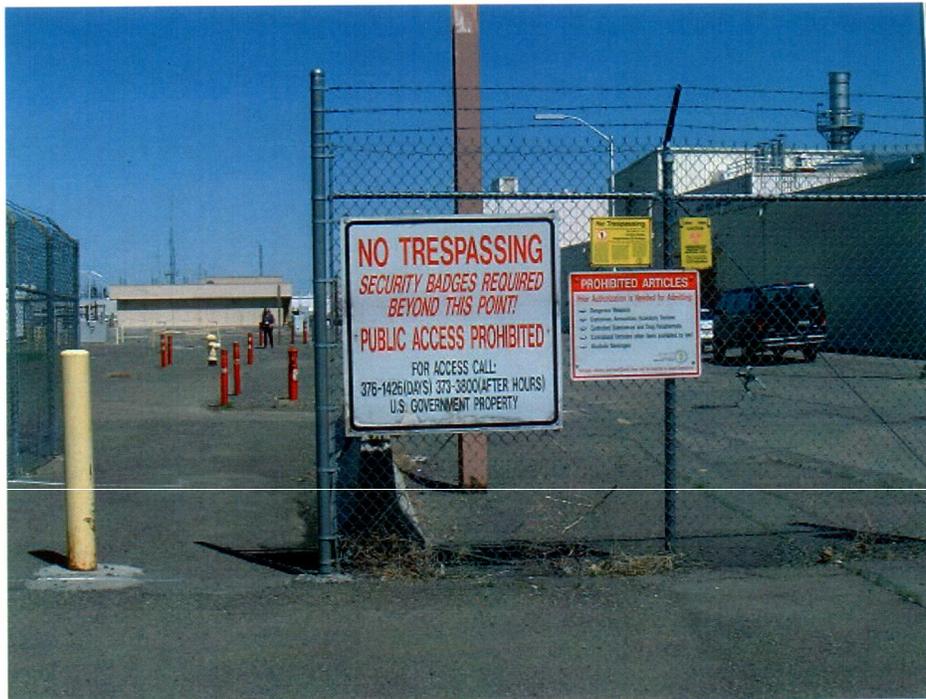
Figure 7. Warning Signs at the 300 Area Entrance on the North Side of the Parking Lot.

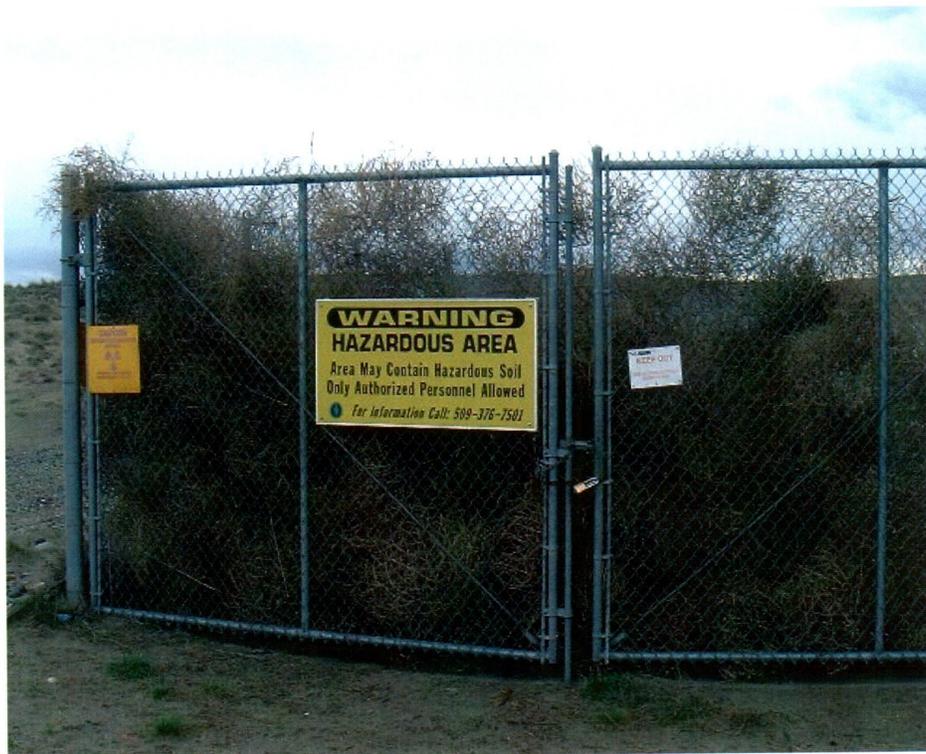
Figure 12. Signs at 618-10 Waste Site

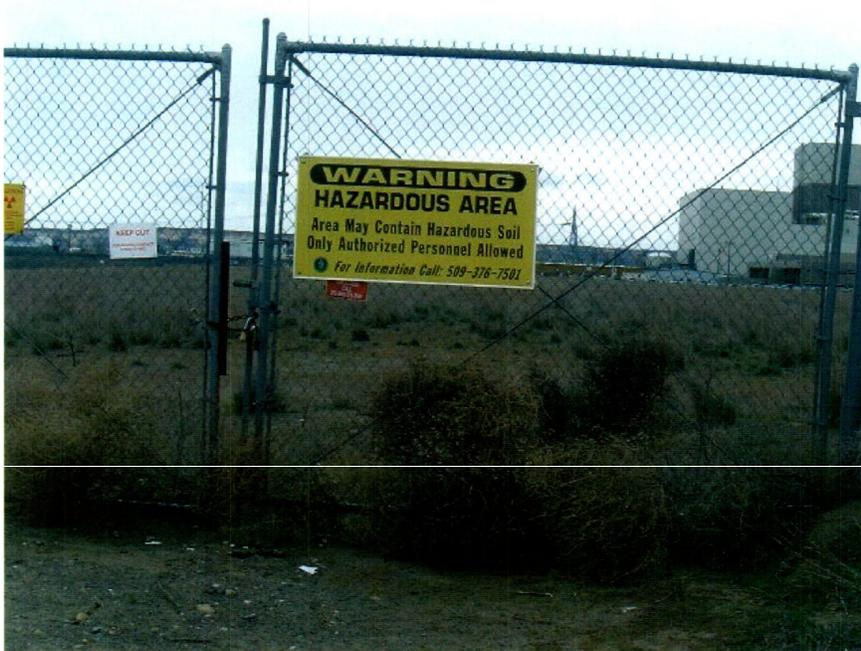
Figure 13. Signs At 618-11 Waste Site.

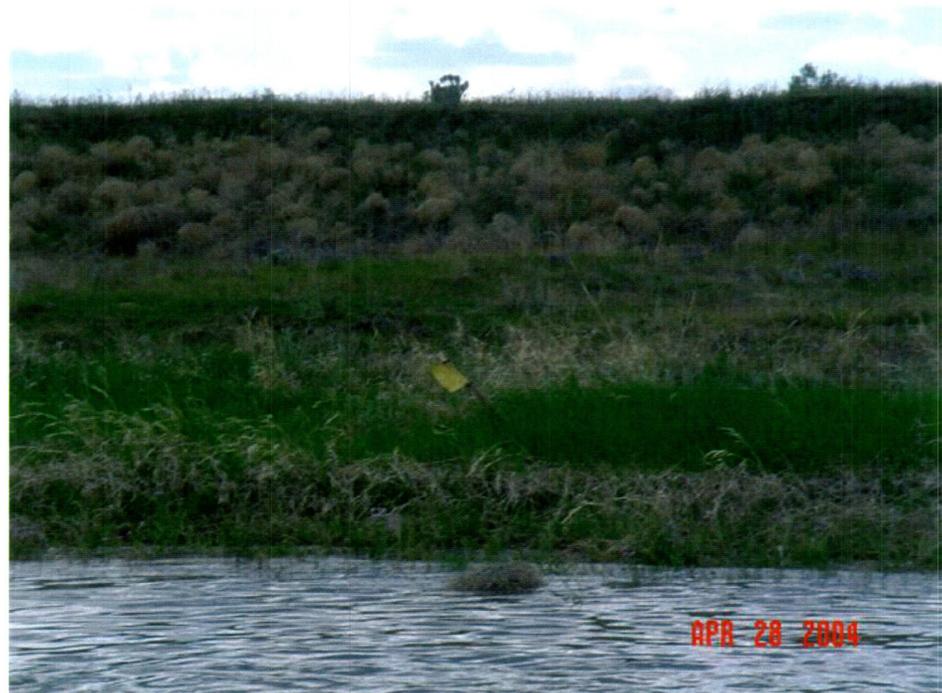
Figure 14. Picture of a Downed Sign Along the Columbia River Shoreline.

IC-FHI-1	Warning signs missing along the Hanford Site shoreline need to be replaced to maintain the voluntary 500-foot interval among signs.	January 31, 2004	This action item is completed. There are 624 signs along the shoreline. All the signs were visited during a 4-week period in October 2003. Approximately 50 to 75 signs defaced due to weather or completely missing were replaced. The remaining signs were repaired as needed. Weeds were growing around the signs making the

Action Item	Description	Due Date	Completion Status
			signs difficult to see from the river. The weeds were removed. FHI Site Services has instituted routine inspections to ensure the signs are maintained and weeds are removed. Additionally, DOE and other contractors conduct annual inspection of the Hanford Site shorelines.
IC-FHI-2	A single strand of the wire fence at the Horn Rapids Landfill entrance needs to be repaired.	December 1, 2003.	This action item was completed. The single strand of the wire fence was repaired in September 2003.
