## Closing in on Closure

# K Basins Closure Project grouts KW Basin discharge chute

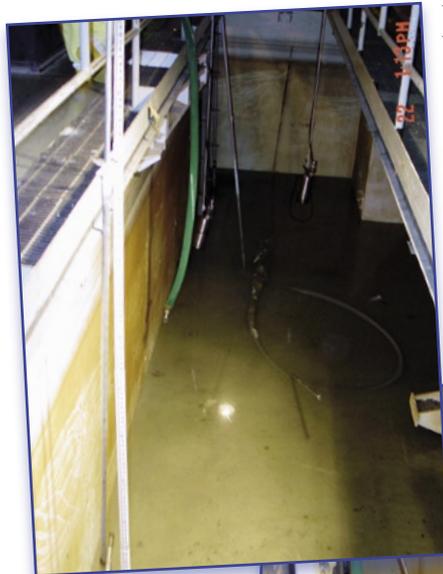
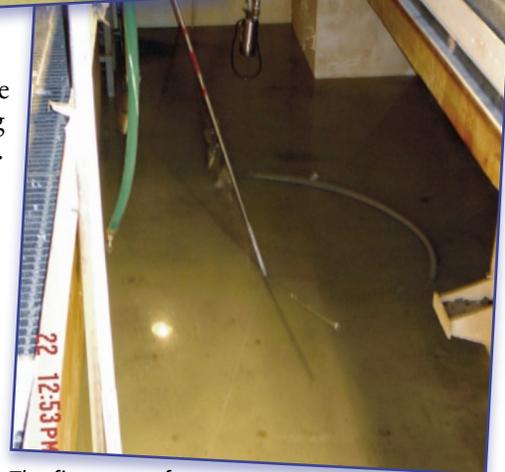
The first pour of grout in September hardens (both photos) after the KW Basin discharge chute was filled from the bottom up to the nine-foot level. Susequent pours raised the level to 17 feet.

was completely dewatered before the grout pours were made. Then, the four pours occurred in rapid sequence in five days. In the K East Basin, the three grout pours were made over a period of about six weeks.

The grouting vendor used a long lance to inject the grout beginning at the bottom of the chute. The company installed a temporary grout plant and wash-out area just outside the KW Basin, and delivered the materials into the chute via a thick hose. KBC operators, radiological control technicians, engineers and others supported the installation.
