Caution Bulletin

Damaged Bullard Powered Air Purifying Respirator Hoses

2007-RL-HNF-0029

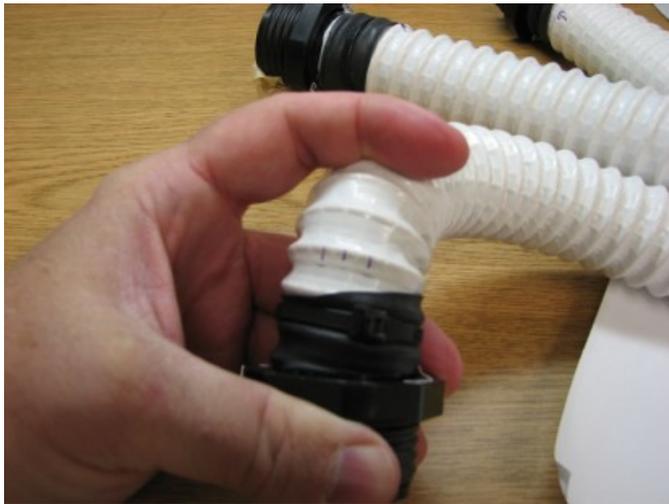
Note how 3 slits occurred in straight line.

A black marker was used to show the area just above the holes.

Discussion of Activities: The Bullard Powered Air Purifying Respirator hood uses a breathing air tube PN# PA1BT which is connected to a part with a sharp outer edge that can cause small holes to develop in the composite plastic breathing air tube which supplies air to the hood (See pictures). The holes can be hard to see and may be partially covered by a black outer wrap around the hose.

The outer edge of the plastic fitting, which inserts into the hose, can score the composite plastic hose and cause a line of small cuts penetrating the hose around its perimeter near where the hose contacts the top of the fitting. After cutting apart one of the hoses, it was observed that the outer edge of the fitting against the hose was sharp and rough in some spots. Normal activities of assembling the hose to the blower unit and normal movement could score the hose and then exacerbate the cutting effect; these cuts can be single or multiple. The observed multiple cuts appear to lie in a straight line around the perimeter where they contact the inner fitting.

- Immediately stop use of all Bullard PAPR in stock.
- Ensure personnel that issue, repair, maintain, or use these air purifiers understand the issue.

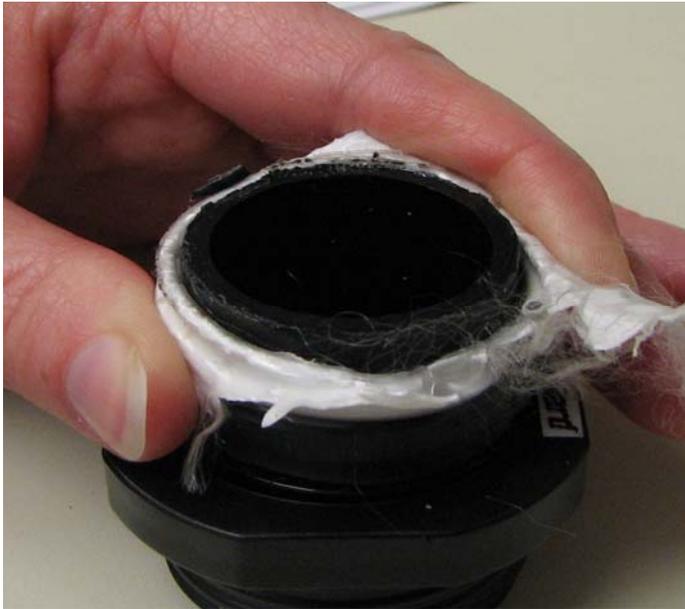
Note rough and sharp edge around external edge of the black tube. The adhesive used to hold the tube on also appears to cause some degradation of the plastic which further increases roughness.
