# Information Bulletin

## Modifications Cause Shelving Failure

2007-RL-HNF-0042

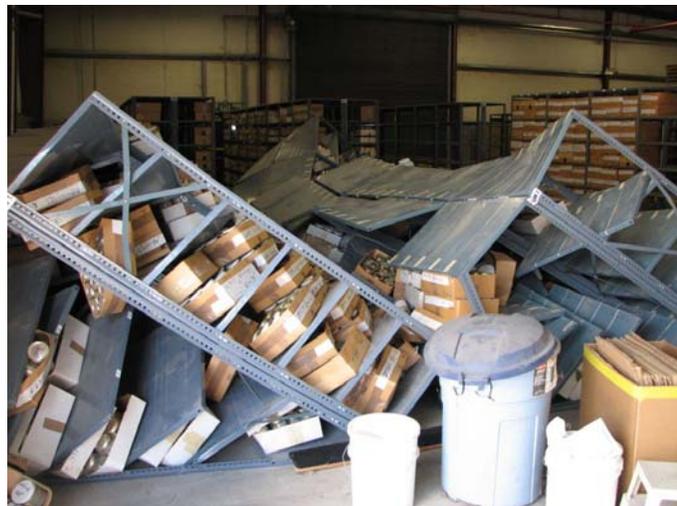
**Discussion of Activities:** On July 19, 2007, during relocation of historical soil samples free-standing shelving collapsed when a box of samples was placed on the top shelf.

**Analysis:** The shelves, as assembled (without using assembly instructions), were poorly braced. The bottom tier and top tier of shelves were not cross braced and as such the shelving was vulnerable to failure due to side loading while carrying the normal vertical load. In addition, fasteners used to connect the individual sections of the shelving were not checked to ensure they were present and tightened. An engineering analysis determined the load presented by the soil samples did not exceed the capacity of the free-standing shelves and did not contribute to the failure.

1. Always obtain and use manufacturer's assembly instructions.
2. Never make modifications which may degrade structural integrity without an engineering analysis and approval.
3. Inspect and verify free-standing shelving fasteners used to connect sections are present and tightened, ensure adequate cross-bracing is present in each section, is adequate for the loads they contain, and attached to the facility structure in some fashion (bolted to the floor, fastened directly to the wall and/or, utilizing a grid system of bracing fastening one section to another).
