# River and Plateau Committee Update on 340 Building Vault Contamination

*River Corridor  
Closure Project*

June 11, 2013

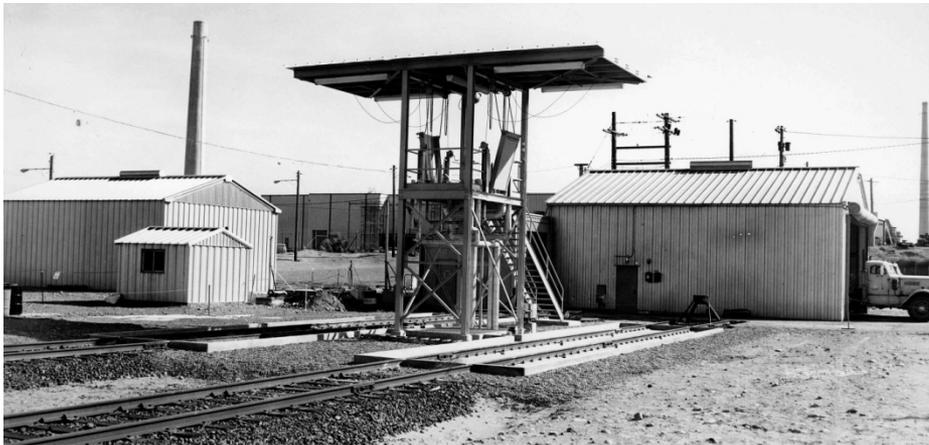
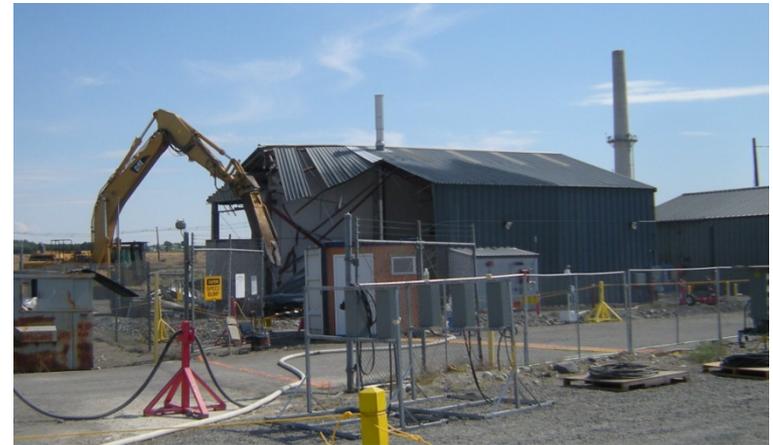
- The 340 Complex, also called the Waste Neutralization Facility, was constructed in 1953 and remaining above-ground structures were demolished in 2011
- The two tanks located in the vault were fed by the radioactive liquid waste system, or RLWS, an underground piping network used to transport waste. Radioactive waste would then be transported by rail car to the 200 Area tank facilities, and non-radioactive waste was disposed in the nearby trenches.
- Tank overflows and piping system failures are known to have occurred during facility operations

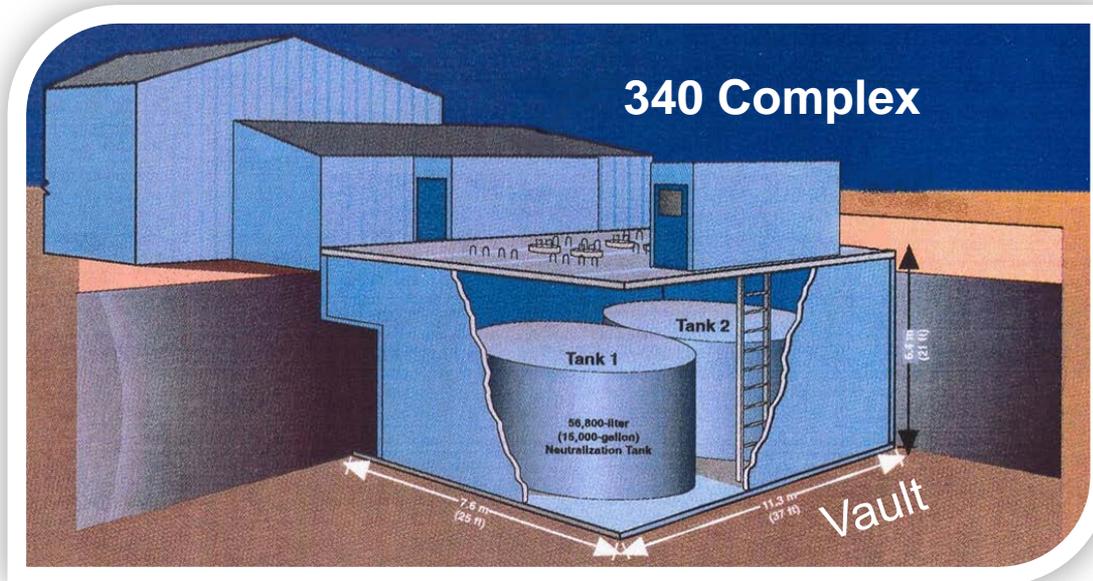
- The 340 Vault, located below-grade, contained two 15,000-gallon stainless steel tanks used to retain highly contaminated waste from several laboratories, fuel fabrication facilities and test reactors
- The two tanks and the bottom of the vault have been grouted in preparation for disposal
- The vault is 41 feet long, 29-feet wide and 25-feet high. The lift weight is approximately 1,100 tons and a transport weight of 1,538 tons

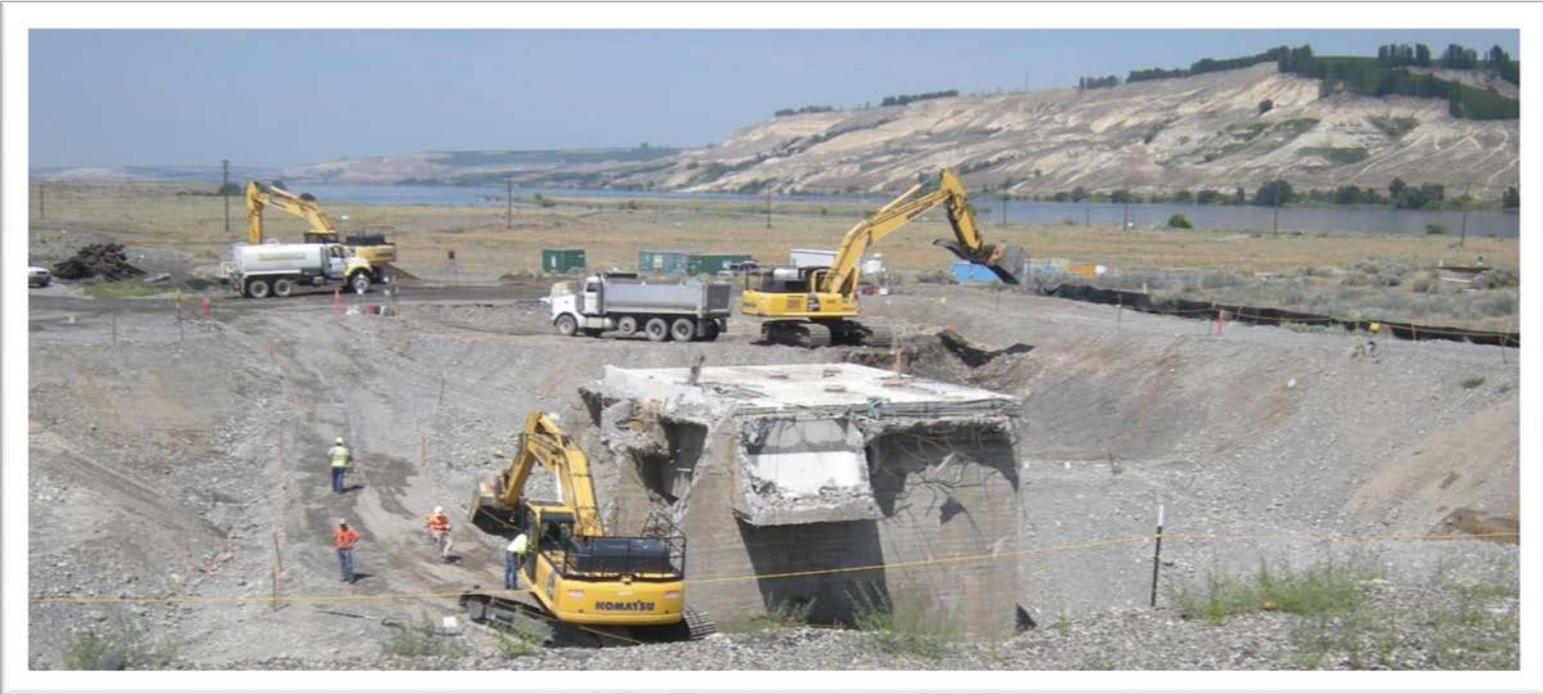
- WCH completed excavation of the vault and haul road in August 2012
- Approximately 54,000 tons of soil were removed during this process and shipped to ERDF

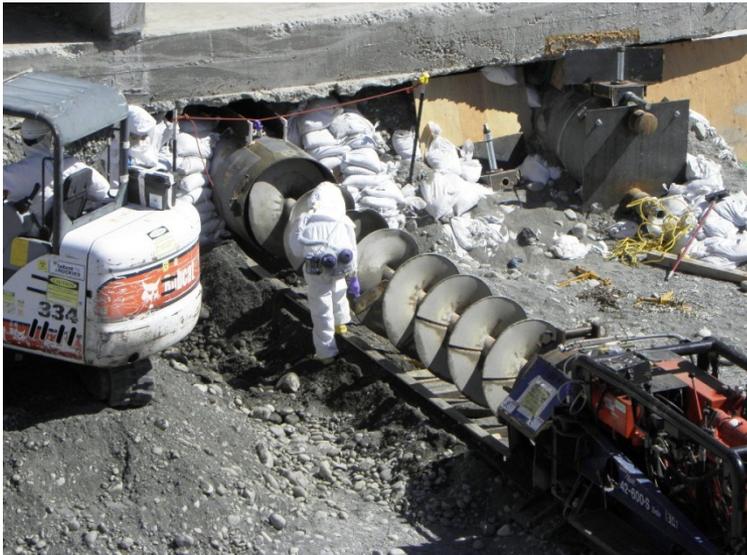
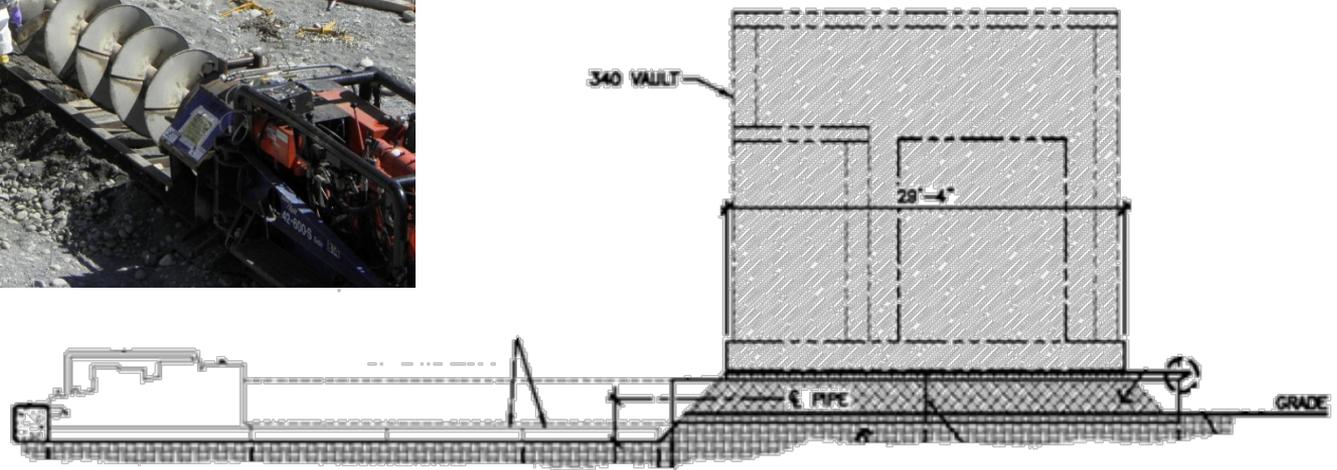
- Workers were installing the final segment of four steel-walled pipes called “casings” which are being used for temporary support of the vault in preparation for the lifting process, when higher levels of contaminated soil were discovered
- Utilizing lessons learned from 324 Building B-Cell contamination, radiation readings were immediately detected and work was safely stopped

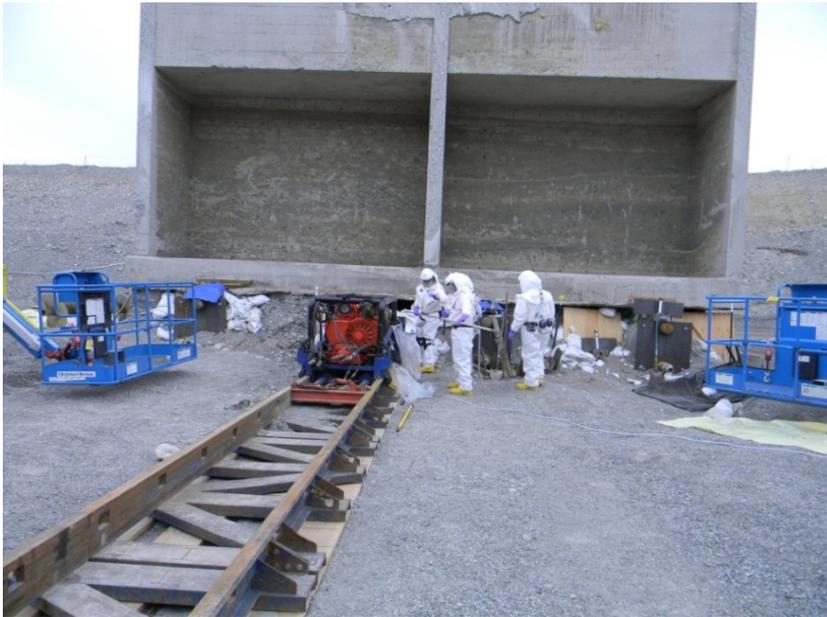
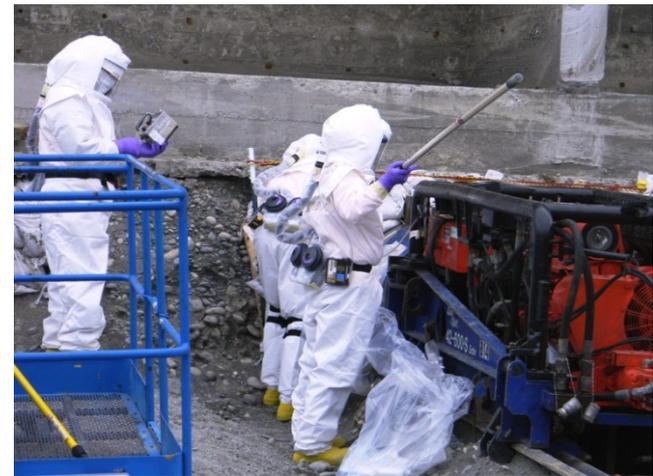
- Work related to the preparation of the vault for shipment was delayed after contamination was discovered under the vault
- WCH then re-focused work on sampling and probing the area under the vault, near the vault sump
- Seven soil samples were taken along both sides of the casings and sent to laboratories for analysis

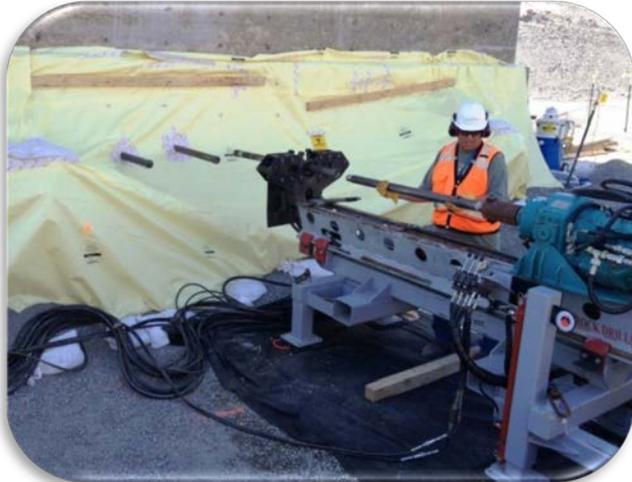
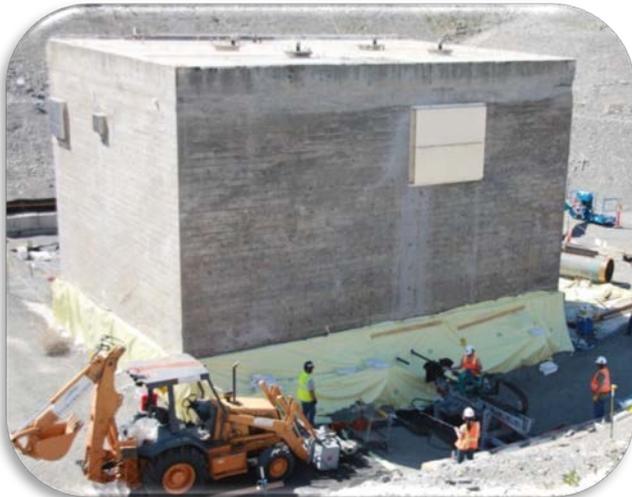
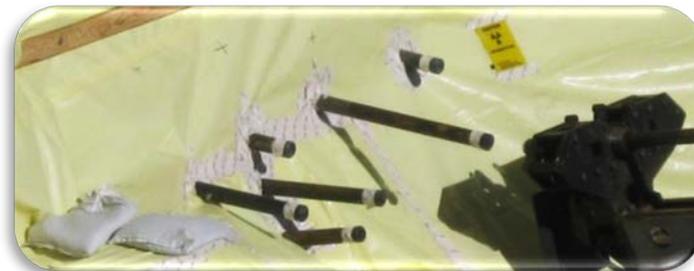
- WCH used a hydraulic push unit to place close-end tubes underneath the vault, including:
  - 4 horizontal tubes
  - 3 angled tubes
- Radiation detectors were used inside the tubes to measure the extent and depth of the contamination

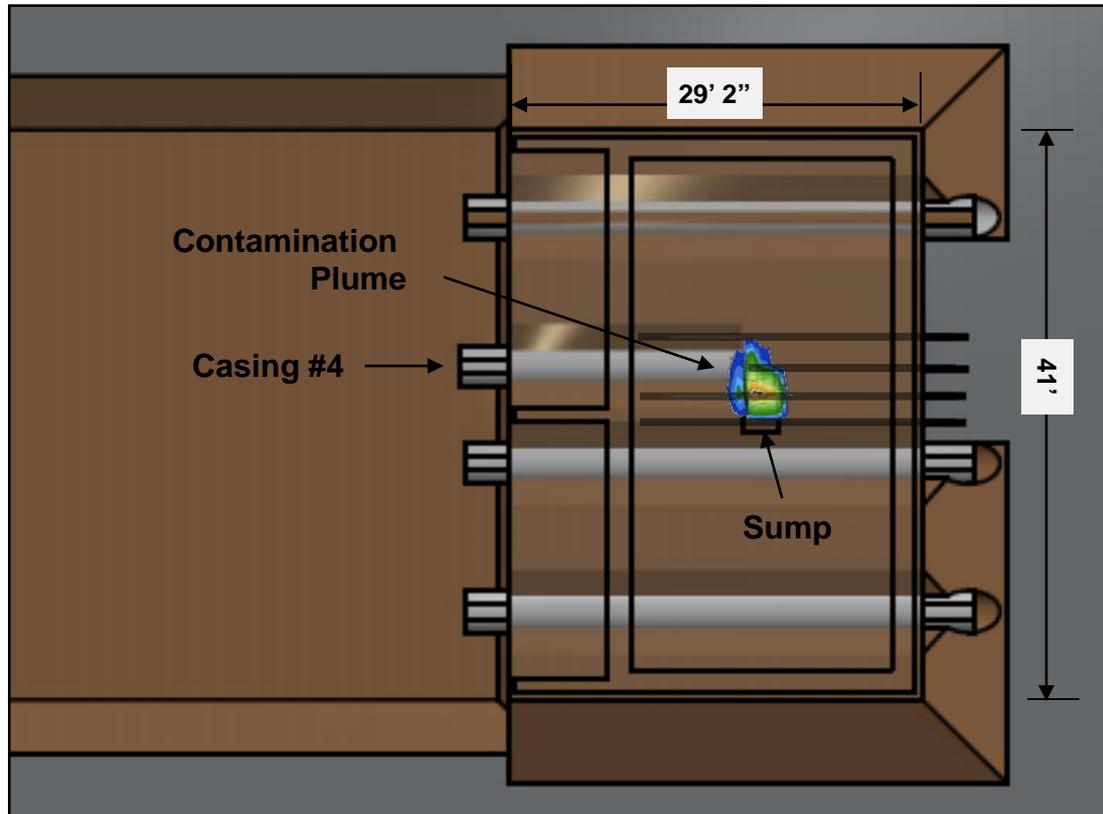
Contour map of radiation field in relation to the vault sump based on probe and casings readings (scale is approximate)

- Peak dose rate 17.5 R/hr at center of the plume
- Angled probes show less than 1 mR/hr at 5 feet below the peak
- Highest recorded ground water elevation is approx. 10 ft. below the vault

- Revision of the Final Hazard Categorization (FHC) for the 340 Complex has been submitted to DOE
- Upon approval, WCH will resume excavation of the contamination underneath the vault using:
  - Auger and casing configuration and/or
  - Remote excavator that was planned for soil removal in between the casings before the discovery of the contamination
- The vault is scheduled for shipment to ERDF in the fall
