DOE's Largest Environmental Cleanup Closure Project

River and Plateau Committee Update on Work in the River Corridor

November 13, 2013

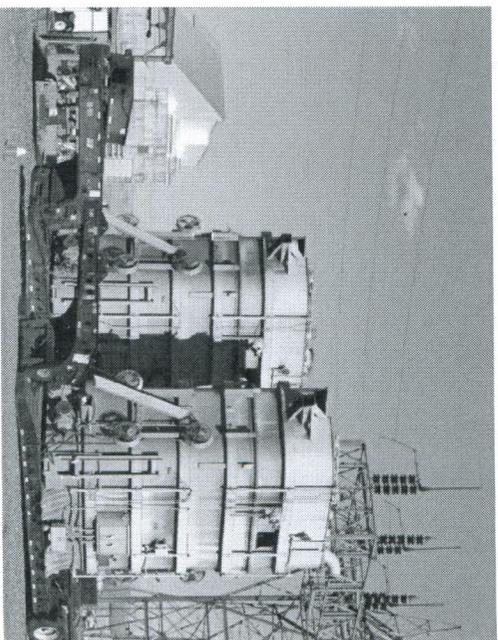
- ## 183-D:
- Nearing completion on above-ground demo.
 - Performing final site clean-up activities
 - Complete backfill, summer 2014

(Below) Aerial 183-D 10/10/13 (Clearwell on Left to Remain for Bat Habitat)

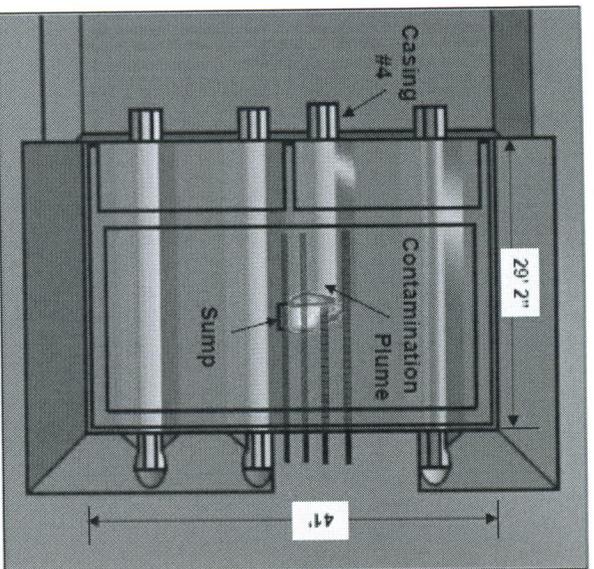
Contour map of radiation field in relation to the vault sump based on probe and casings readings (scale is approximate)

- Highly contaminated soil beneath the 340 Vault has been removed
- Preparations for the installation of the lifting beams is underway

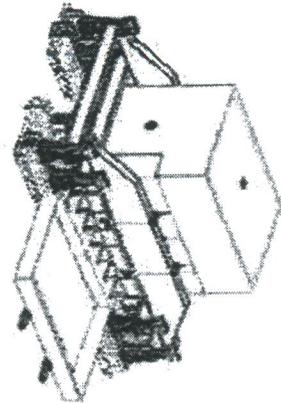
Pull Up Gantry (PUG) lifting system installed and IP-1 pan placed under the vault

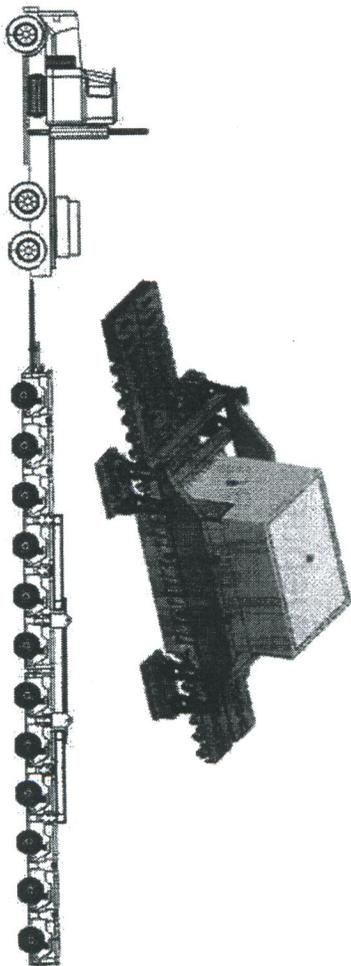
Transport trailer positioned under vault

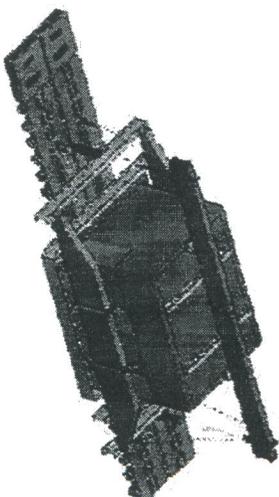
Vault secured with girders for transport

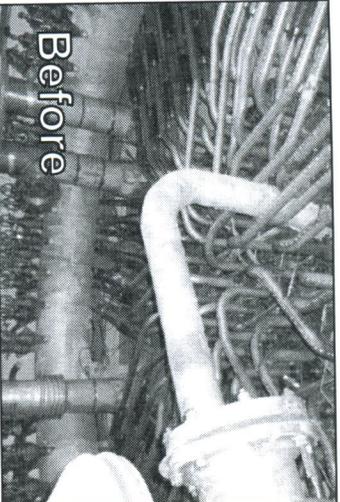
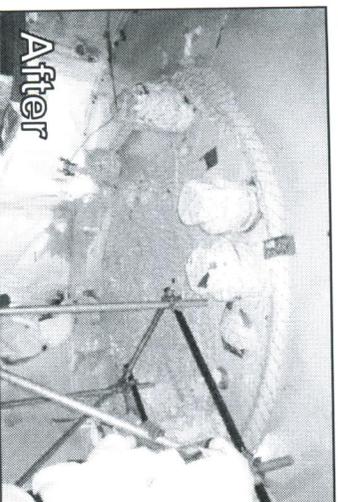
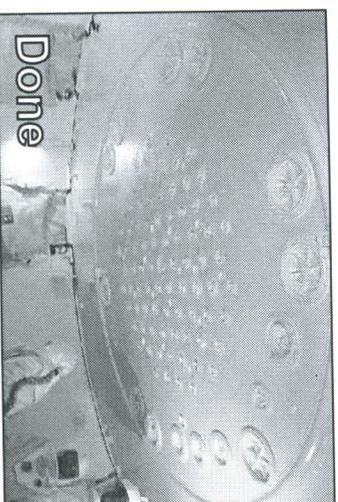
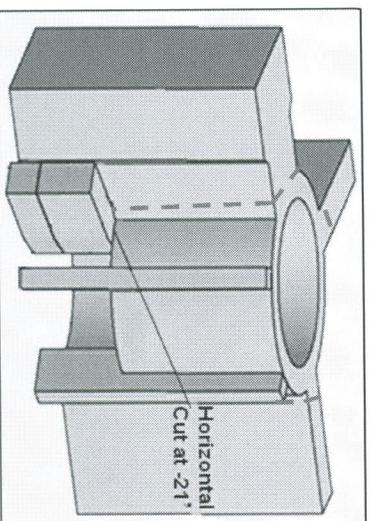
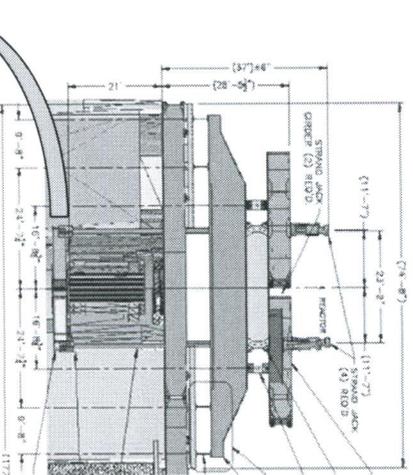
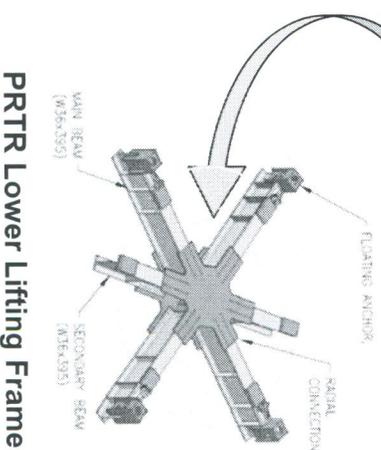
- Completed interference/piping removal
- Completed macroencapsulation of bottom of PRTR with epoxy

- perform final concrete cuts
- install an interim structure 32 ft. below grade to assemble the 23-ton lower lifting frame in place.

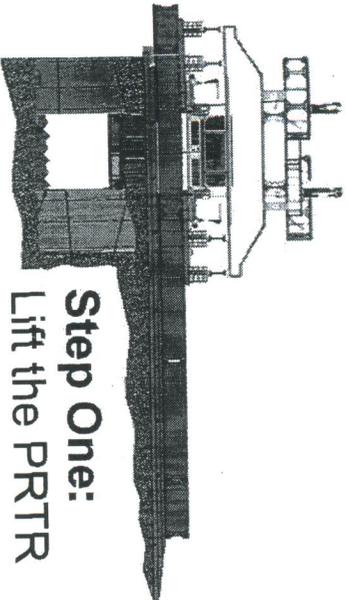
Step One:
Lift the PRTR

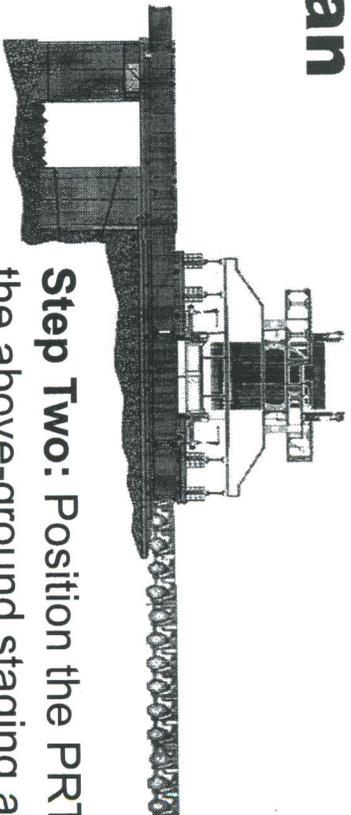
Step Two: Position the PRTR on the above-ground staging area

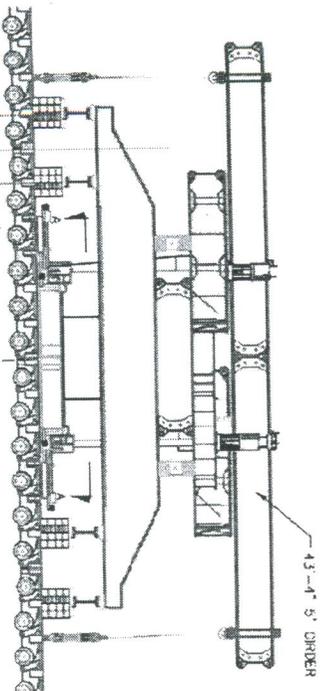
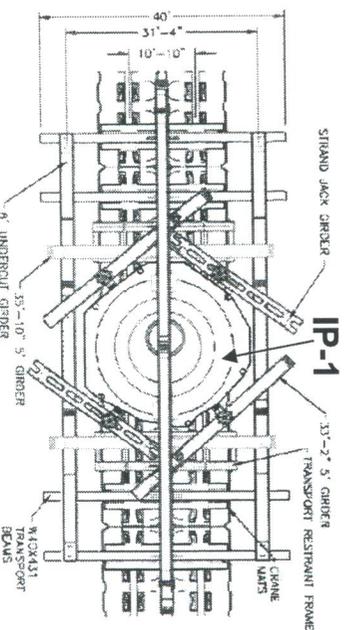
Step Six: Install IP-1 Waste Package cover

Step Seven: Secure PRTR onto Goldhofer

Step Eight: Prepare for transport to ERDF
