Corrective Actions to Ensure Safe Storage of Waste in The Plutonium Uranium Extraction Plant Storage Tunnels 1 and 2

Date Published
August 2017

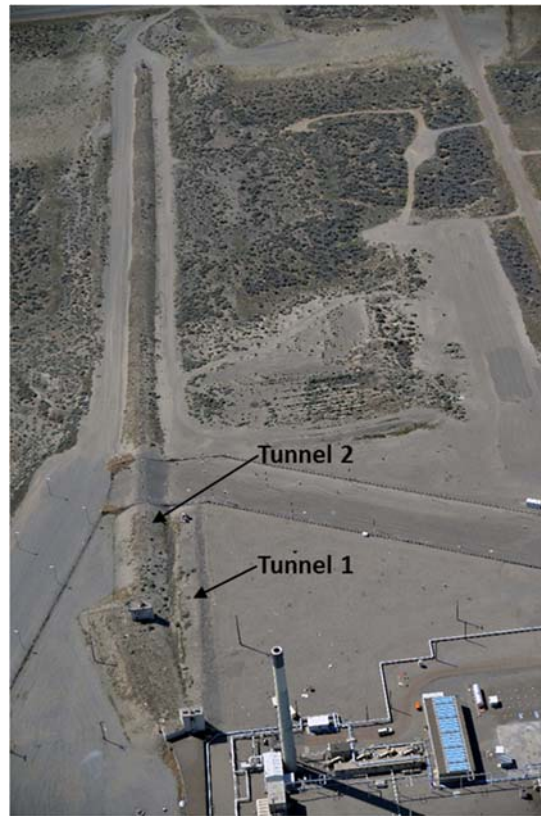
Figure 2. Relative Size and Location of Tunnels 1 and 2 (May 2014)

The PUREX Plant processed spent nuclear fuel from reactors located on the Hanford Site from 1955 to 1989 to recover plutonium, uranium, and other radioactive isotopes. The PUREX storage tunnels are used for the storage of waste from the PUREX Plant and other onsite sources. Most of the waste stored in the tunnels consists of large failed equipment components. The tunnels were designed and constructed to provide a means of protecting workers from exposure to highly radioactive residues within the failed equipment. The relative size and location of the tunnels can be seen in Figure 2. Photographs of Tunnels 1 and 2 during construction are shown in Figure 3.

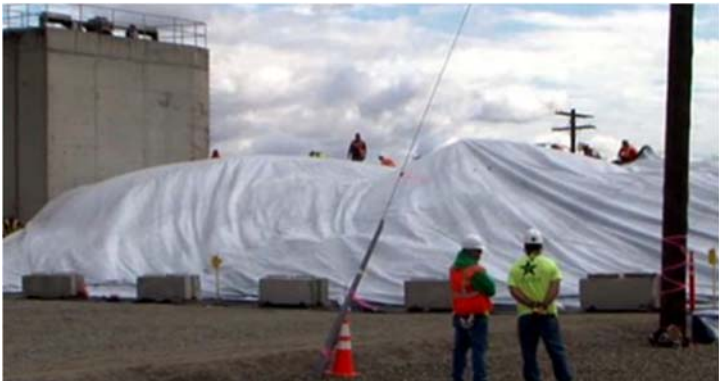
Table 2. High-Density Polyethylene Cover (Option 2)

Description	Placement of a heavy high-density polyethylene (HDPE) plastic cover over the structure. The use of an HDPE cover for protection from adverse ambient conditions is a widely used and versatile option. HDPE cover thickness can range from 40 to 120 mil. For this application, a cover would be custom fit in the field to the designed configuration.
Advantages	<ul style="list-style-type: none"> • Provides some contamination control in the event of a tunnel failure • Protects against water infiltration in soil overburden • Lightweight • Does not preclude future remedial action or closure decisions
Disadvantages	<ul style="list-style-type: none"> • Does not prevent tunnel failure • Does not protect against added load from snowfall • Stormwater can pool in areas • Would not be totally effective to contain contamination spread in event of tunnel failure • Surveillance of tunnel surface is more difficult due to obstructed visibility and limited access • Would require periodic replacement until final closure is implemented

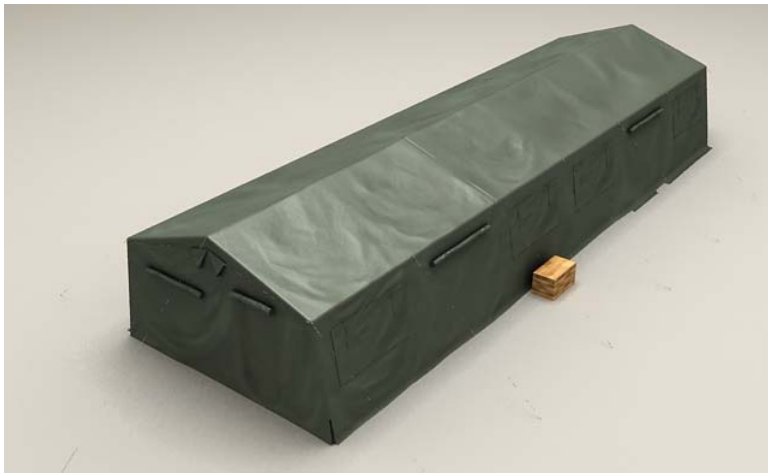
Table 3. Soft-Surface Tent Cover (Option 3)

Description	Construction of a tent over the entirety of the tunnel. The tent would be a custom design that would use materials that would prevent infiltration of rain and provide protection against wind. Although tents can be constructed from various materials (e.g., cotton, polyester, Protex®, Hydrotex®, polycotton, ripstop nylon), the design specification to meet the environmental and radiological requirements of this type of soft structure could require a long procurement timeframe.
Advantages	<ul style="list-style-type: none"> • Provides some contamination control in the event of tunnel failure • Protects against water infiltration in soil overburden • Provides limited protection against added load from snowfall • Does not preclude future remedial action or closure decisions
Disadvantages	<ul style="list-style-type: none"> • Does not prevent tunnel failure • Lead time to custom manufacture would be long • Construction activities could trigger tunnel failure • Could interfere with response actions in the event of a tunnel failure • Would likely become contaminated in a future event and controls would have to be established to control/allow personnel access • Surveillance of tunnel surface is more difficult due to obstructed visibility and limited access • Would require periodic replacement until final closure is implemented

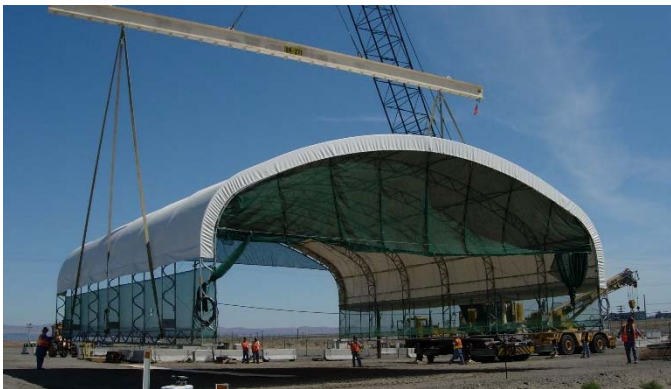
Table 4. Hard-Surface Tent Cover (Option 4)

Description	Construction of a hard surface tent. DOE has used hard structured tents in various locations throughout the DOE complex. These structures are typically constructed with an aluminum frame, a double-coated ultraviolet-resistant polyvinyl chloride roof cover, and options such as a rolling door or rigid wall. The hard surface tent provides better contamination control and more robust protection than a soft tent in the event of structural collapse of the tunnel.
Advantages	<ul style="list-style-type: none"> • More protection than HDPE cover or soft-sided tent • Provides some contamination control in the event of a tunnel failure • Protects against water infiltration in soil overburden • Protects against added load from snowfall • Does not preclude future remedial action or closure decisions
Disadvantages	<ul style="list-style-type: none"> • Does not prevent tunnel collapse • Construction activities could trigger tunnel failure • Surveillance of tunnel surface is more difficult due to obstructed visibility and limited access • Could interfere with response actions in the event of a tunnel failure • Would likely become contaminated in a future event and controls would have to be established to control/allow personnel access

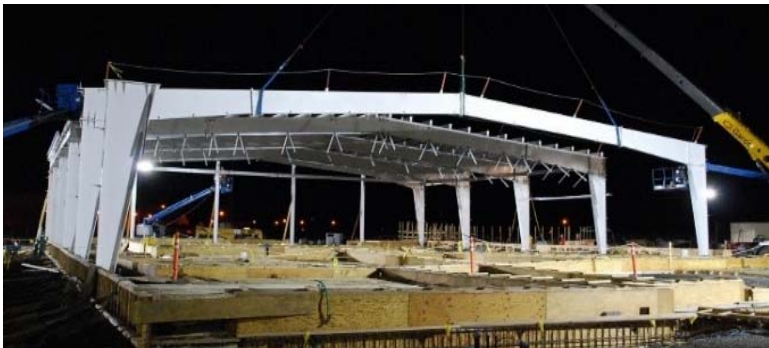
Table 5. Pre-Engineered Building Construction (Option 5)

Description	Erection of a pre-engineered metal building over the length of the tunnel. Steel construction mounted on concrete foundation/footings would be the highest degree of protection and containment that could be constructed around the tunnel. The building could be designed with an active ventilation system to provide greater contamination control.
Advantages	<ul style="list-style-type: none"> • Most robust protection of options involving exterior covers • Provides more contamination control in the event of a tunnel failure in comparison with options involving exterior covers; active ventilation would further improve control • Protects against water infiltration in soil overburden • Protects against added load from snowfall • Does not preclude future remedial action or closure decisions
Disadvantages	<ul style="list-style-type: none"> • Does not prevent tunnel failure • Extended timeline to implement increases risk of tunnel failure prior to completion • Construction activities could trigger tunnel failure • Surveillance of tunnel surface is more difficult due to obstructed visibility and limited access • Could interfere with response actions in the event of a tunnel failure

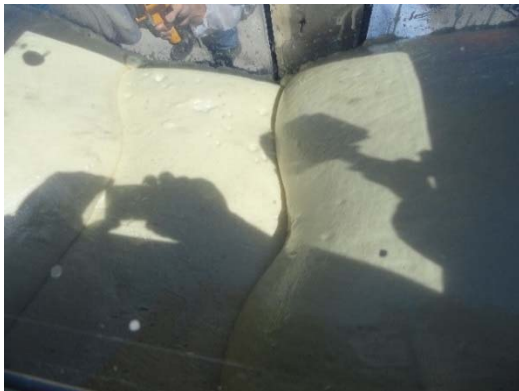
Table 6. Injection of Poly Foam Void Fill (Option 6)

Description	Spray polyurethane foam (SPF) is a spray-applied plastic that can form a continuous insulation and air sealing barrier to fill voids within the tunnel. It is made by mixing and reacting unique liquid components at the job site to create foam. The liquids react very quickly when mixed, expanding on contact to create foam that insulates, seals gaps, and can form moisture and vapor barriers. SPF insulation is known to resist heat transfer extremely well, and it offers a highly effective solution in reducing unwanted air infiltration through cracks, seams, and joints thus providing control of contamination and preventing contamination spread in the event of a release. High-, medium-, and low-density SPF is available to be formulated for specific purposes.
Advantages	<ul style="list-style-type: none"> • Provides additional structural support to tunnel and prevents future tunnel failure • Provides ability to withstand added load from precipitation • Protects stored waste and acts as fixative for contamination • Does not preclude future remedial action or closure decisions

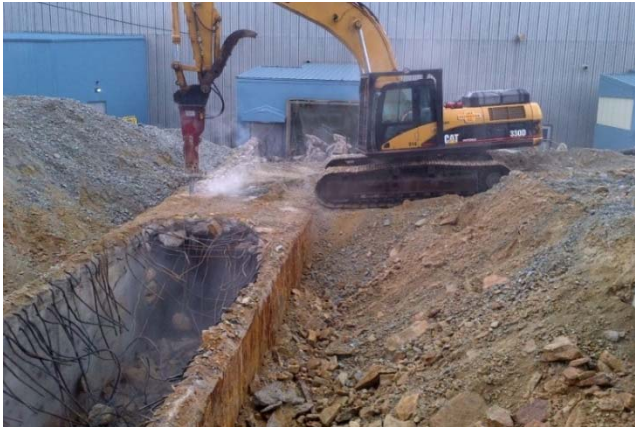
Table 7. Controlled Collapse In Place (Option 7)

Description	Create a controlled collapse of the tunnel by using controlled implosions or by using heavy equipment to place strategic loads at specified points of the tunnel structure. The intent would be to use the existing overburden to fill the void spaces within the tunnel, and would likely require the placement of additional overburden to compensate for the decrease of the existing shielding that would occur. Controlled collapse can be achieved by several methods, but the most probable methods would be by controlled use of explosives, direct mechanical stress from heavy equipment, or the addition of overburden by equipment or a conveyor to cause planned structural failure.
Advantages	<ul style="list-style-type: none"> • Minimizes/removes future tunnel failure potential • Does not preclude future remedial action or closure decisions
Disadvantages	<ul style="list-style-type: none"> • Extended timeline to implement, increases risk of tunnel failure prior to completion • Difficult to control contamination migration and dose to workers during implementation • Could cause damage to stored equipment and boxes in the tunnel that could lead to contamination migration, dose to workers, and impacts to future remedial action or closure decisions • Limits ability for in situ characterization (e.g., use of robotic crawler-type characterization devices) of stored waste post-implementation • Complicates ability to segregate wastes requiring different disposition paths • May require additional soil overburden to achieve desired shielding as part of implementation

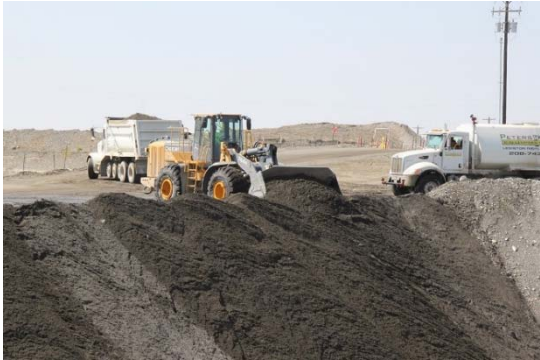
Table 8. Sand or Clay Void Fill (Option 8)

Description	Injection of sand or clay (e.g., bentonite) into the tunnel to fill void spaces to provide both structural stability and minimize potential future subsidence of the overburden. Either sand or clay could be injected by creating sufficient penetrations to place or spray the sand or clay into the tunnel to fill voids. Sand could also be injected by mixing with water to create a slurry that would flow into voids. If properly distributed, the sand or clay would reduce dose rates from radiological sources and stabilize the structure of the tunnel. It could potentially be removed from the tunnel using a vacuum or slurry removal methods more readily than grout or foam.
Advantages	<ul style="list-style-type: none"> • Provides additional structural support to tunnel and prevents future tunnel failure • Provides ability to withstand added load from precipitation • Protects stored waste • May be removed if necessary to implement future remedial and closure actions • Does not preclude future remedial actions or closure decisions

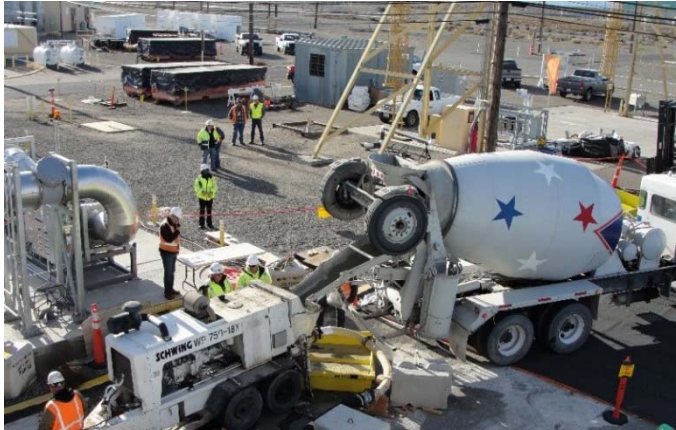
Table 9. Grout Void Fill (Option 9)

Description	Injection of grout into the tunnel to fill all void spaces to provide both structural stability and minimize potential future subsidence of the overburden. The grout mix can be tailored to specific compressive strength needs and desired flow characteristics to access small spaces. Grouting is routinely used across the Hanford Site and the nuclear industry to immobilize and stabilize contamination, reduce dose rates from radiological sources, and stabilize structures. Grouting material can be tailored to meet these objectives and ensure void spaces are corrected. Injection of grout would encapsulate the failed equipment/waste containers.
Advantages	<ul style="list-style-type: none"> • Provides additional structural support to tunnel and prevents future tunnel failure • Provides ability to withstand added load from precipitation • Protects stored waste and acts as fixative for contamination • Does not preclude future remedial actions or closure decisions

Due to the risk of failure identified in the structural integrity evaluations (17-AMRP-0201), a plan has been approved to void fill Tunnel 1 with grout. The use of grout as void fill has been successful at the Hanford Site and throughout the DOE complex and can be effectively implemented at a reasonable cost. When implemented, the stabilization response action for Tunnel 1 will improve tunnel stability, provide additional radiological protection, and increase durability while not precluding future remedial actions or closure decisions.

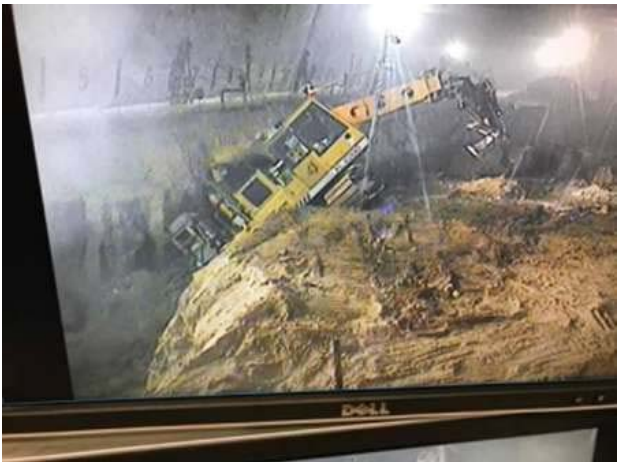
Table 10. Stored Waste Retrieval (Option 10)

Description	<p>Waste in the tunnel could be retrieved and processed for disposal or continued storage elsewhere. Retrieval could potentially be accomplished by reactivating the tunnel entry and crane facilities and removing the waste through the PUREX Plant. This would require extensive planning, engineering, and potentially replacement of existing equipment. Retrieval could also be accomplished by controlled demolition of the tunnel and removal of railcars and equipment using external equipment. Where a tunnel is filled with foam or grout as an interim measure, cutting technologies would have to be used to retrieve waste. Because of the variable nature of the waste packages in the tunnel as well as unknown dose and contamination levels, determination of conditions would be required prior to design and installation of equipment and facilities necessary to characterize, treat where necessary, size reduce, and repackage wastes. Alternately, a conservative approach could be employed where all activities would be conducted in a structure that provides containment and shielding for expected worst-case conditions. Based on current knowledge it is expected that some wastes could be disposed of in the Environmental Restoration Disposal Facility as low-level wastes and some could be dispositioned as contact-handled or remote-handled transuranic or transuranic mixed wastes for disposal in the Waste Isolation Pilot Plant. However, some of the waste may not have a clear disposition path and may have to be repackaged for continued storage onsite until a final disposition path is available.</p>

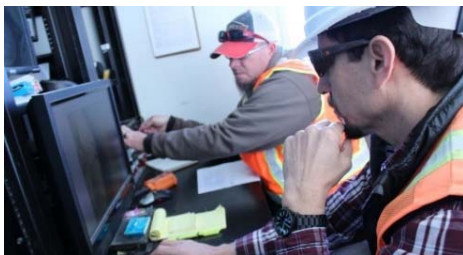
Table 11. Surveillance and Monitoring Enhancements (Option 11)

Description	<p>Enhanced surveillance and monitoring consists of a combination of increased active monitoring of the tunnel conditions and use of various tools to gather additional information to supplement the existing design/as-built knowledge base. Potential enhancements may include the following:</p> <ul style="list-style-type: none"> • Visual surveillance of the tunnel surface and perimeter to identify changed conditions • Remote camera/video surveillance of the tunnel surface • Radiological surveys in vicinity of the tunnel to identify changes in background or contamination levels • Geophysical surveys to provide indication of depth of soil cover and rail car locations • Digital imaging (i.e., Light Detection and Ranging [LiDAR], global positioning system, high-definition surveying laser technologies) to detect changes in surface elevation over time • Robotic or other unmanned entry equipment to assess interior tunnel condition, location and condition of stored waste, and radiological conditions <p>The potential methods and tools represent a mix of off-the-shelf items that could be immediately deployed and items that would require some modification for the specific tunnel conditions. Interior conditions may limit the value of information attainable by some tunnel entry tools.</p>
