Tank 241-Z-361 Documented Safety Analysis

Document Type: DSA Program/Project: CPRM

HNF-20503, Rev. 3

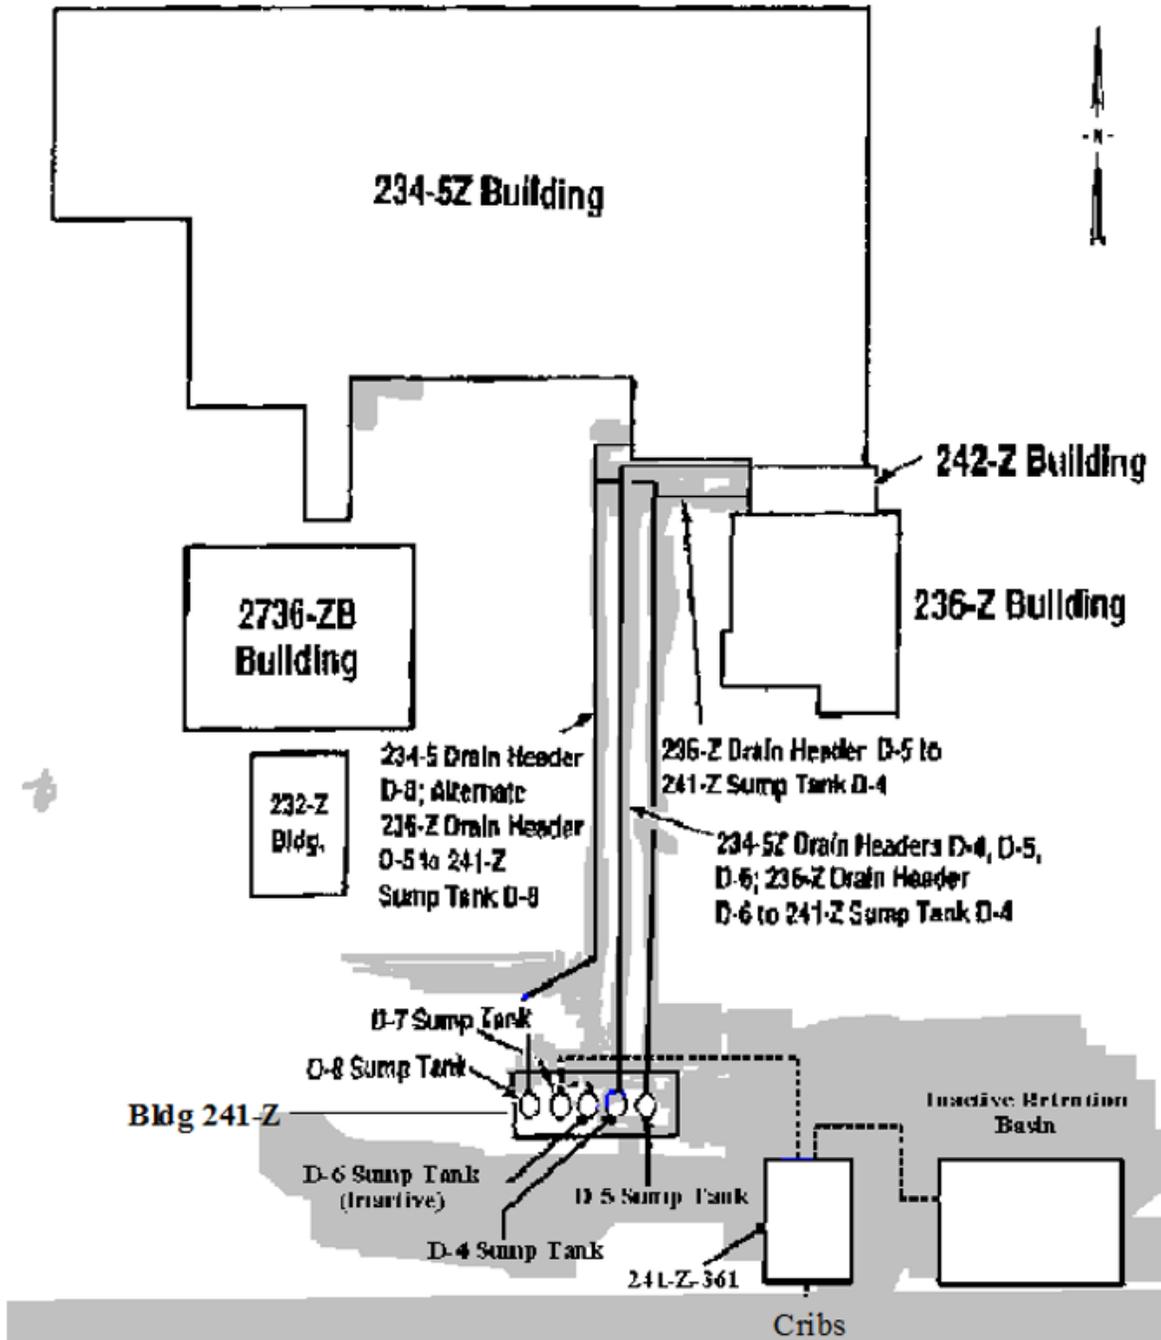
Figure 2-3. PFP Drain System (Historical Configuration)

The transfer lines to Building 241-Z were numbered 241-D-4 to 241-D-6 (Figure 2-3). (Note: There were several different configurations of the PPF drain system.) The 241-Z Sump Tanks were numbered 241-D-4 through 241-D-8. The 241-D-4, 241-D-5, and 241-D-6 drains went to the 241-D-6 sump tank. When the 241-D-6 tank was full, it was transferred to the 241-D-7 tank. The 241-D-6 sump tank eventually failed and D-7 was used in its place. Prior to transfer to cribs, the 241-D-7 tank contents were sampled. If the plutonium content was analyzed to be more than 10 g per batch, generally the batch was reprocessed. Below the plutonium discard limit, caustic was added and the material was sent to the cribs via Tank 241-Z-361, where solids settled out and the liquid overflowed by gravity to the cribs. Accordingly, the materials discharged via Tank 241-Z-361 would be expected to have been low in plutonium concentration. In addition to drain lines, a large un-quantified amount of process water was discharged from the retention basins to the cribs through Tank 241-Z-361.

Waste liquids that passed through the Tank 241-Z-361 settling tank flowed from PPF to ground in the following sequence: processes to 241-D-4, 241-D-5, and 241-D-6 Drains to 241-D-6 Sump Tank to 241-D-7 or 241-D-8 Sump Tank to Tank 241-Z-361, and then to the cribs.

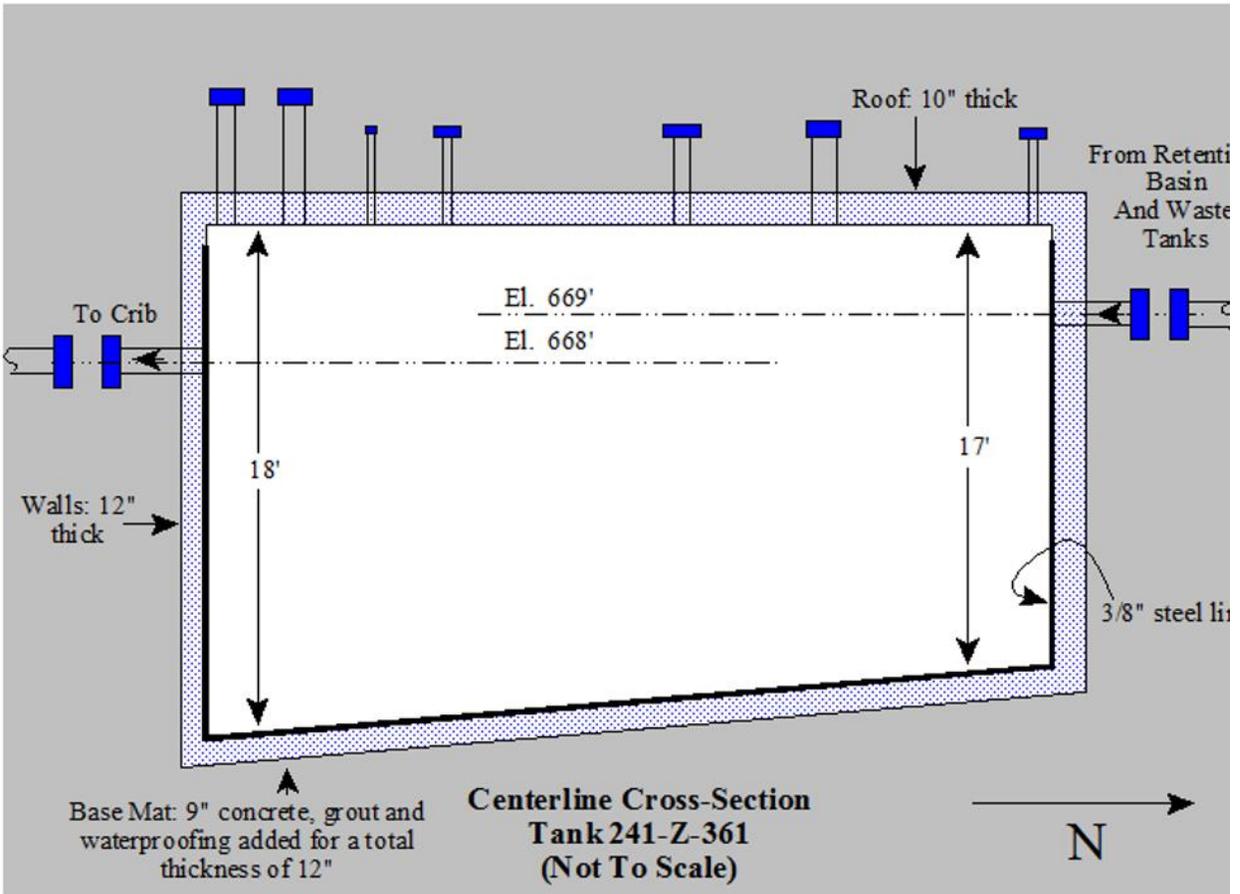
Figure 2-4. Section View of Tank 241-Z-361

The interior of the tank was lined with 0.95 cm (3/8 in.) carbon steel on the bottom and up the sides to within 15.2 cm (6 in.) of the roof. A protective coating was placed between the liner and the concrete as a corrosion barrier. Two 15.2-cm (6-in.) stainless steel pipes lead into the tank (from the retention basin and 241-Z) at the north end of the tank, and one 20.3-cm (8-in.) stainless-steel pipe forms the discharge at the south end of the tank. Baffle boxes were installed around the inlet and discharge pipes and attached to the liner. The bottom of the inlet piping is at elevation 203.9 m (669 ft) and the bottom of the discharge pipe is at elevation 203.6 m (668 ft).

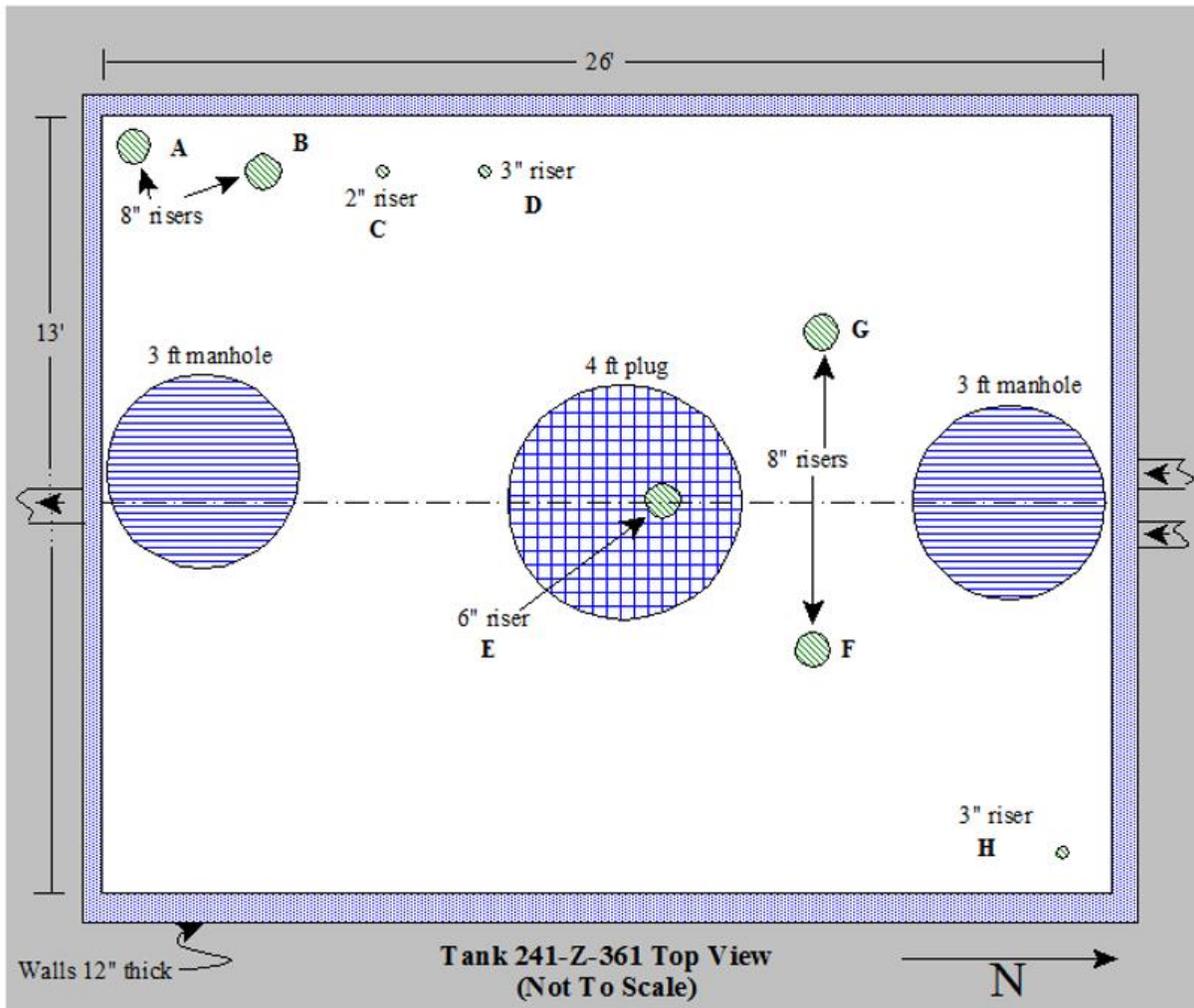
Figure 2-5. Top View of Tank 241-Z-361

The sludge is approximately 2.39 m (94 in.) deep. One of the south end 20.3-cm (8-in.) risers had a dry well installed, but it has been removed or corroded away. The inlet and outlet pipes have been isolated and plugged or flanged 0.61 m (2 ft) from the outer wall of the tank. The reinforced concrete poured over the top of the tank has been removed from over the two manholes and the tank was opened for sampling in the mid-1970s. The manhole covers were subsequently reinstalled, covered with weather covers, and buried. The tank is covered with approximately 0.61 m (2 ft) of soil (HNF-2024).

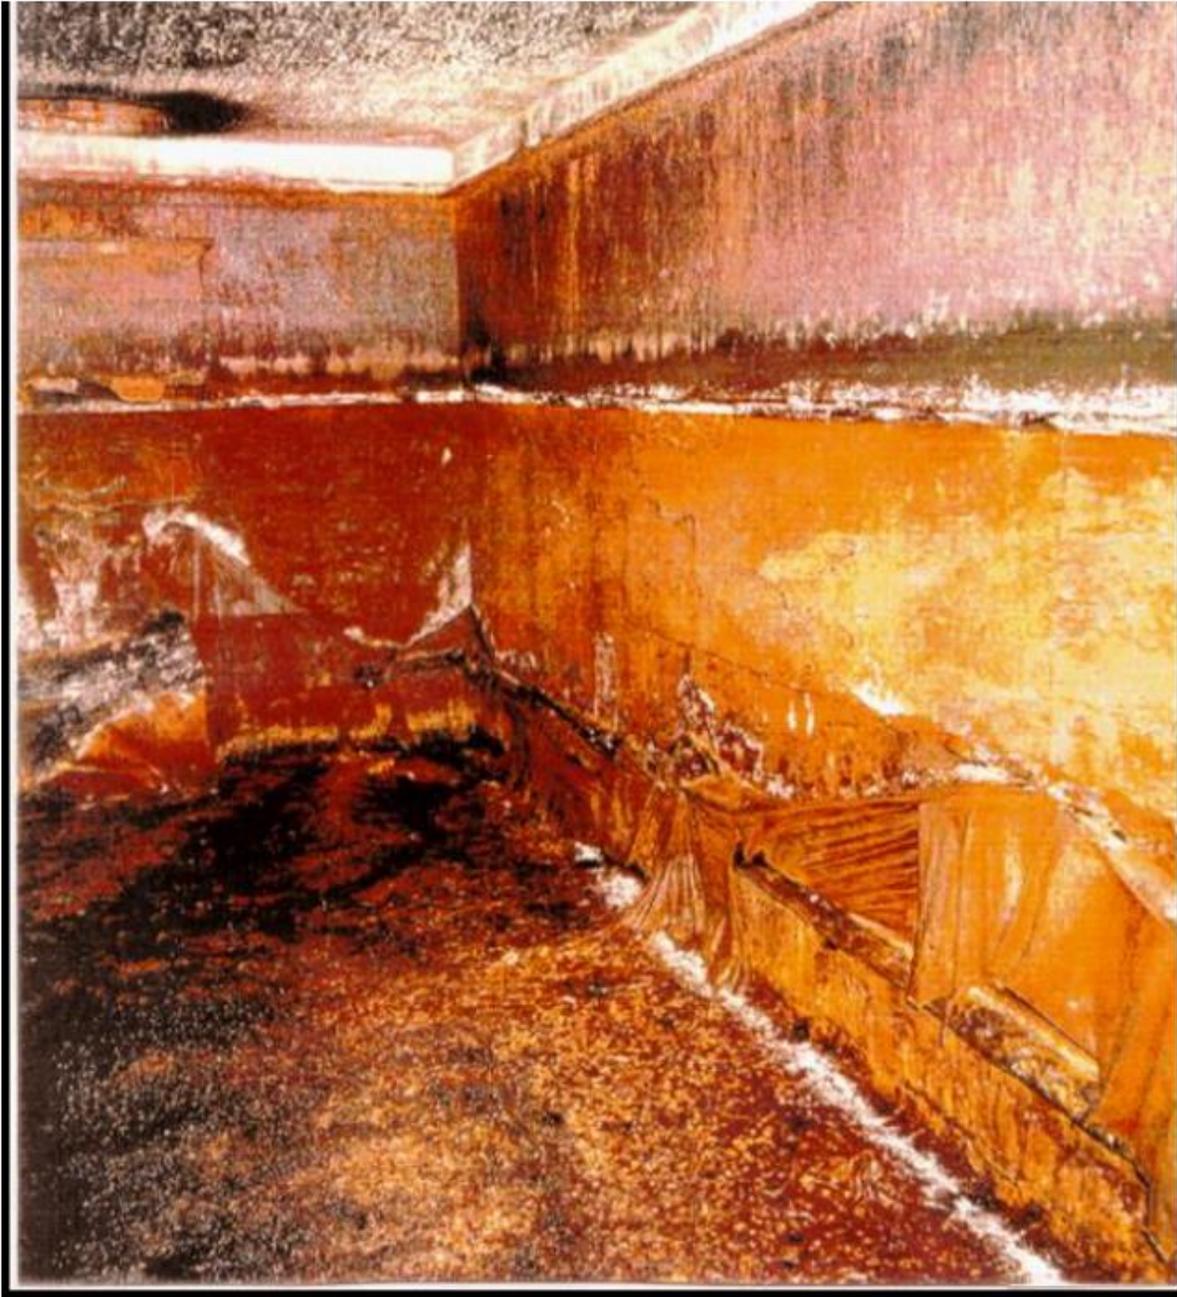
Figure 2-6. Tank 241-Z-361 Interior

Photographs show that the liner plate (elevation 203.6 m [668 ft]) appears to be corroded away down to the level of the sludge (Figure 2-6). Videographs taken during activities authorized by Phase I of the JCO show that five dry wells are installed in the tank. Dry wells appear to be installed in both 0.91-m (3-ft) concrete manholes (Figure 2-4). Dry wells are also installed in Risers F and G. The dry wells are not sealed (closed) at the top; instead, they are open to the tank headspace.

- The conditions do not appear markedly different from those shown in 1985 photographs. The 0.95-cm (3/8-in.)-thick steel liner was dissolved below the maximum liquid level. However, much of the water proofing material originally installed between the steel liner and the concrete remains.

- A limited number of small areas were visible where both the steel liner and the water proofing material had been removed. Exposed aggregate was observed in some of these locations, potentially reducing the concrete wall structural capacity.

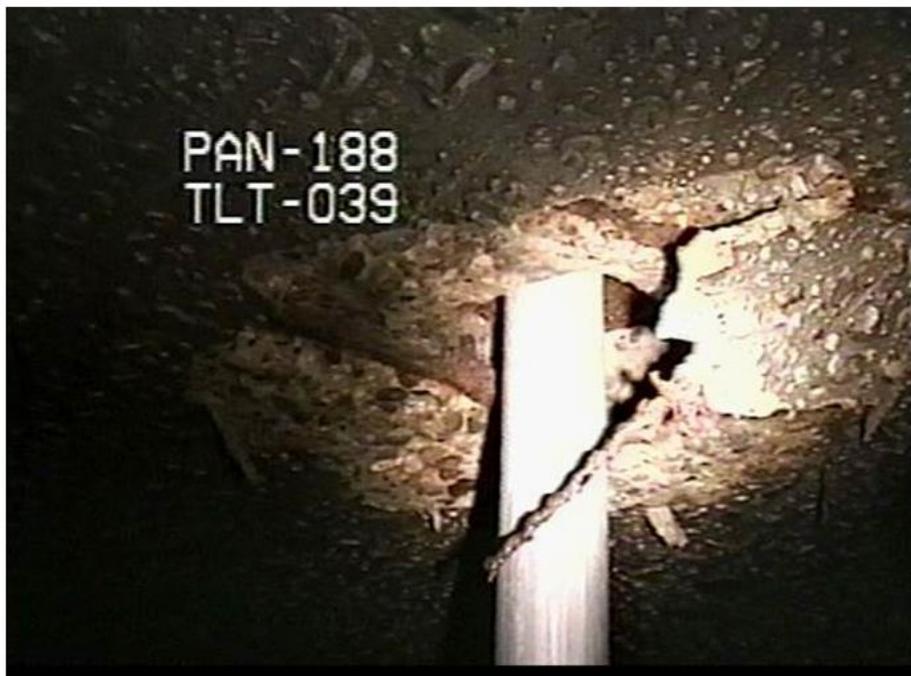
The In-Tank Video provides visual information on the tank roof condition that has not been available from prior reviews. Local damage to the roof structure around Riser F is shown in Figure A-1 with dry well installed. The actual mechanism causing the observed spalling is unknown. There are several features in the image worthy of comment.

Figure A-1. Tank 241-Z-361 Roof Local Damage at Riser F – Toward Northeast Corner

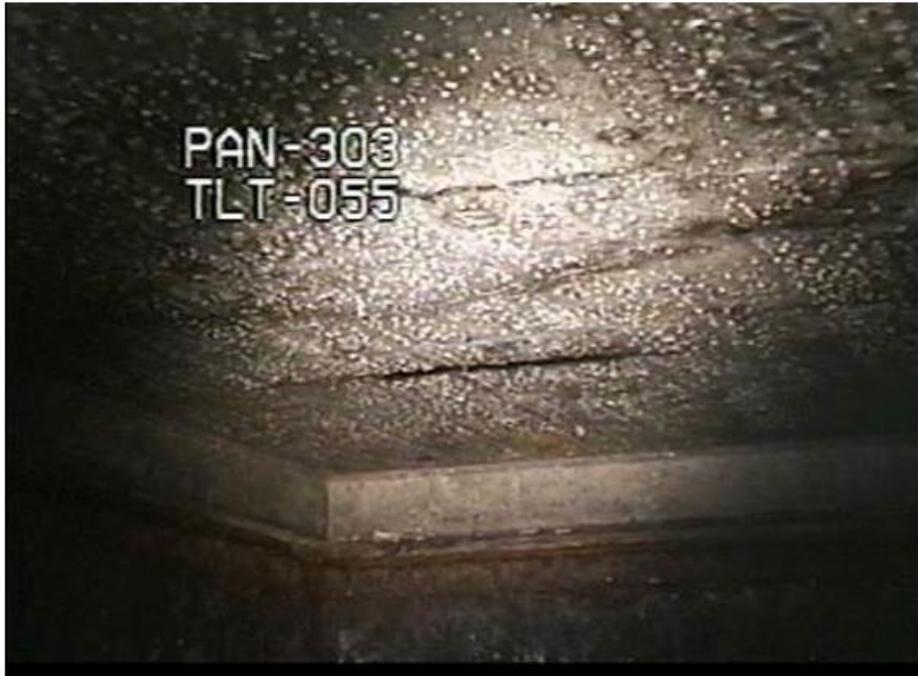
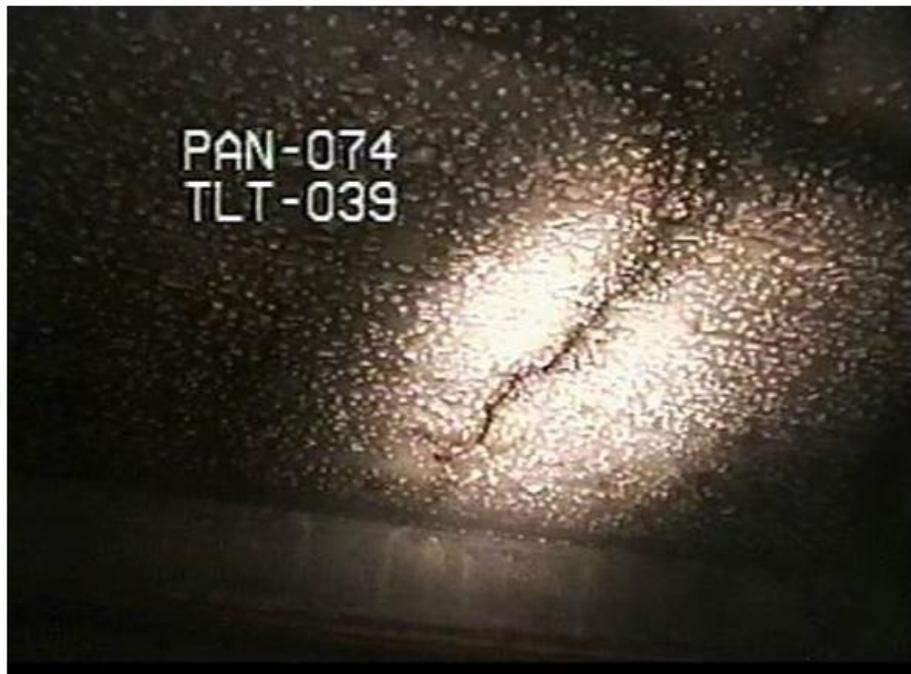
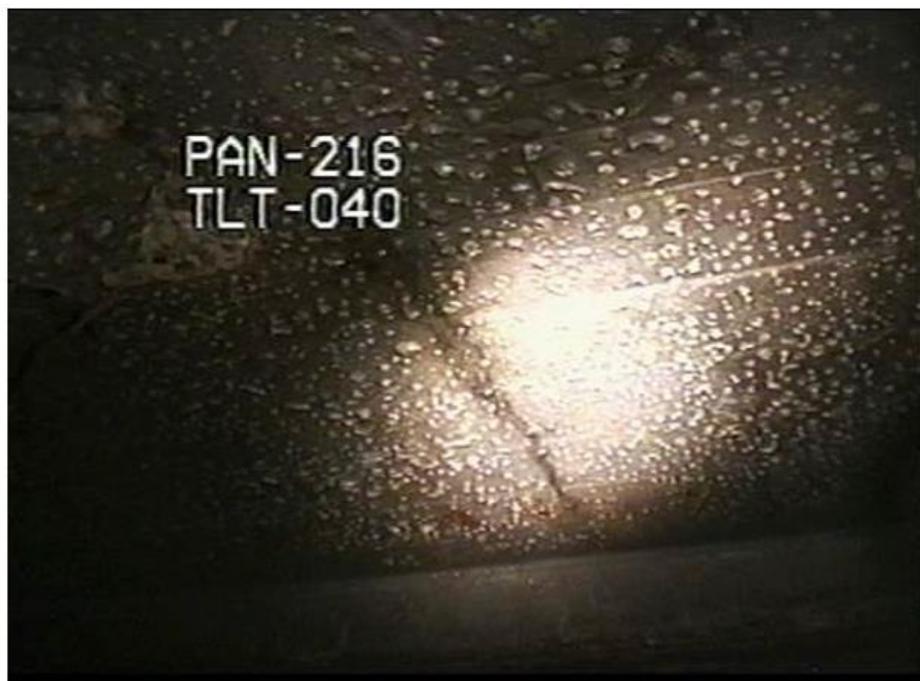
The general undisturbed roof surface has an appearance similar to an exposed aggregate slab finish. This is attributed to the tank atmosphere etching the cement paste off the lower surface of the slab during past operations. Two of the roof reinforcing bars are visible near the spalled surface on each side of the dry well. Based on the tank drawings (H-2-16024), these reinforcing bars are 1-1/8-inch square bars spaced 12 inches on center. The design drawings show that these bars had 3/4-inch cover as-designed. Specification of 3/4 inches of cover implies that the maximum aggregate size was also 3/4 inch. The physical size of the bar can be used to estimate the remaining cover on the roof slab bottom bars. It is estimated that about one-quarter, but less than one-half the cover cement paste has been removed by this etching process. Similar exposed aggregate is seen on the entire lower surface of the tank roof as shown in Figures A-2a, A-2b, and A-2c.

Figure A-2a. Tank 241-Z-361 Roof Damage – Near Southeast Corner

Figure A-2b. Tank 241-Z-361 Roof Damage – Near Center of West Wall

Figure A-2c. Tank 241-Z-361 Roof Damage – Near Center of East Wall

Cracking indications are shown in Figures A-2a, A-2b, and A-2c also, all of which show the underside condition of the tank roof. All of these pictures show the initiation of spalling of the slab underside surface, probably immediately below the 1-1/8-inch square bottom bars in the roof slab. The corrosion has progressed far enough to cause splitting, but not spalling of the concrete cover. There were many indications of rust-like discolorations observed on the underside of the roof at intervals consistent with the bottom bar spacing; suggesting widespread corrosion of the bottom rebar of the concrete roof structure. This could lead to additional splitting and spalling of the concrete, reducing the load carrying capacity of the roof structure.

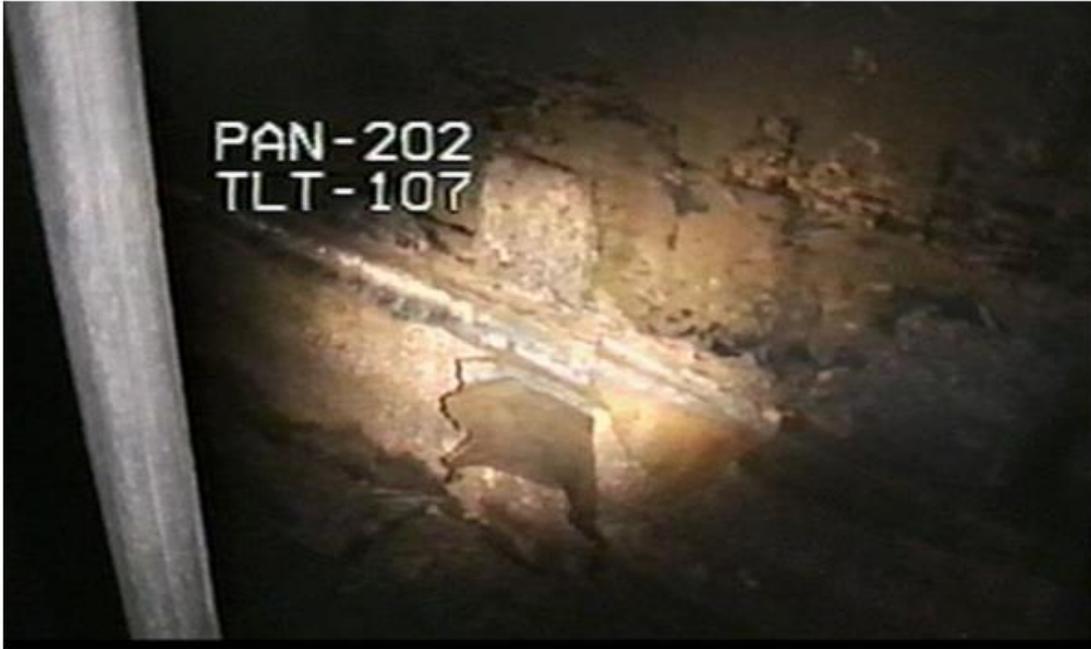
Figure A-3a shows a view of the inner tank wall in the lower part of the tank. The inner steel plate (3/8 inch) liner was dissolved or removed over most of the area exposed to the tank liquid contents. Two shelf angles and the upper portion of the liner remain intact and obscure direct observation of the inner concrete wall surface near the top of the tank. Although the liner plate is gone from the middle and lower elevations of the tank sidewalls, the waterproofing system (a mastic material with reinforcing fabric) remains partially in place on most of the wall area available for visual inspection. The remaining waterproofing material precludes direct visual examination of the current condition of the concrete inner wall in these areas. Figure A-3a shows an area where the concrete does not appear to have been much affected by the tank liquids. Two locations were observed in the videotape where the waterproofing system had completely failed.

Figure A-3a. Tank 241-Z-361 Wall Damage – Bottom Near Northeast Corner.

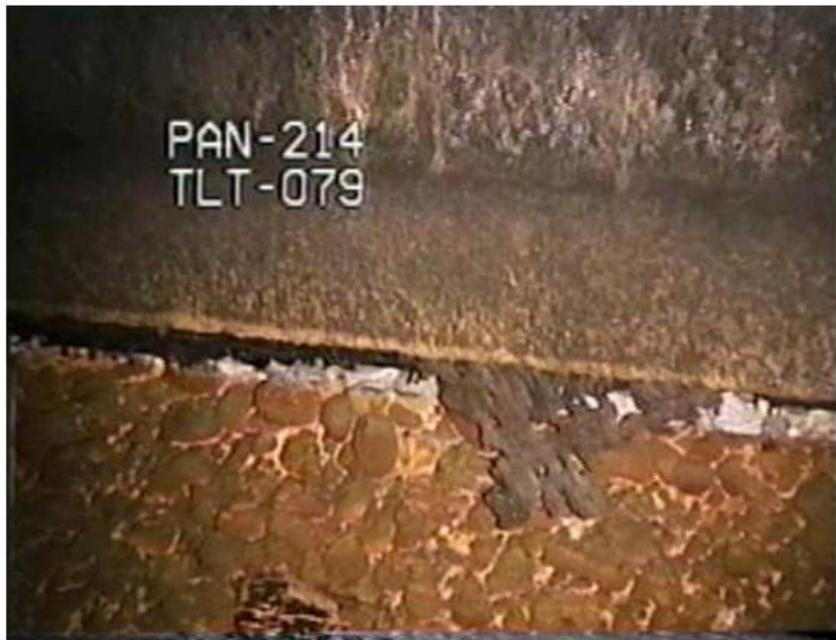
Figure A-3b. Tank 241-Z-361 Wall Damage – Near Center of East Wall. Adjacent to Remaining

At these locations, the tank liquid content has removed the cement paste around the aggregate rocks at the inner surface of the wall. Figure A-3b is an example of this etching of the sidewall as seen by the exposed aggregate. The images do not allow an estimation of the distance that this effect may extend into the wall thickness but is an indication of potential loss in wall structural capacity. Because of the limited visual access, the probable areal extent of this kind of degradation cannot be estimated accurately. These observations partially confirm the current concept that the tank lower sidewalls may have significantly reduced strength. All indications are that the tank roof and sidewalls have reduced structural capacity, which is consistent with the current JCO structural analyses.
