OFFICE OF
RIVER PROTECTION
United States Department of Energy

Hanford Single Shell Tank Integrity Program Updates

March 2019

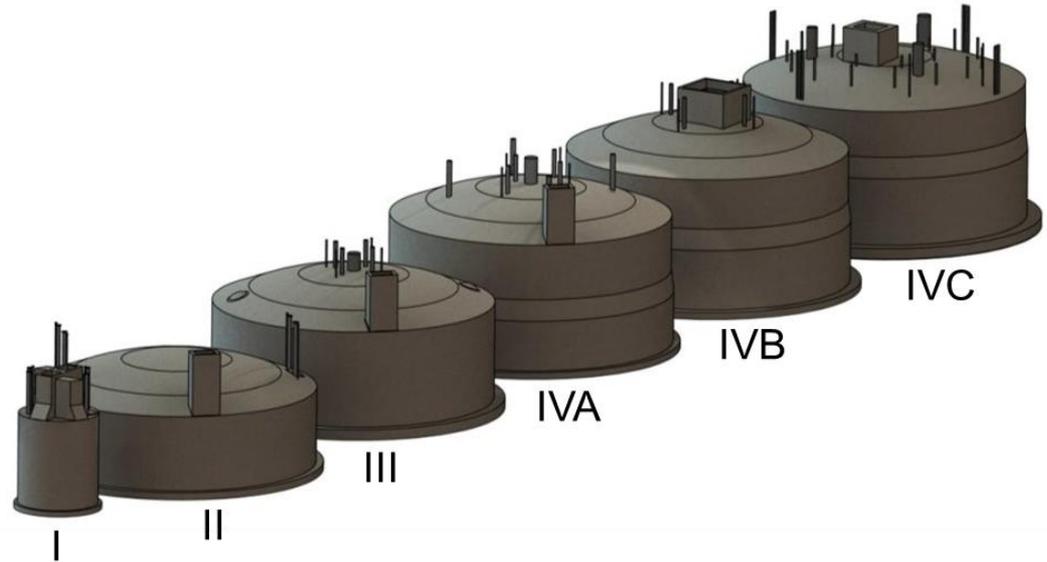
- 12 SST Farms were built between 1943 and 1964
- 149 total single-shell tanks
- Various capacities:
 - Type I 55 kgal
 - Type II 530 kgal
 - Type III 760 kgal
 - Type IV 1 million gal

Tank Series	I	II	III	IVA	IVB	IVC
Farms	241-B 241-C 241-T 241-U	241-B 241-BX 241-C 241-T 241-U	241-BY 241-S 241-TX 241-TY	241-SX	241-A	241-AX
Total Tanks	16 Tanks	60 Tanks	48 Tanks	15 Tanks	6 Tanks	4 Tanks

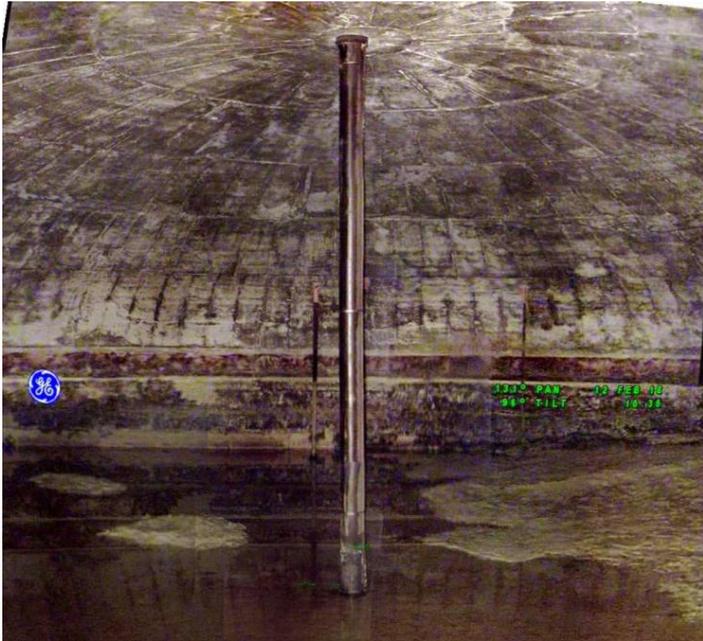
Tank B-104 Composite View from Dome to Waste Surface

Images from RPP-RPT-60565, FY18 SST Visual Inspection Report

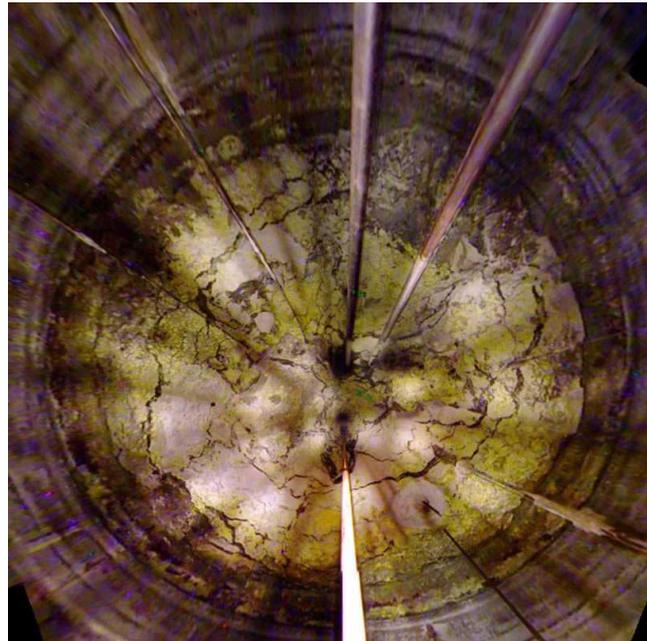
Tank SX-105 Composite View of Waste Surface

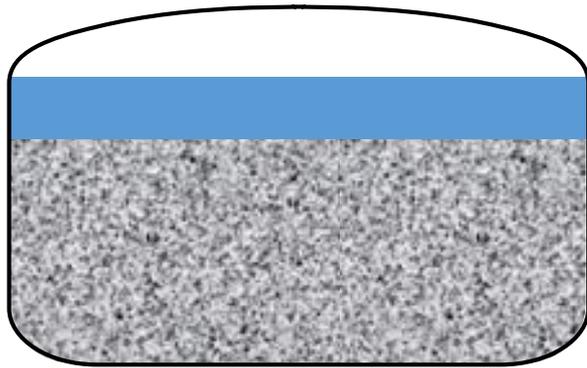
Tank with saltcake and supernate layer

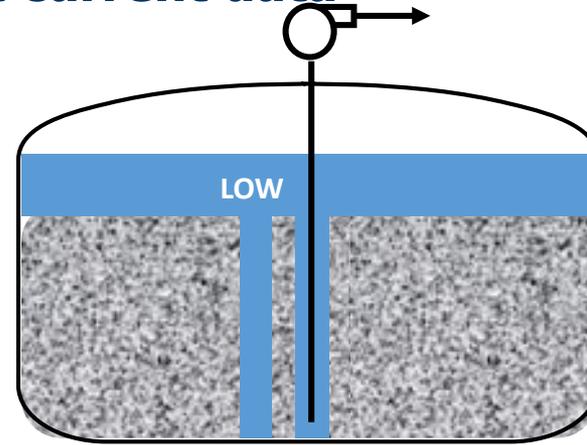
Salt well and supernate pump with Liquid Observation Well (LOW)

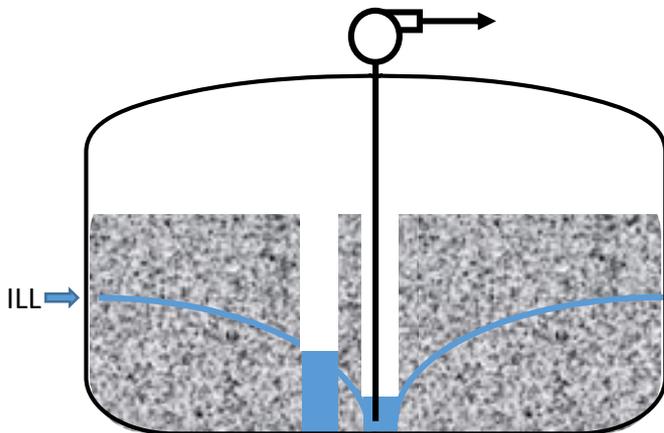
Pumpable supernate removed, Interstitial Liquid Level (ILL) not yet stabilized but used for previous DIL calculations

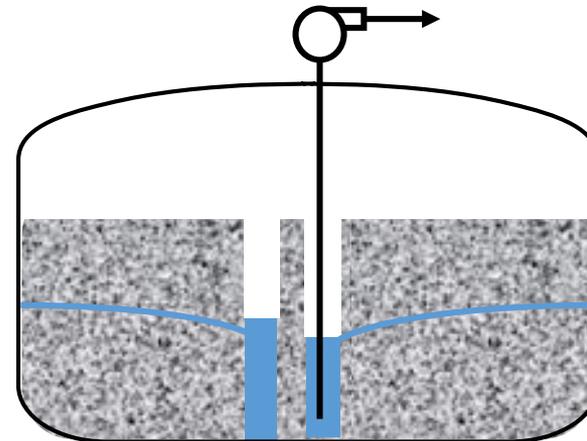
Over time, ILL profile flattens and LOW level increases

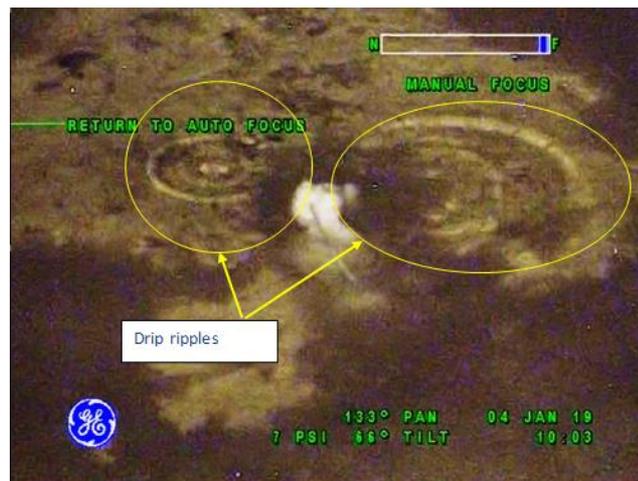
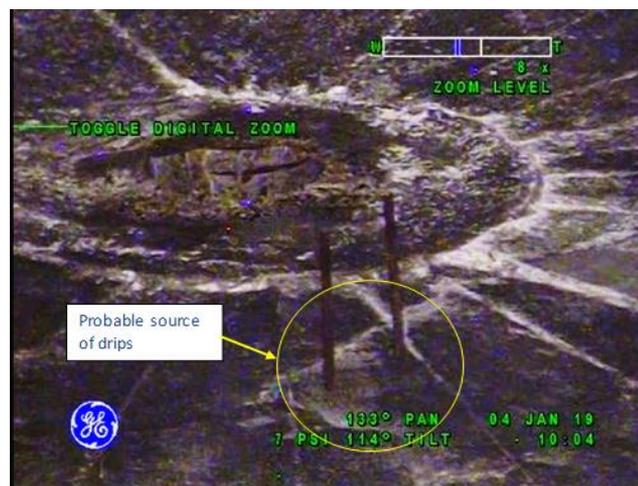
B-112 Visual Inspection

- Data in Table 4-4 and Table 4-5 in HNF-EP-0182, "Waste Tank Summary Reports" will be updated to reflect current data
- Continue visual inspection of SSTs to identify potential for water intrusion
 - Tank added to visual inspection list based off trending of the LOW or ENRAF readings
 - Data analyzed and notifications made if necessary
