PUREX Tunnels Update

U.S. Department of Energy
Richland Operations Office

PUREX Tunnel Construction

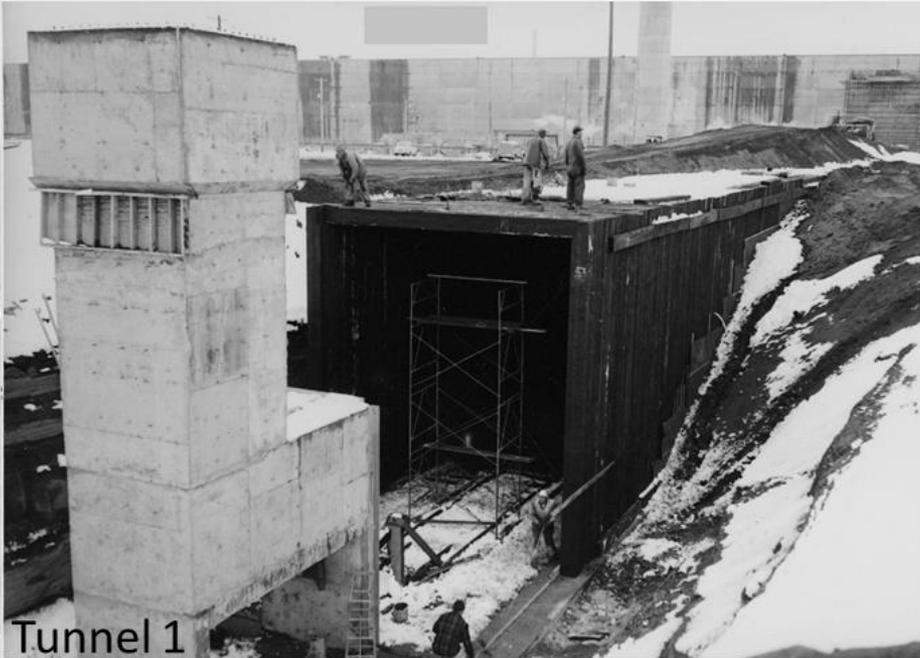
Tunnel 1

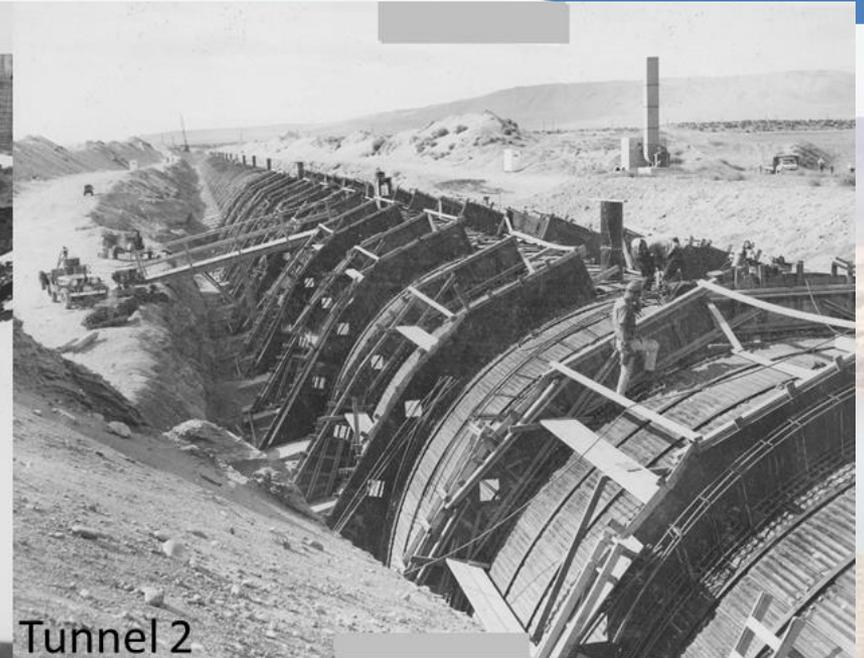
Tunnel 2

Tunnels 1 and 2 during construction

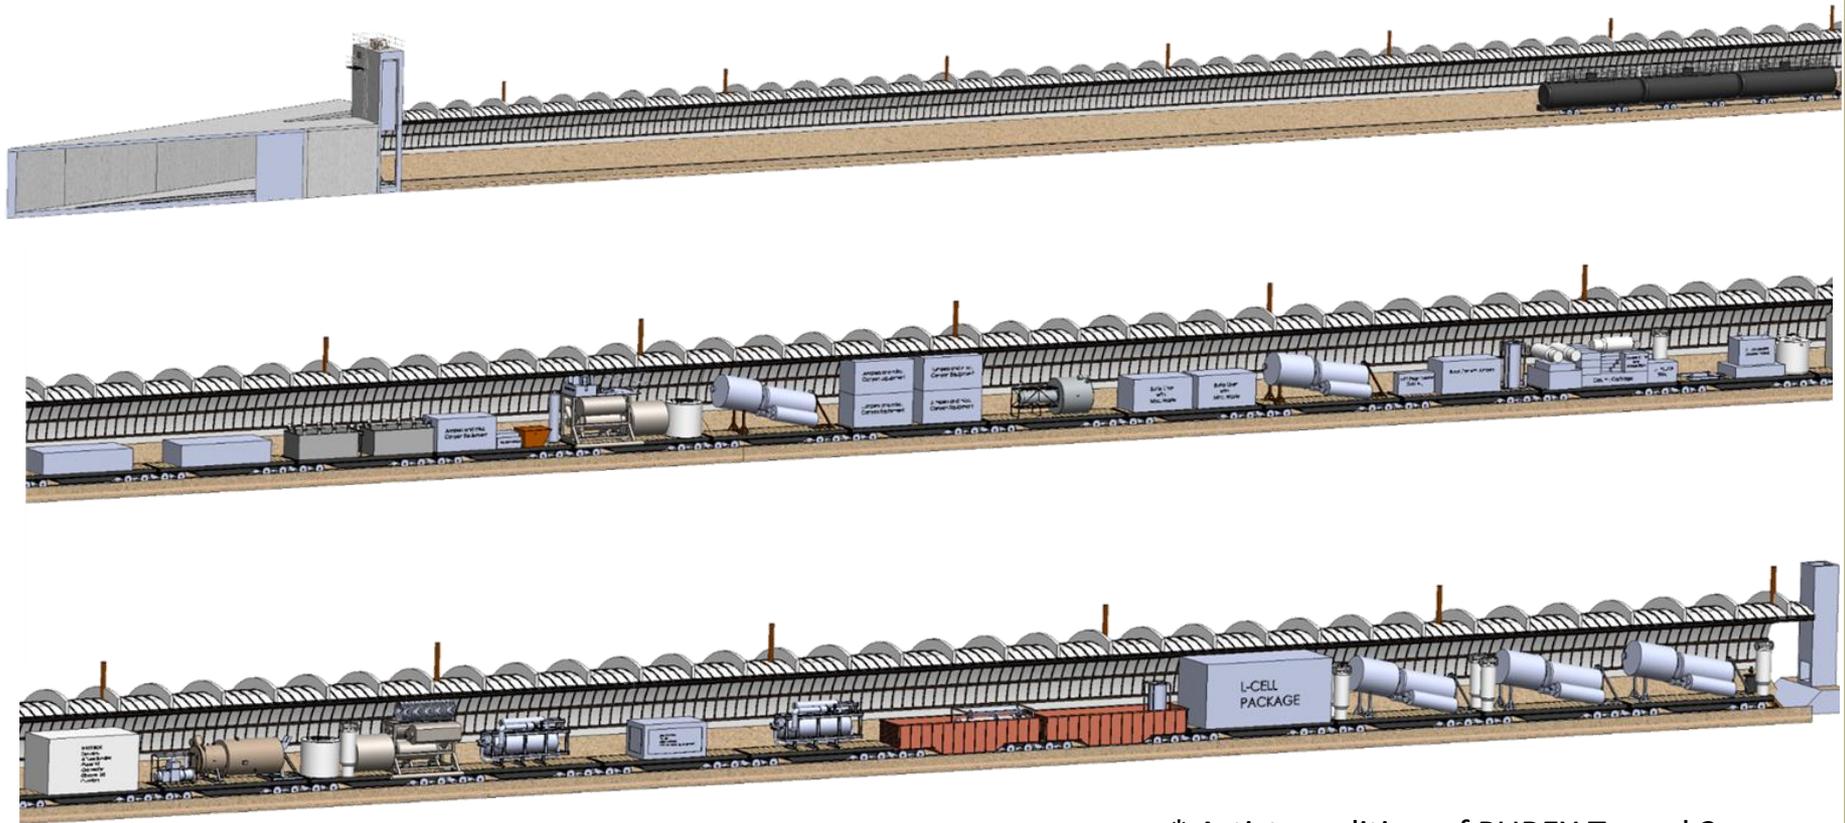
* Artist rendition of PUREX Tunnel 2

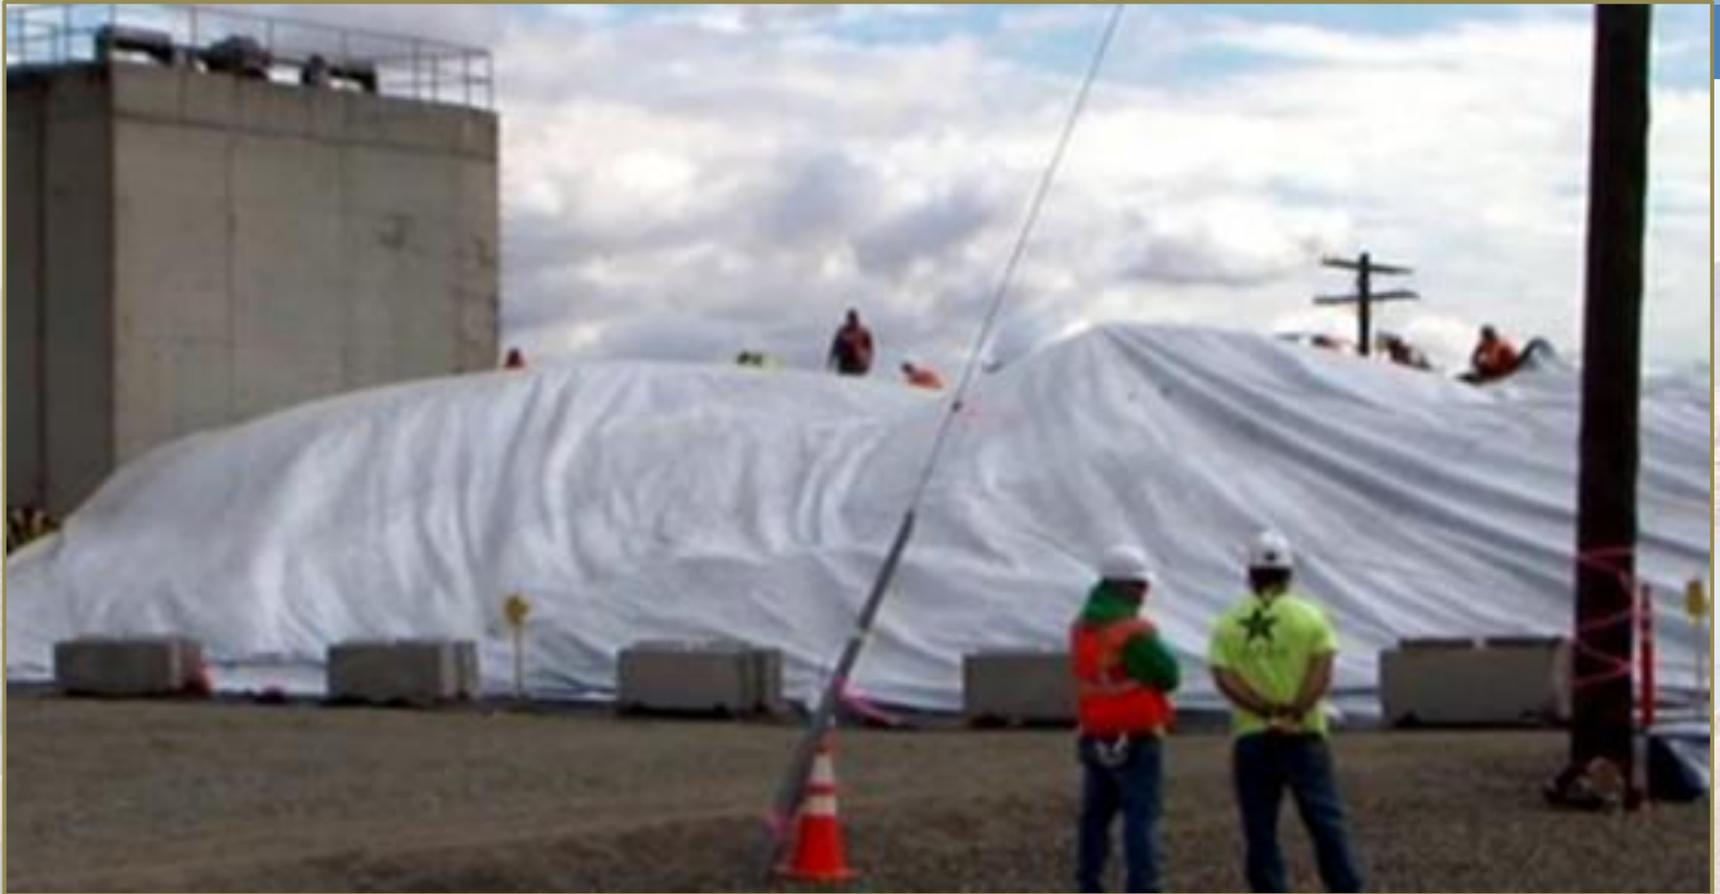
High-Density Polyethylene Cover

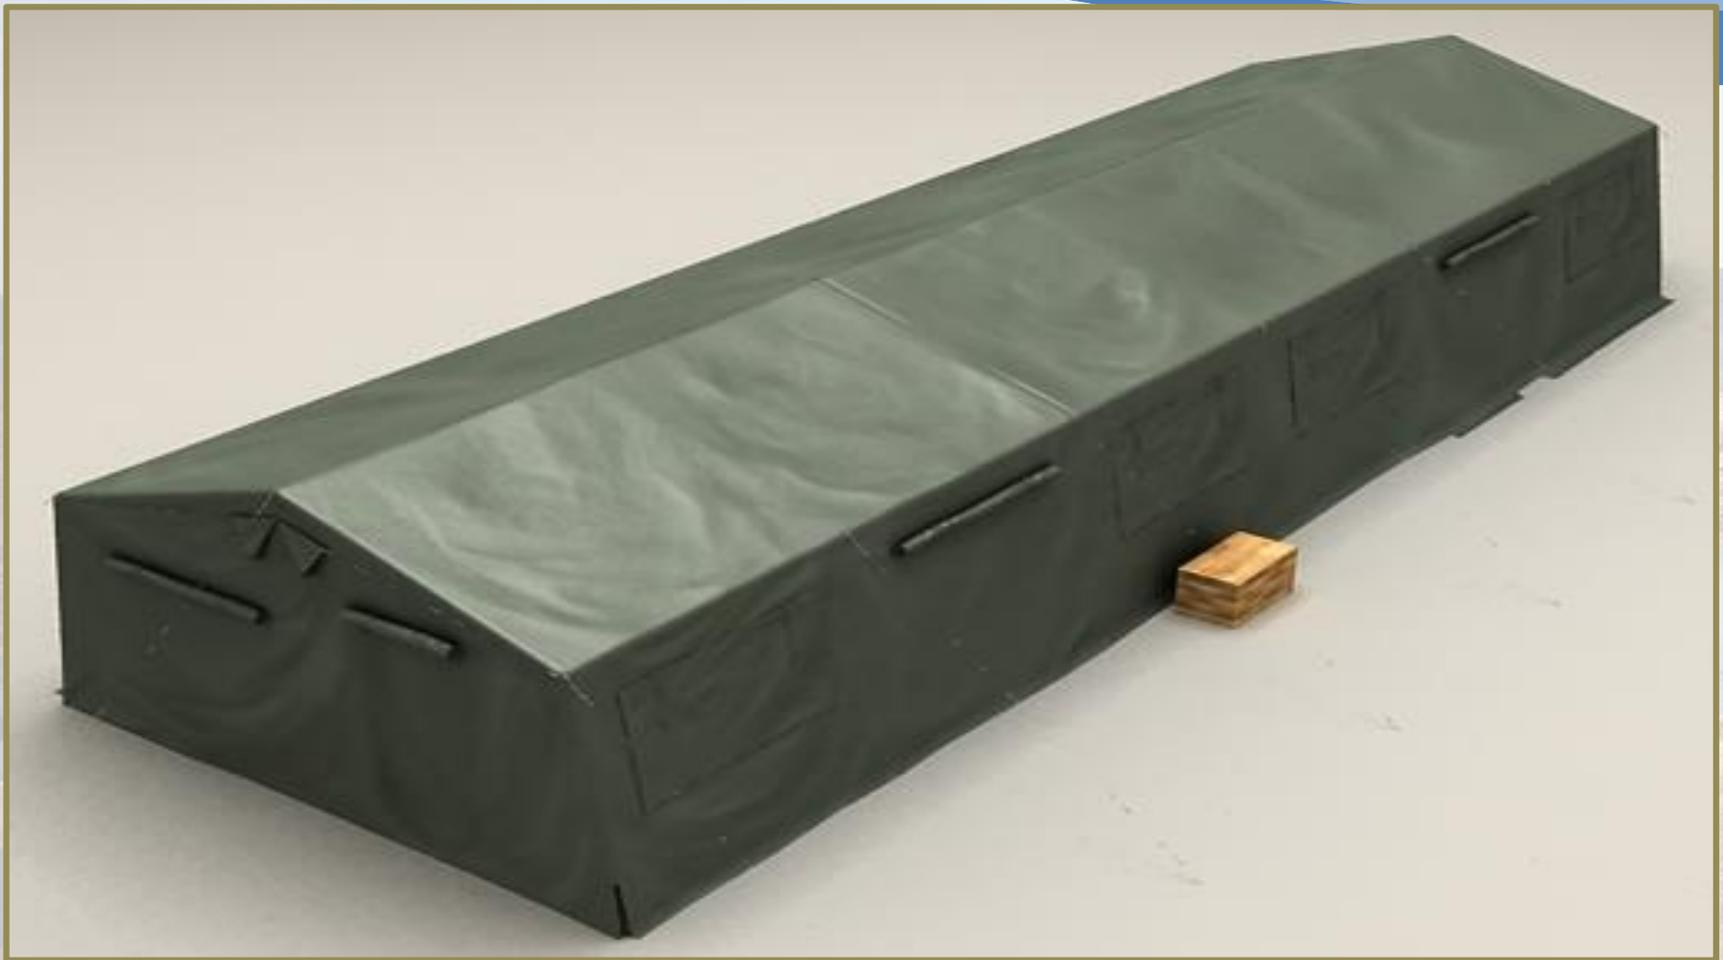
Soft-Surface Tent Cover

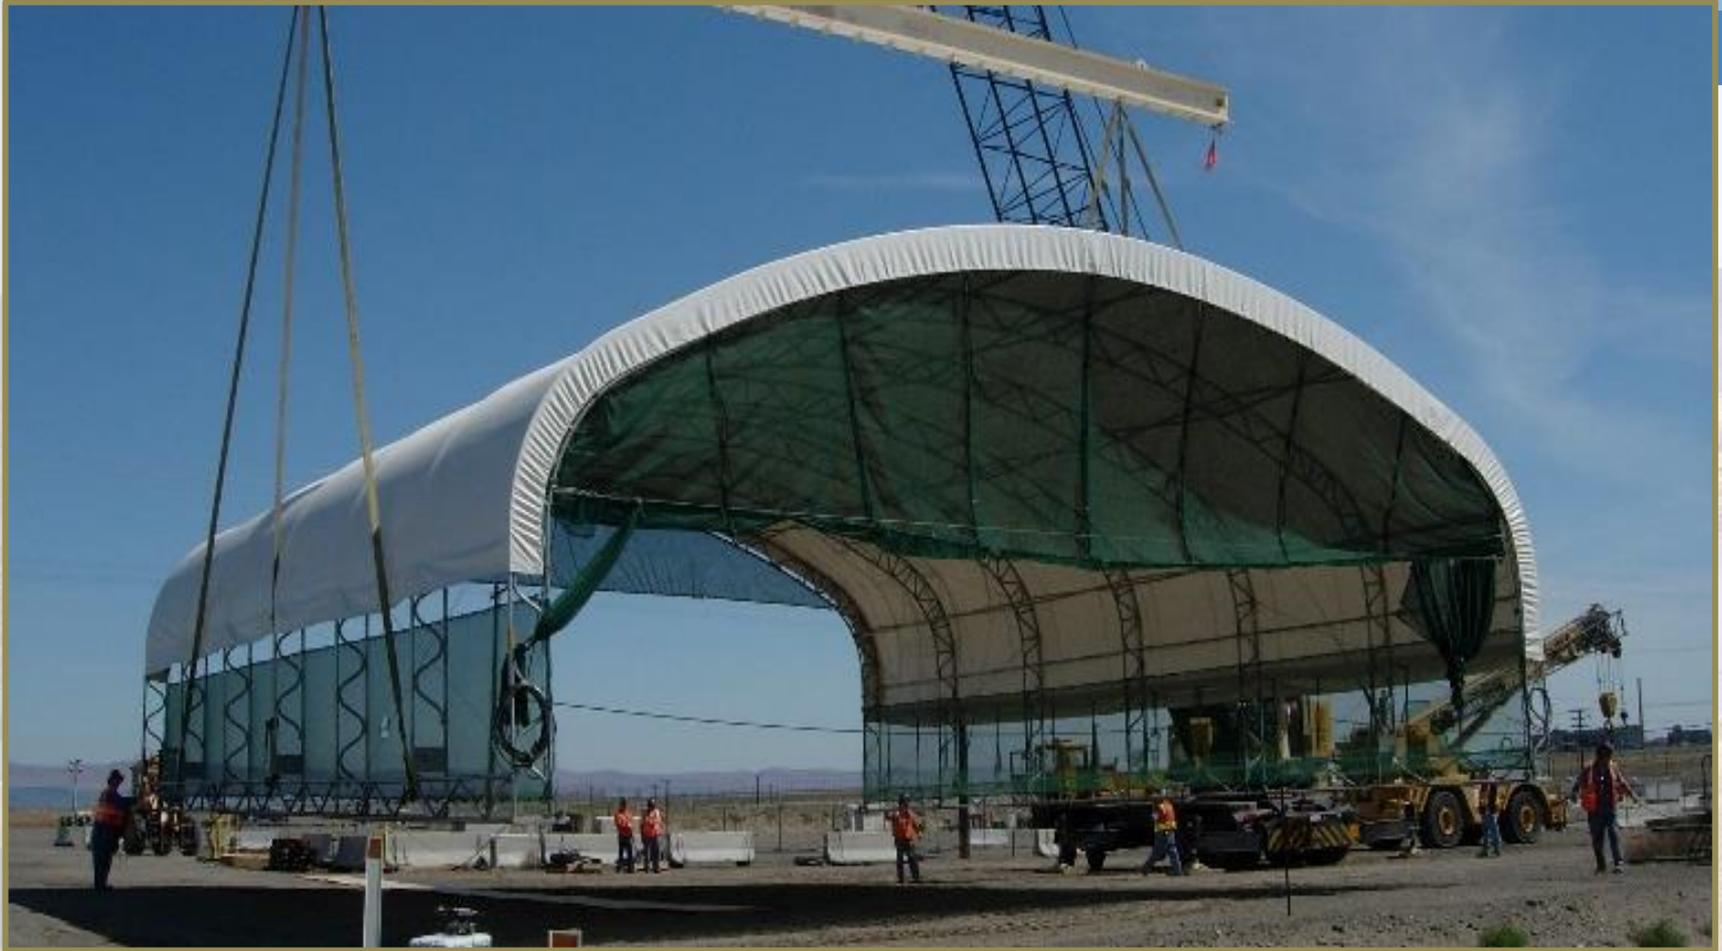
Hard-Surface Tent Cover

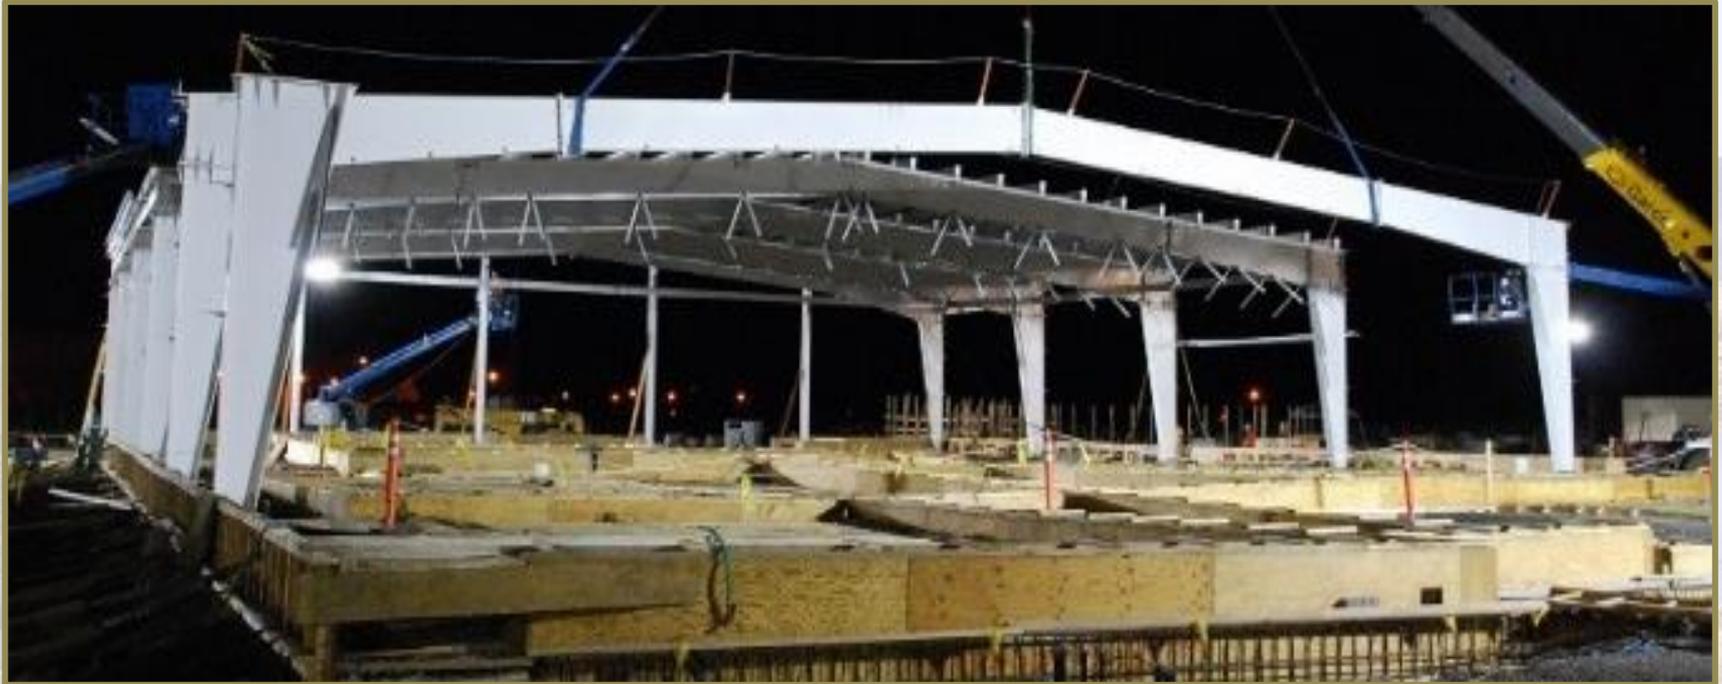
Pre-Engineered Building Construction

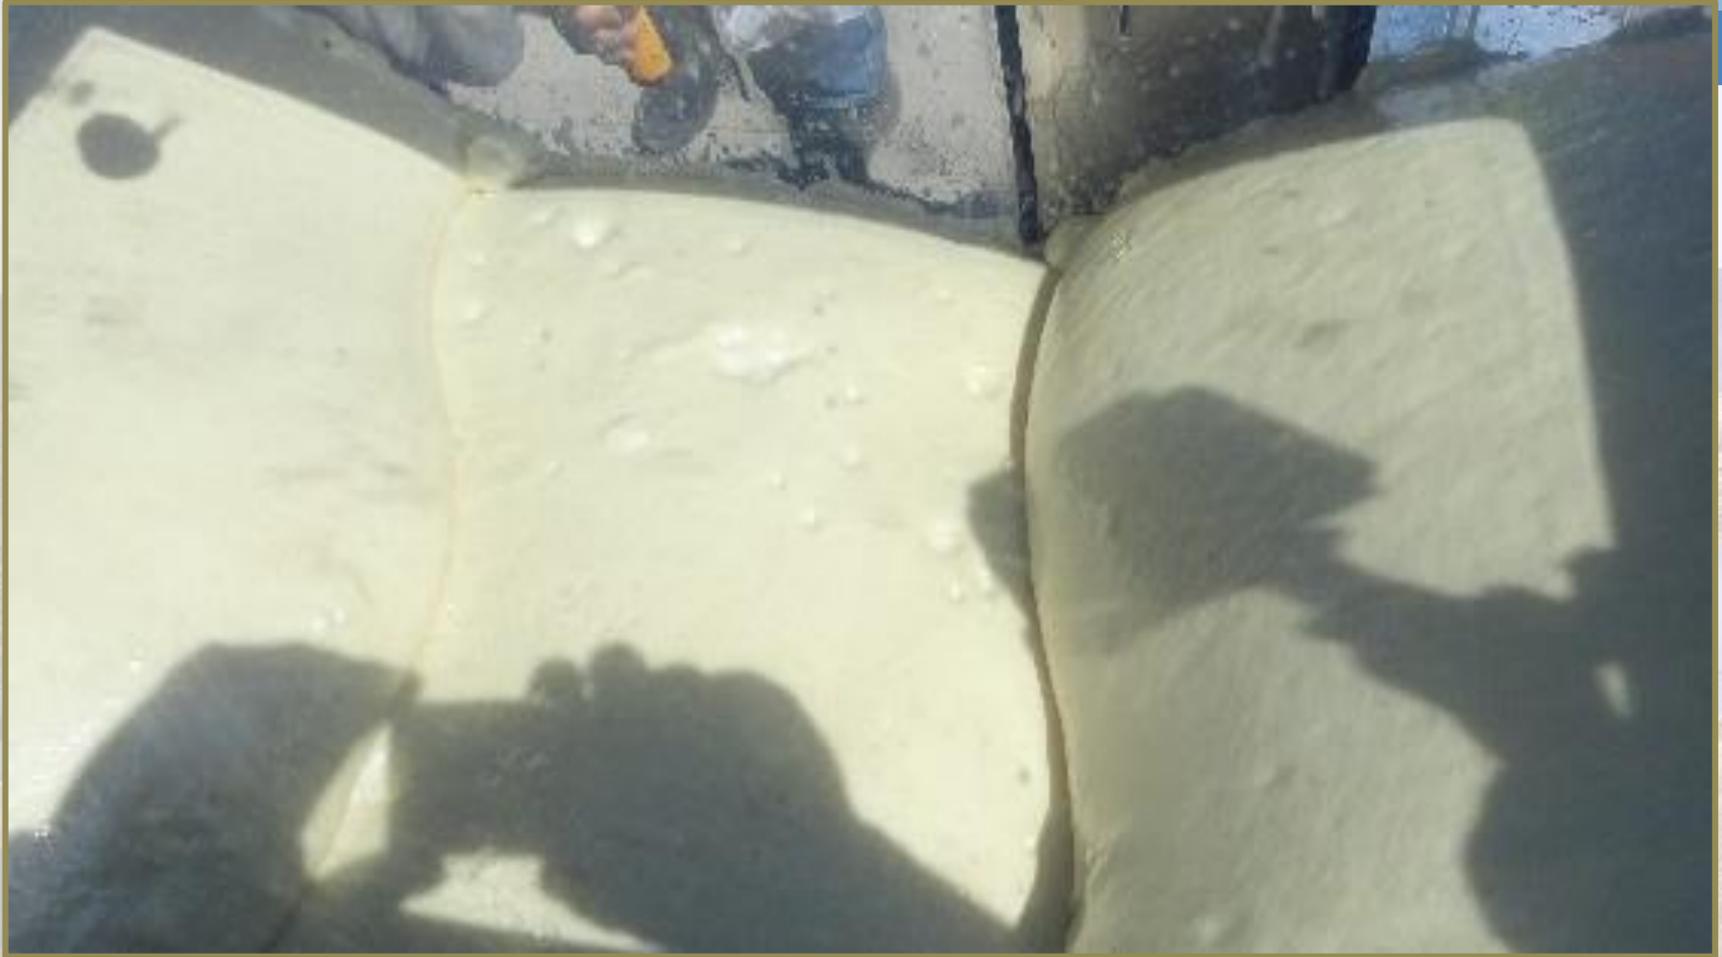
Injection of Poly Foam Void Fill

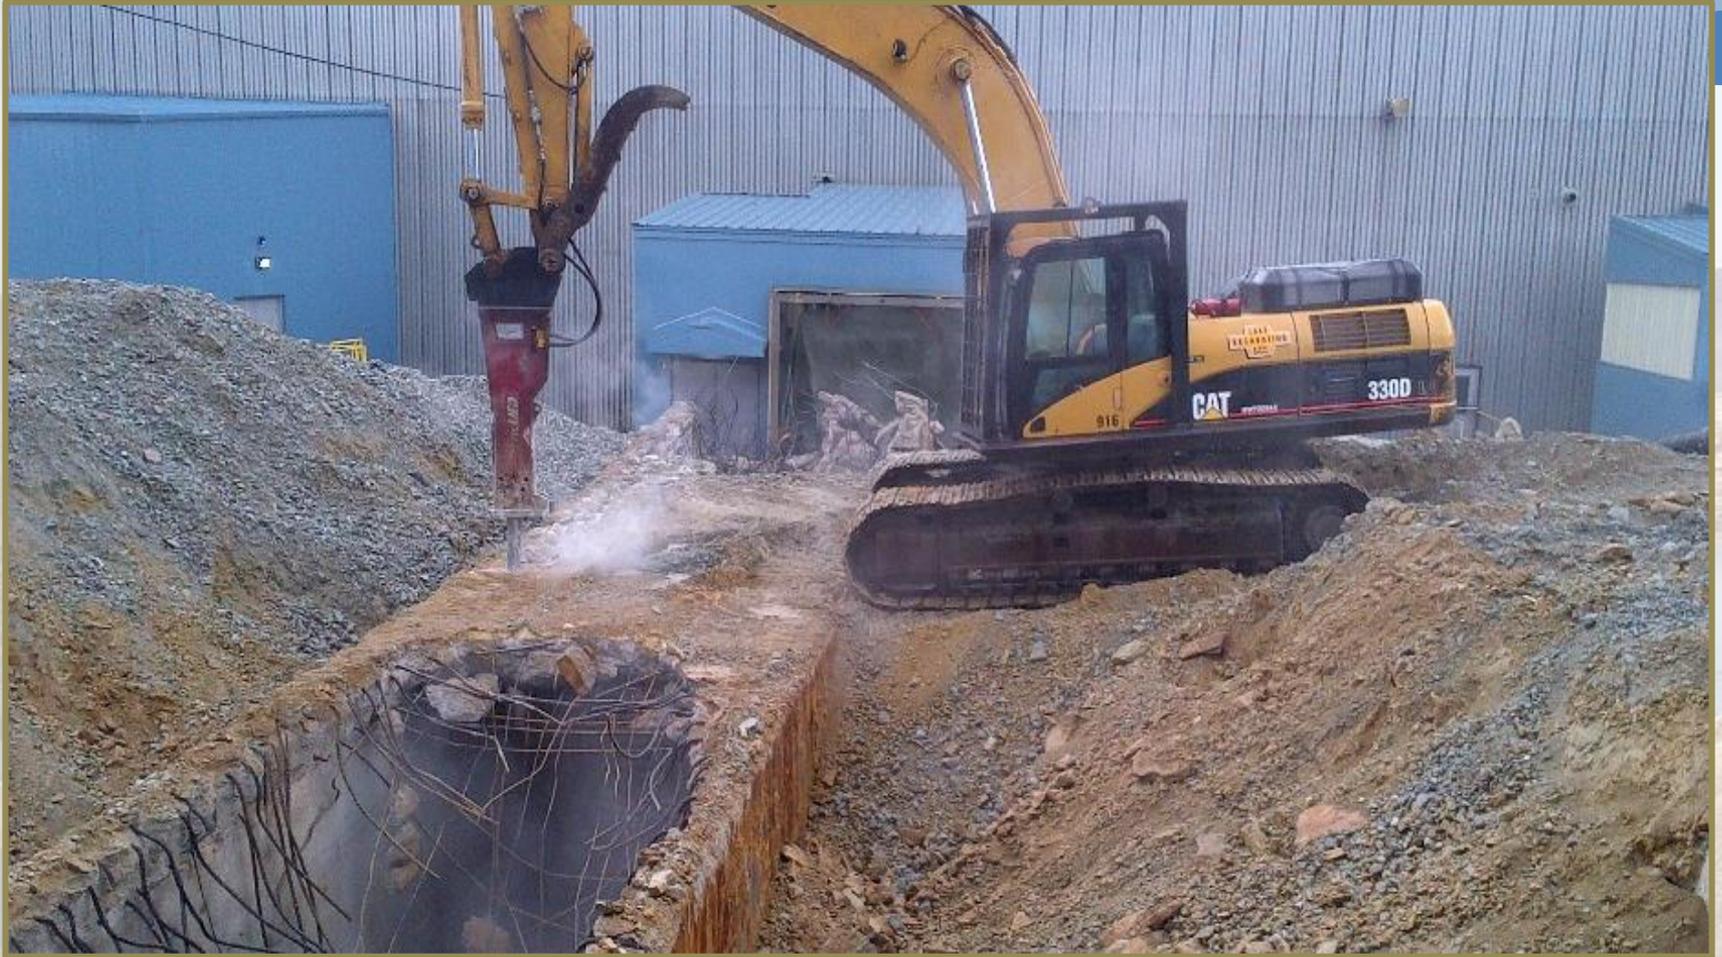
Controlled Collapse In Place

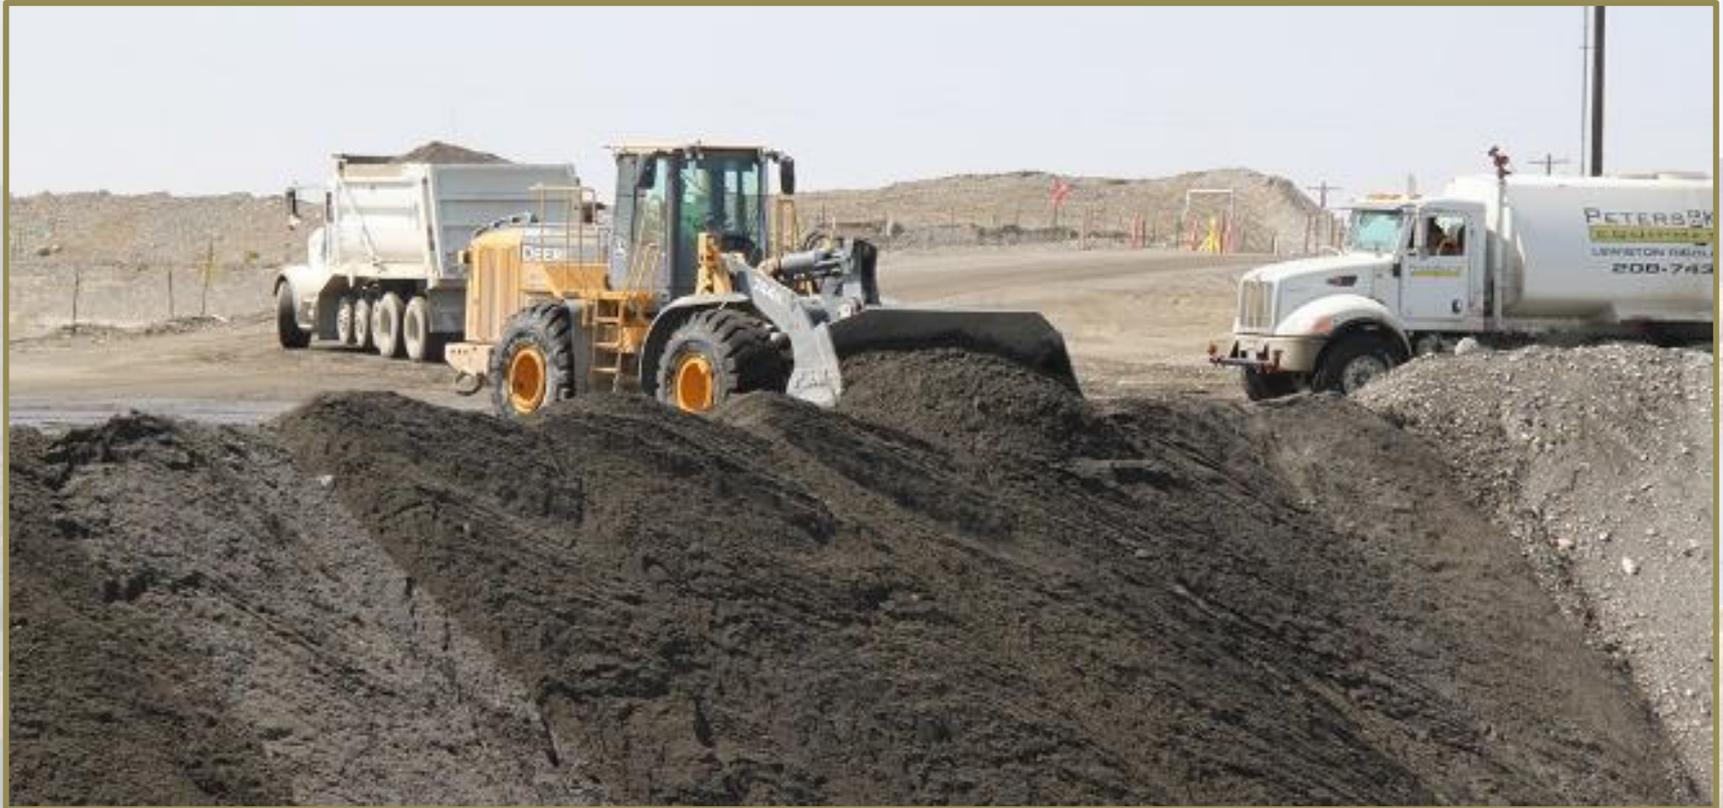
Sand or Clay Void Fill

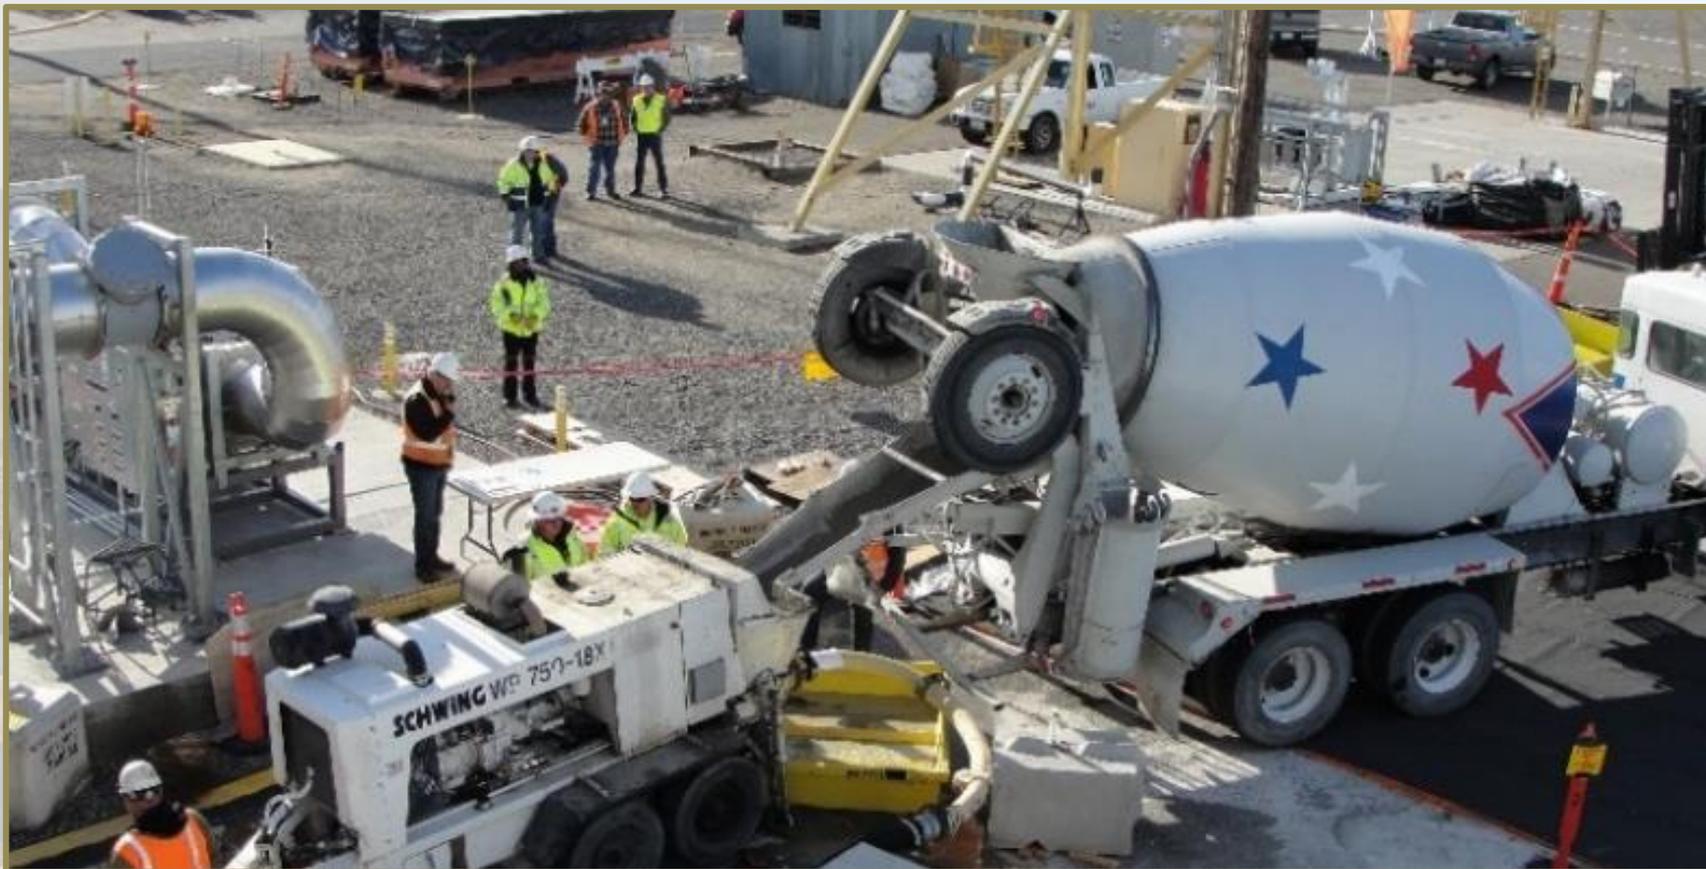
Grout Void Fill

- May 31, DOE notified Ecology of plans to fill Tunnel 1 with engineered grout.
- Grouting Tunnel 1 will improve tunnel stability, provide additional radiological protection, and increase durability while not precluding future remedial actions or final closure decisions.
- Grout fill will be used as part of continuing response actions in accordance with the Hanford Facility RCRA Permit.
- June 8, Ecology approved plan to grout Tunnel 1 as interim response action that would not preclude future closure/remedial decisions.

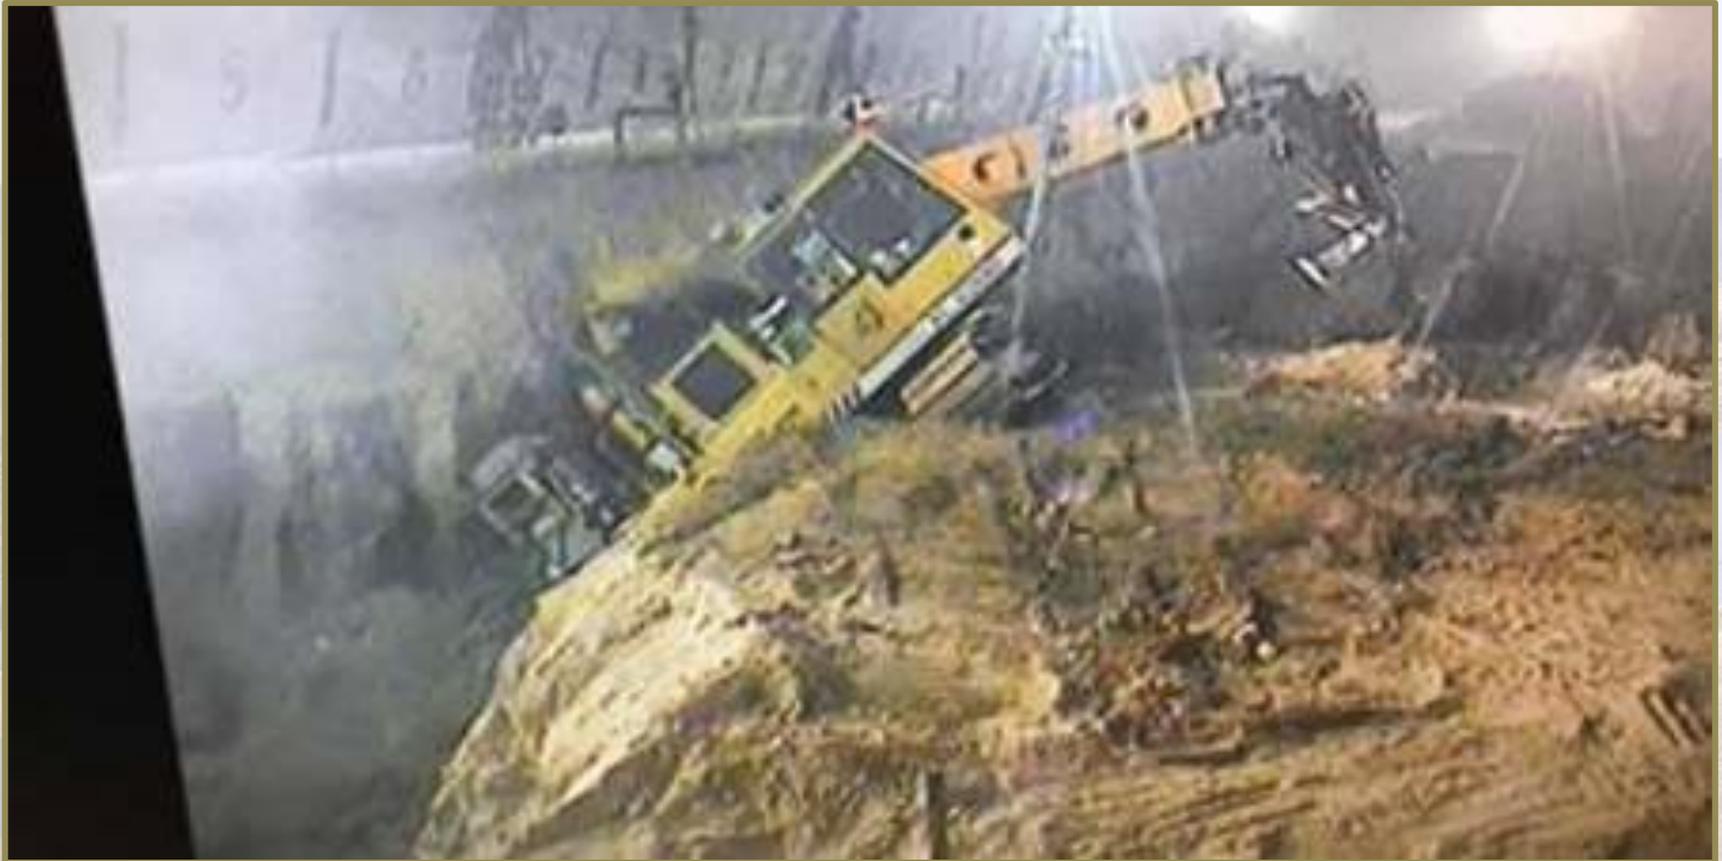
Stored Waste Retrieval

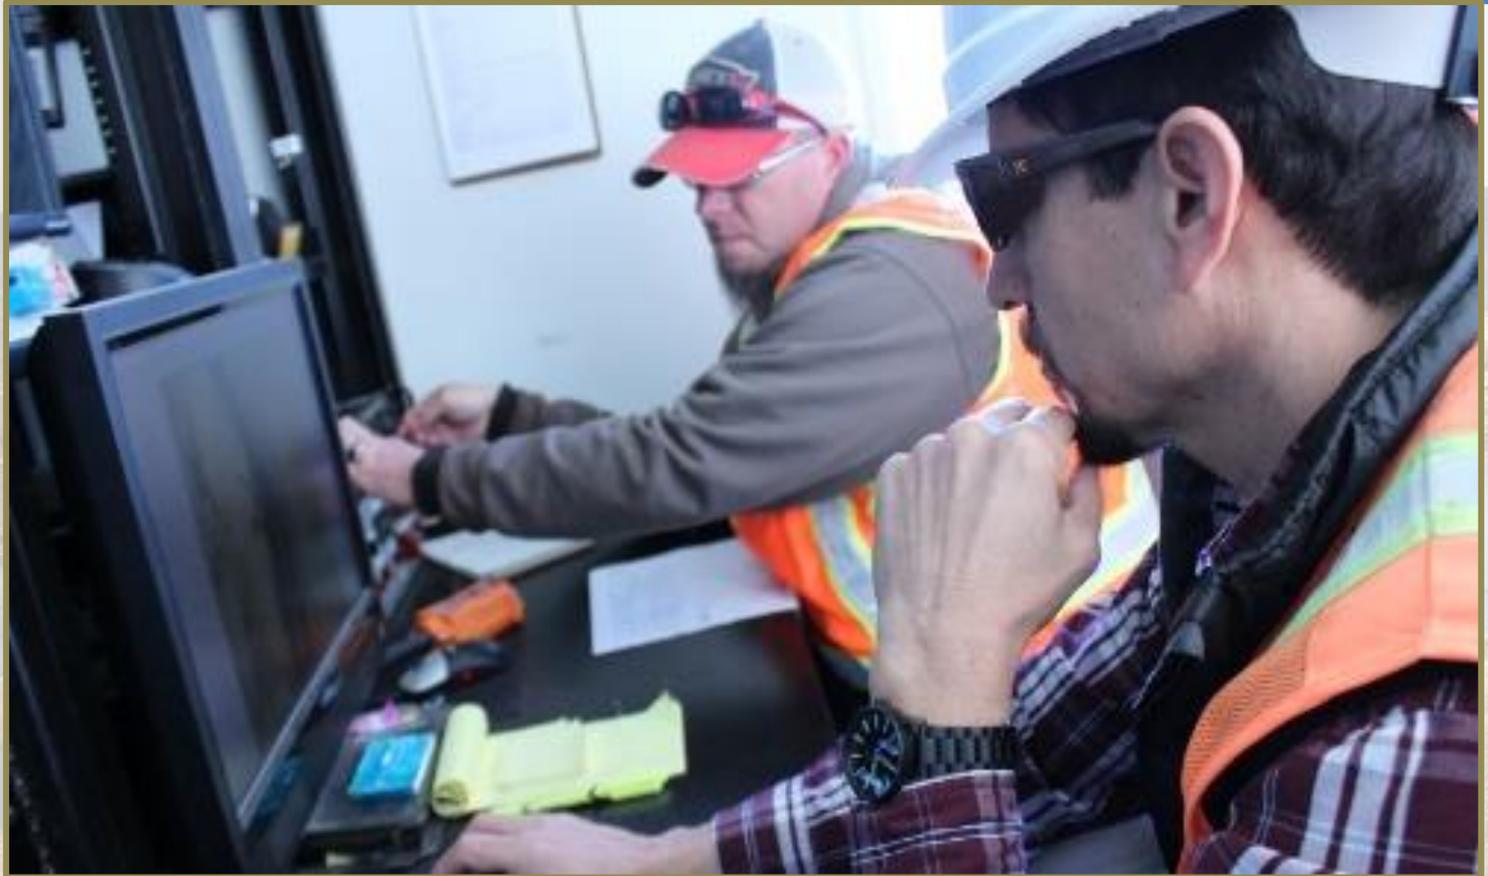
Surveillance and Monitoring Enhancements

- Daily visual observations and radiological surveys of the exterior of Tunnel 2 were initiated in June 2017 and will continue until stabilization response actions are completed.
- A video camera used to observe the Tunnel 2 surface was installed, and daily review of associated video footage was initiated in June 2017 and will continue until stabilization response actions are completed.
- An advanced monitoring system of the Tunnel 2 exterior will be selected and installed.
