THE HANFORD SITE

Stabilization of the 216-Z-2 Crib, 216-Z-9 Crib, and 241-Z-361 Settling Tank

Al Farabee
Richland Operations Office
U.S. Department of Energy

May 2020

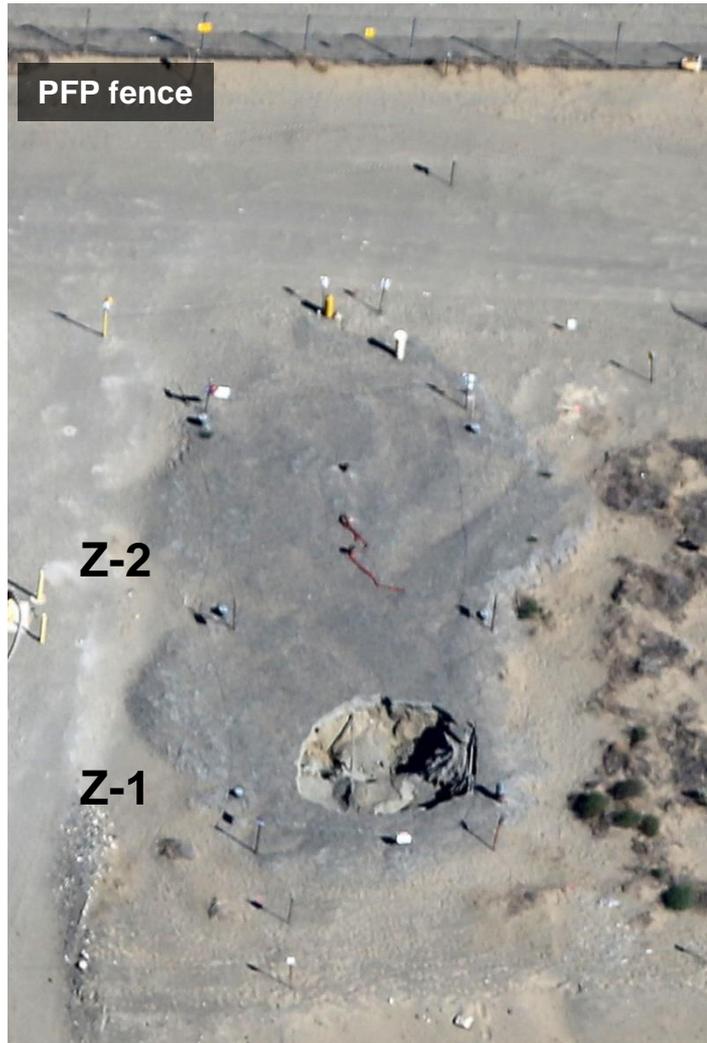
216-Z-2 Crib Location and Design

Size: Excavated to 14 feet square and 21 feet deep; a 12-foot-square, 14-foot-tall open-bottom wooden box was installed within the excavation for support

Photo taken in (2016). Subsidence over Z-1 has been backfilled.

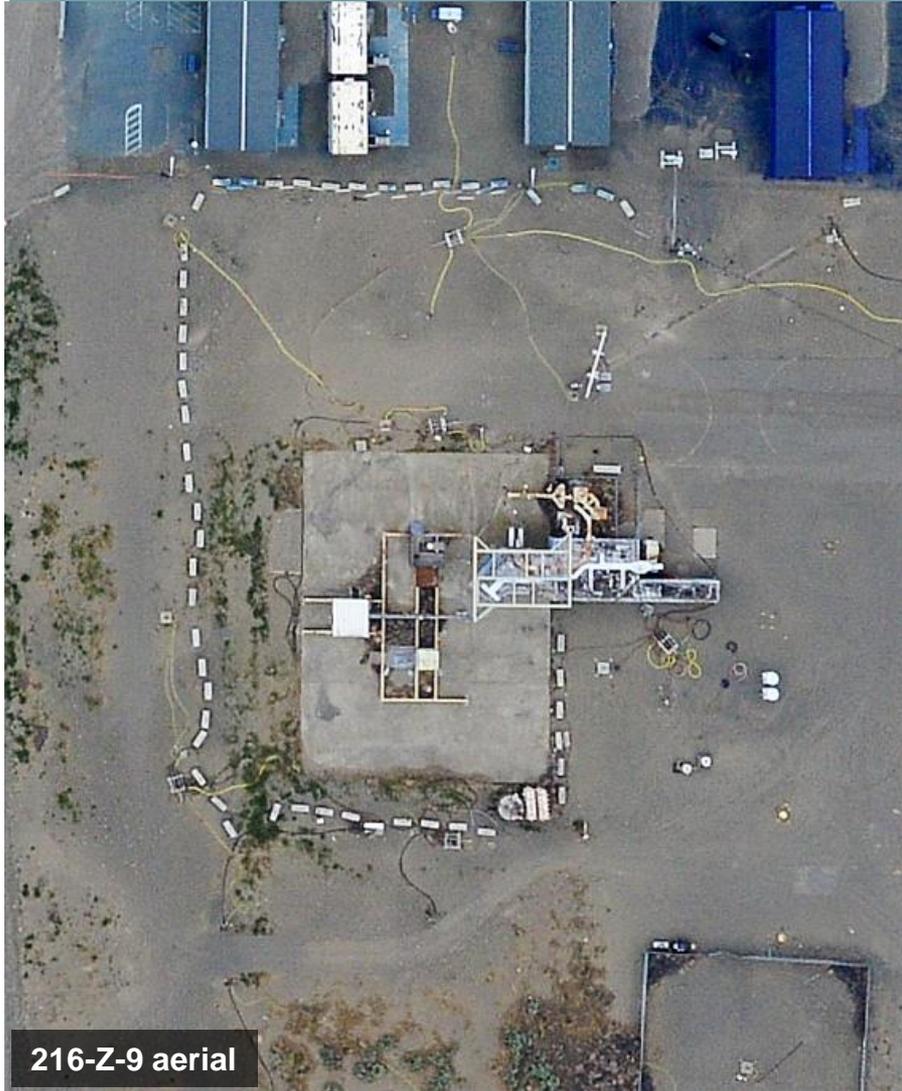
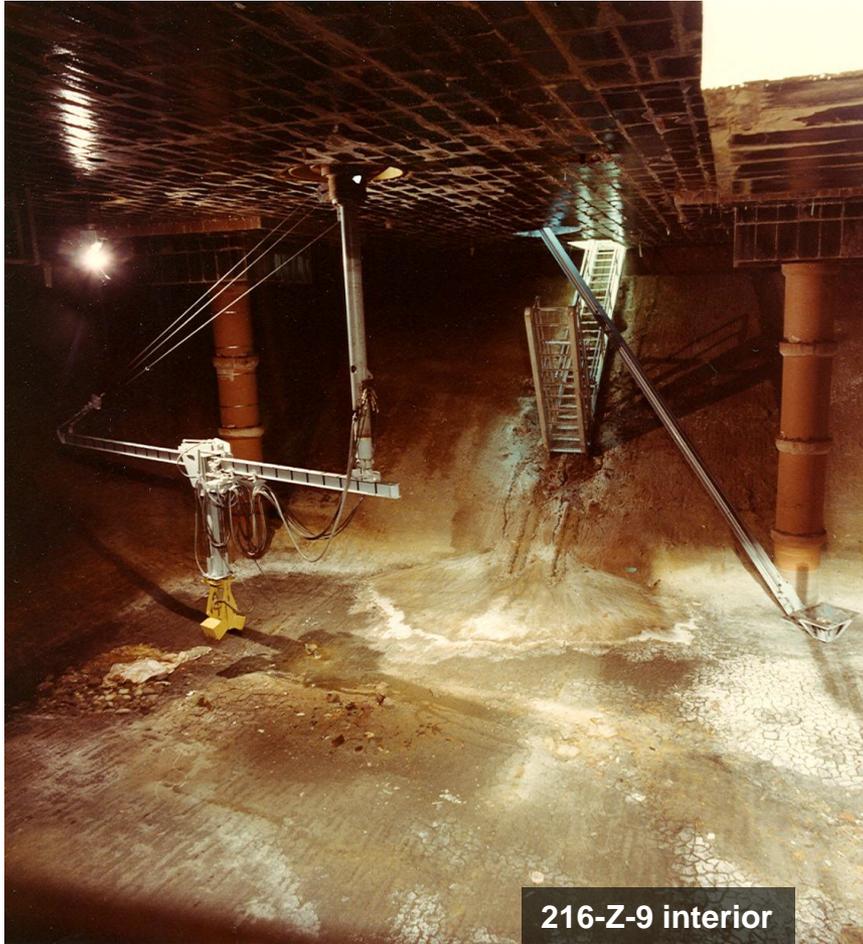
216-Z-9 Crib Location and Design

Size: 20-foot-deep excavation (120 by 90 feet) sloping to a 60-by-30-foot floor, with a concrete cover supported by six concrete columns

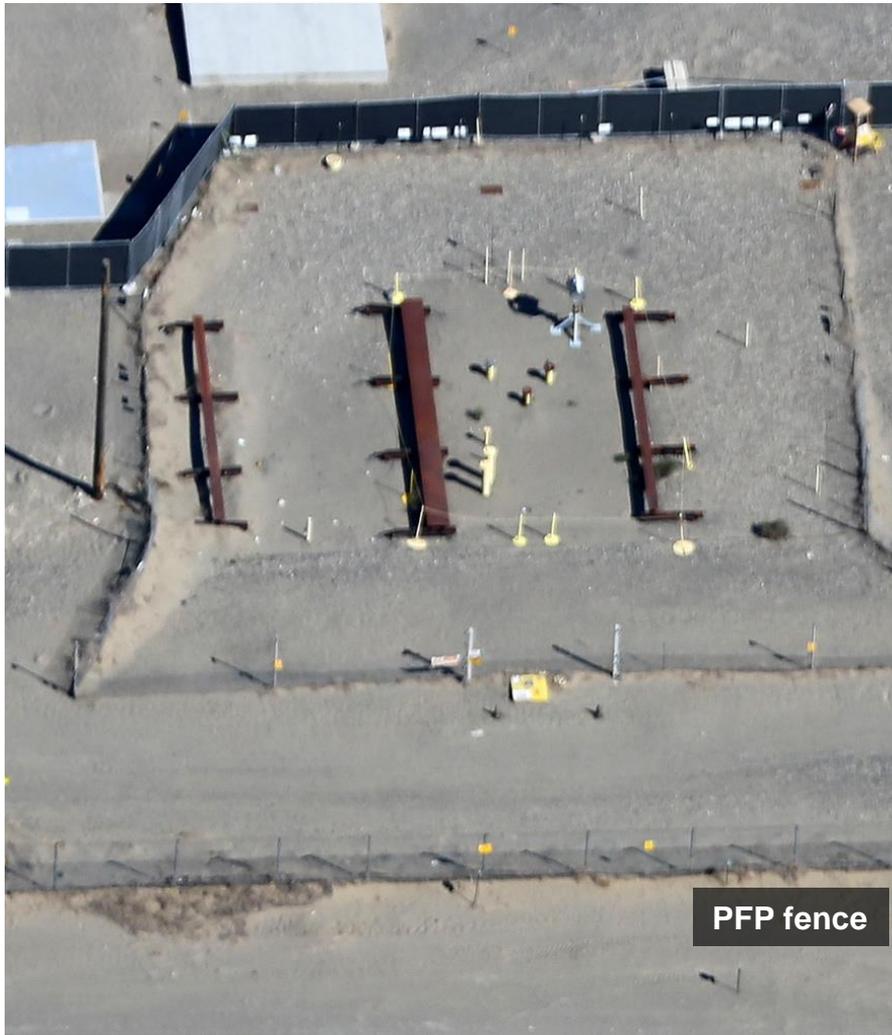
241-Z-361 Settling Tank Location and Design

Size: Reinforced concrete structure 28 feet long and 15 feet wide, with a 3/8-inch-thick steel liner
