324 Building

Characterization

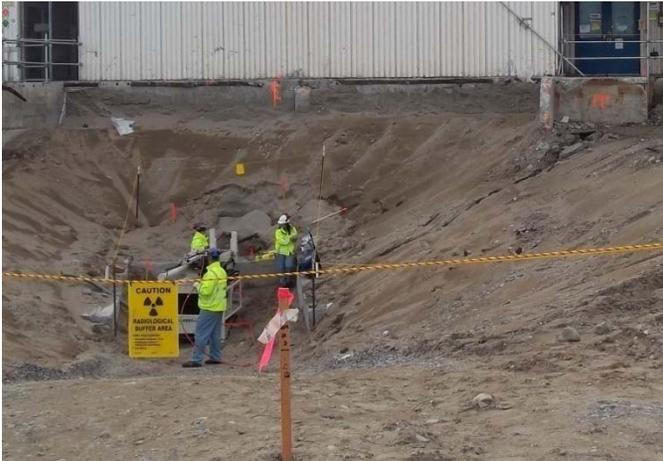
Closed-end tubes were pushed approximately 60 feet under 324. Radiological instruments discovered the presence of contaminated material below B-Cell. Readings peaked at 8,900 R/hour directly below concrete joints in the slab floor of B-Cell.
