# Caution Bulletin

**Title:** Assumptions Contribute to Arc Flash Incident at 331 Building

**Date:** August 24, 2006

**Identifier:** 2006-RL-HNF-0036

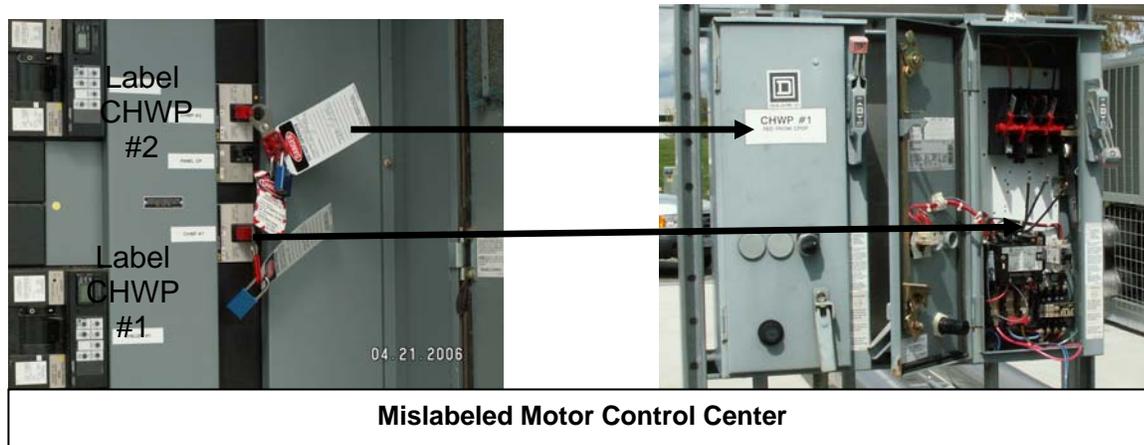
Close-up of contact point

A factory-provided arc suppressor, designed to prevent phase-to-phase arcing within the combination motor starter, was in place during the Safe-Condition and Safe-to-Work checks. The design of the arc suppressor, however, limited access and visibility of the phase lugs (the intended point of contact).

Use of the probe holder on the Fluke model T-2 meter to position the test probe could have resulted in failure of the probe to contact the phase lug. The two most likely scenarios were:

The investigation team was not able to determine conclusively which of these scenarios was responsible for the ineffective Safe-Condition and Safe-to-Work check associated with this work. They were, however, in agreement that lack of contact caused the false indication of a de-energized state of the combination motor starter supplying power to chilled water pump #2.
