**Discovery of Contamination Spread at the Plutonium Finishing Plant
during Demolition Activities**

EM-RL--CPRC-PFP-2017-0018

ROOT CAUSE EVALUATION REPORT

March 5, 2018

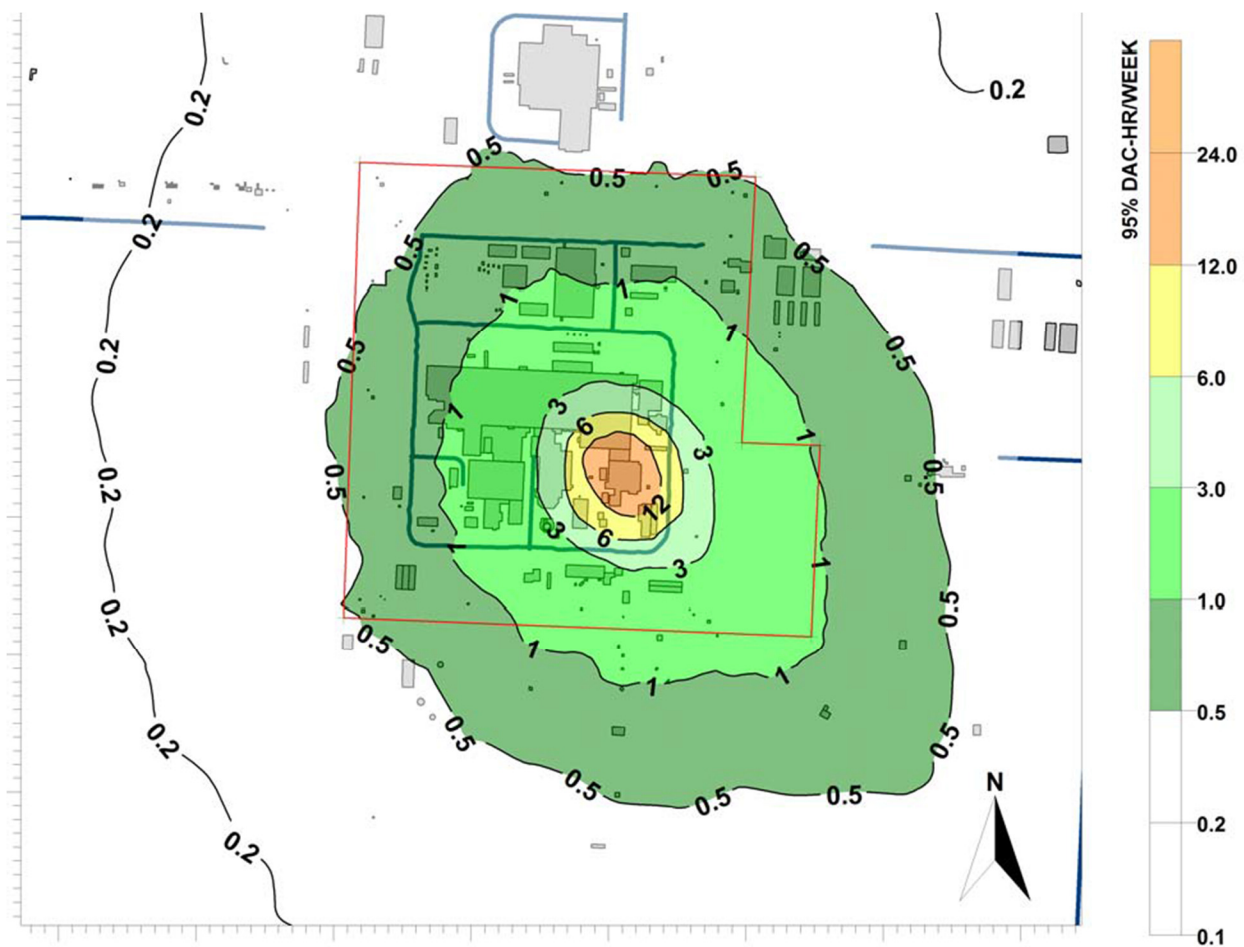
FIGURE 8 - PREDICTED ^{236}Zr CELL DEMOLITION 95TH PERCENTILE WEEKLY AIR CONCENTRATIONS

Figures 8 and 9 show predicted levels of air exposure and ground deposition of contamination anticipated to occur during demolition.
