AY-102 Recovery Project Update

Retrieval Process
Engineering

8/9/2017

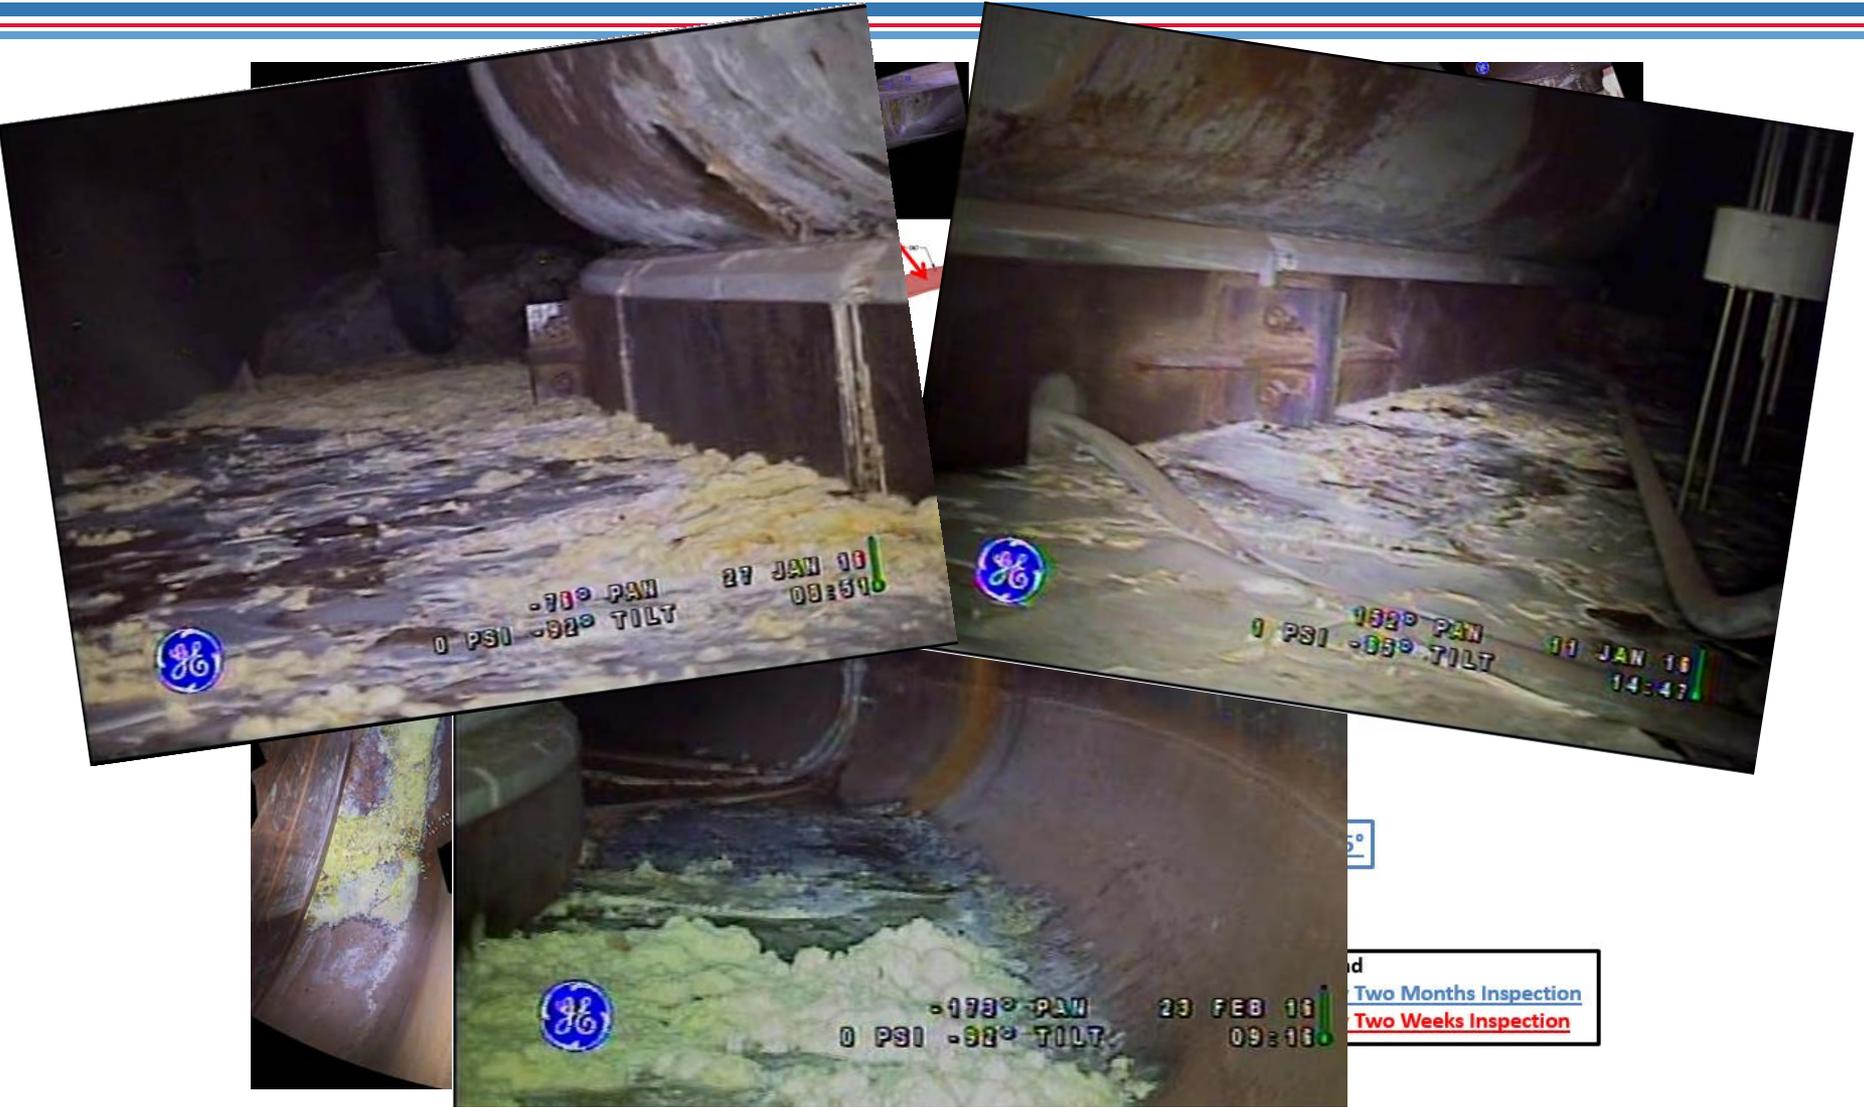
JANUARY 2016 INSPECTION SUMMARY

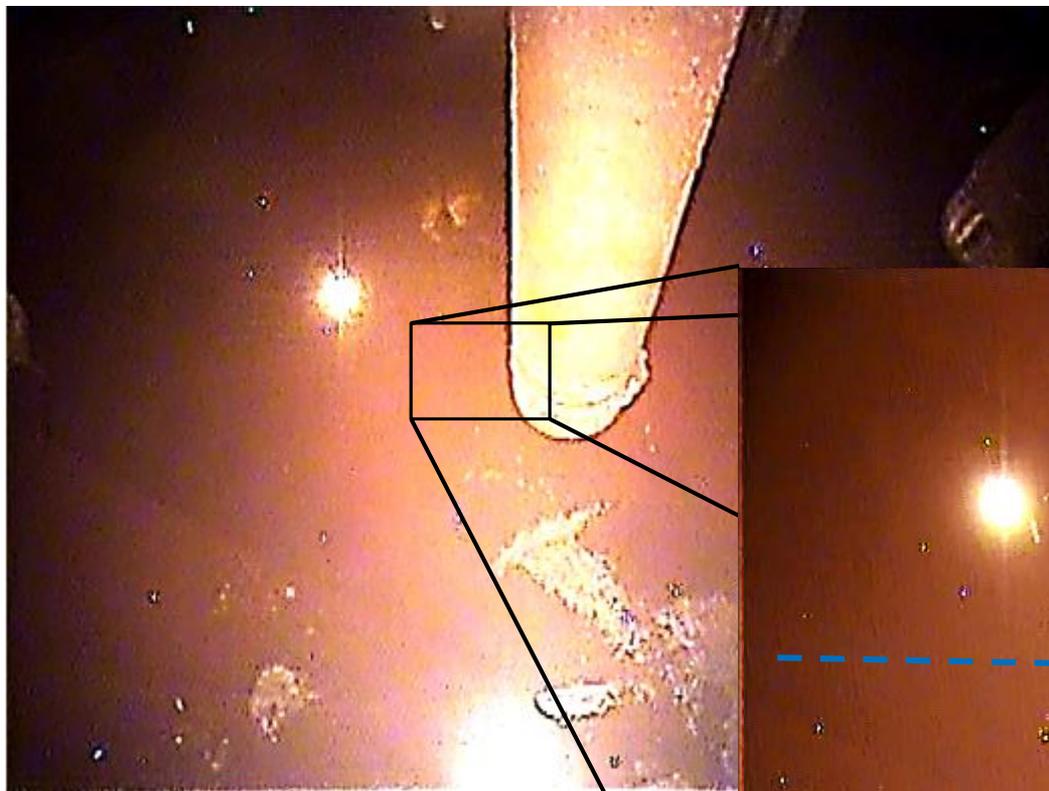
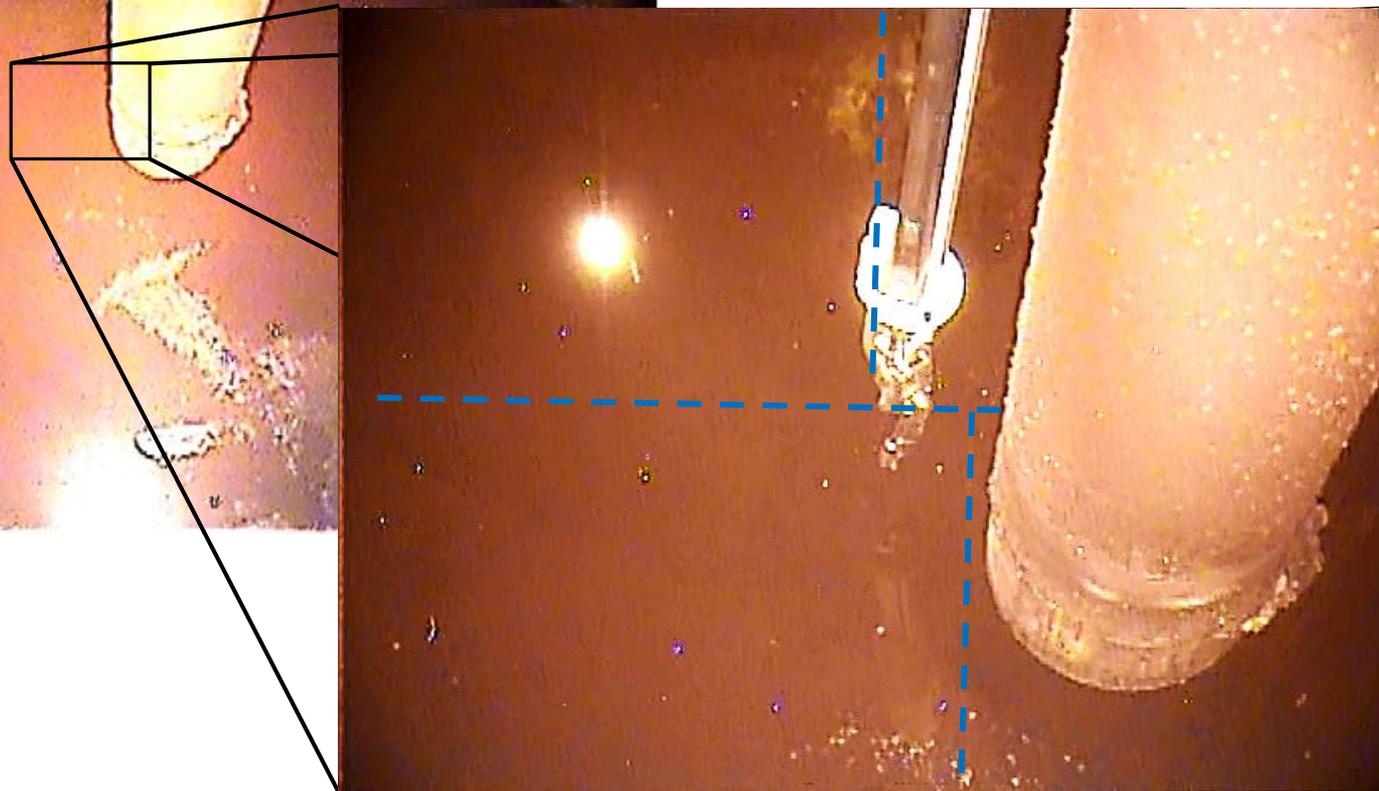
Riser 54
March 22, 2017

- Applied high-pressure water to the suspected leak site area to further clear residual settled solids in preparation for visual examination
- ~10 gpm at ~5,000 psi discharge pressure
- Nozzle ~1 foot above surface
- Bubbles observed at two sites near perpendicular weld seams
- Provided confirmation of two primary tank failure points

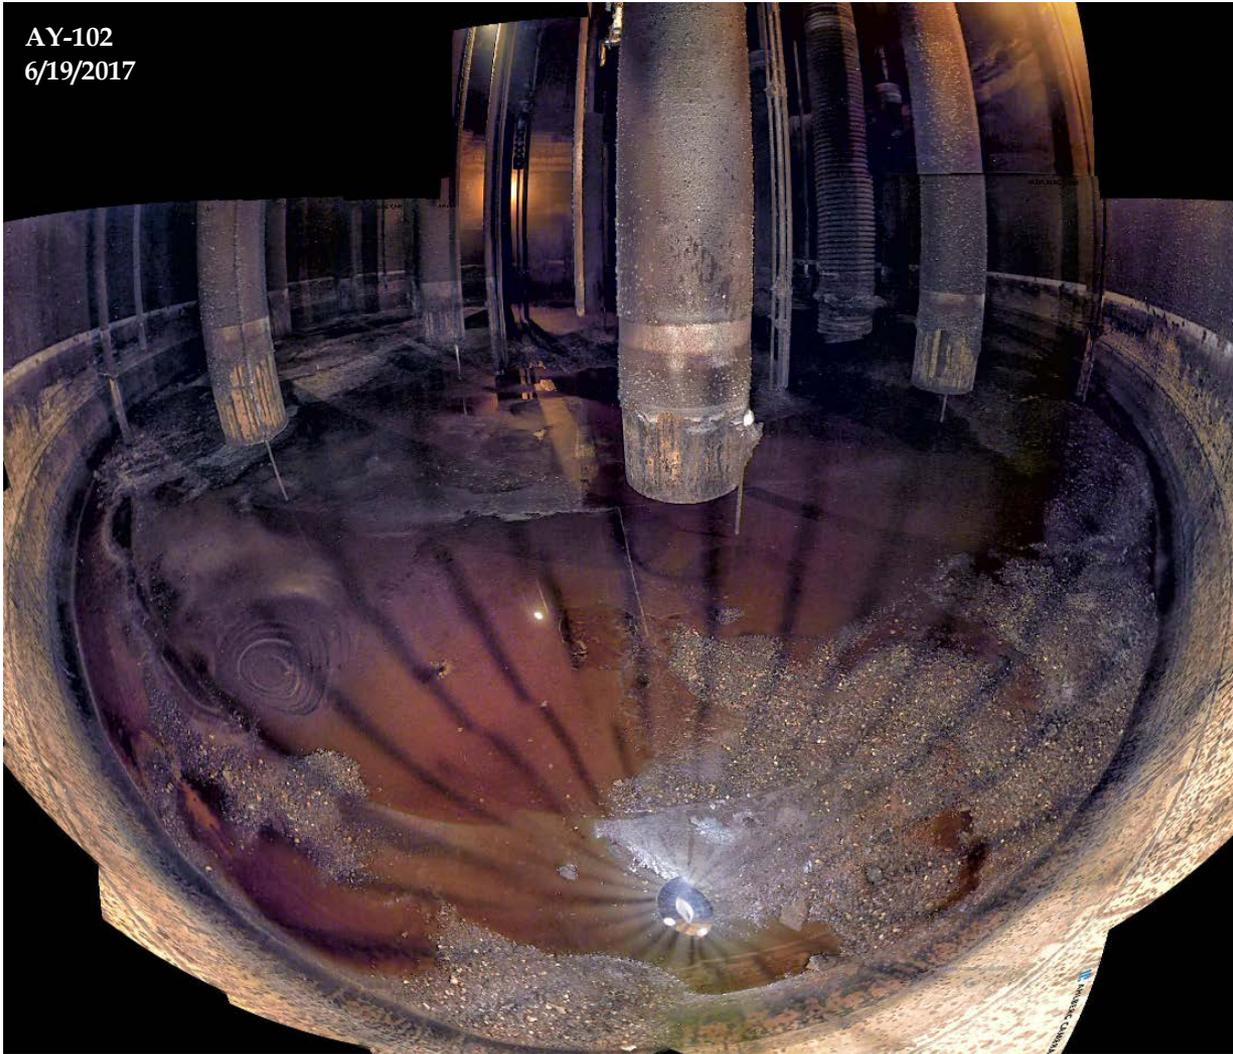
AY-102
6/19/2017

- Confirmed leak sites (bubble sites) located within discontinuities along weld seams, appearing as depressions
 - Leak Site 1 appears to be within a ~2-inch-wide area
 - Leak Site 2 appears to be within a ~4-inch-wide area
