DOCUMENT NO. RHO-CD-1076

DATE September 1980

STRUCTURAL EVALUATION OF THE PUREX NO. 1 BURIAL TUNNEL

G. R. Silvan

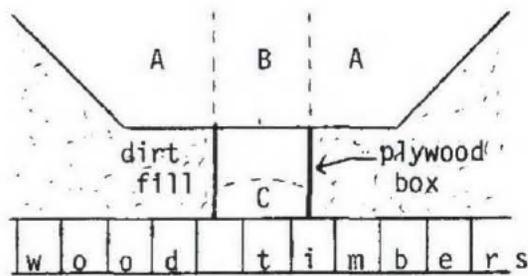
First Stage: Plywood shoring box in place

Sample Location No.	First Stage			Second Stage		Third Stage	
	Area A	Area B	Area C	Area A	Area B	Area A	Area B
1	150-200	700	2,000	20	250	8	8
2	300-500	2,000	8,000	50	450	10-15	10-15
3	0	0	15	0	0	0	0

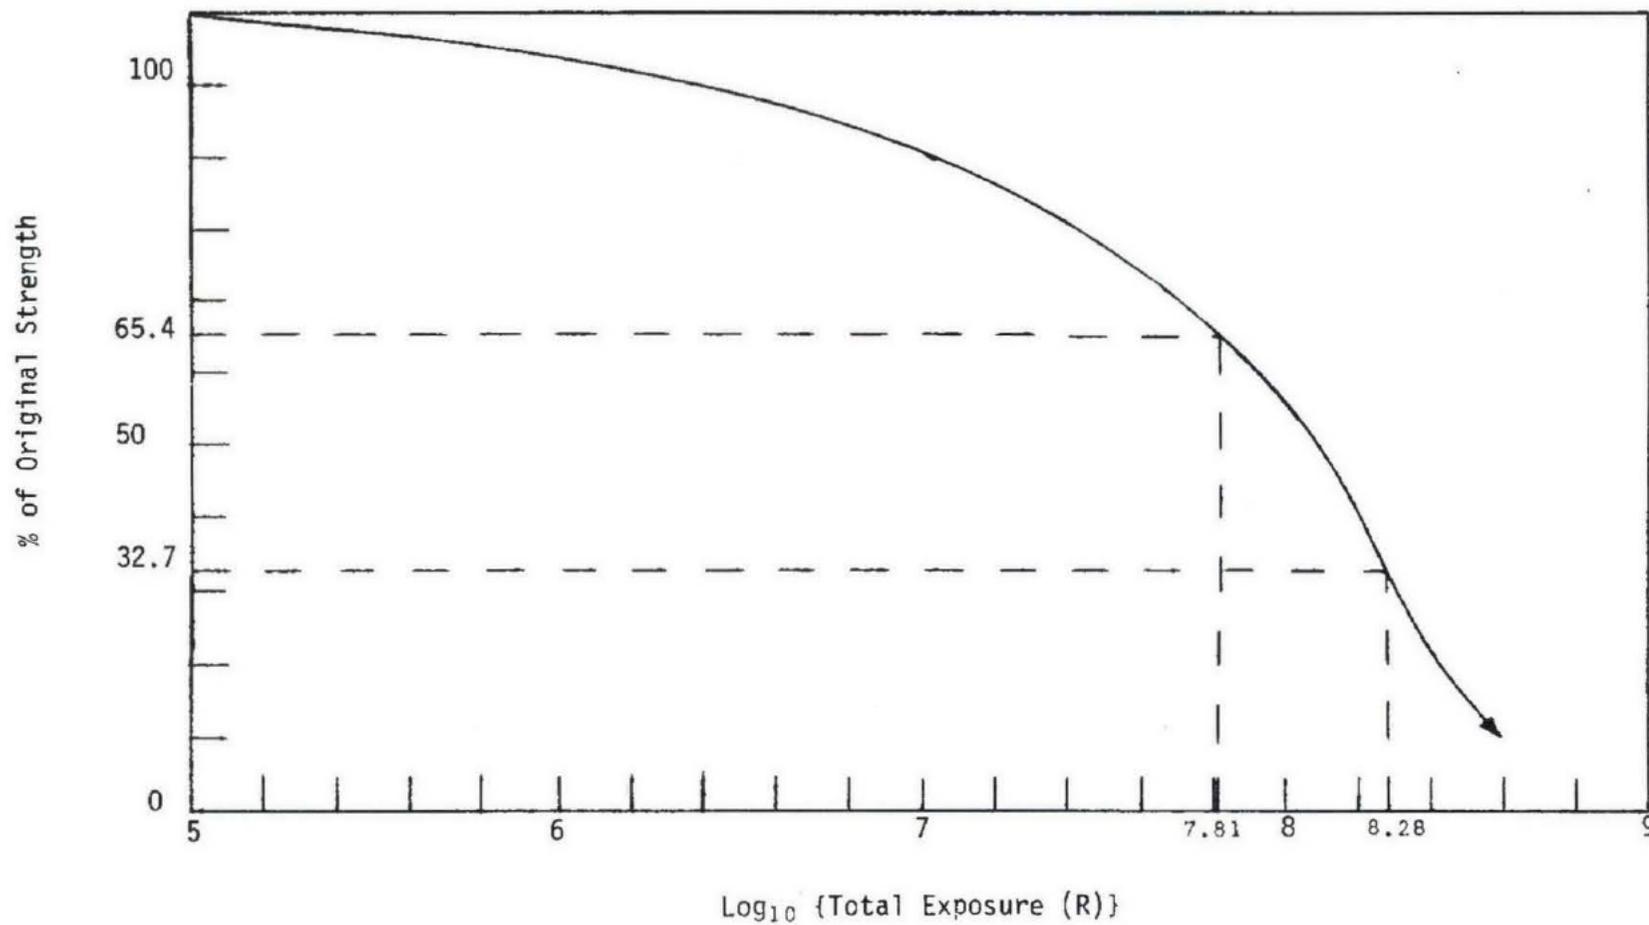
FIGURE A-1: EFFECT OF GAMMA RADIATION ON WOOD BENDING STRENGTH<sup>(1)</sup>

In 1978 (t = 17)	E = 121 R/hr = $1.06 \times 10^6$ R/yr
In 1980 (t = 19)	TE = $6.46 \times 10^7$
