ROOT CAUSE EVALUATION REPORT
MANAGEMENT STOP WORK ON RADIOLOGICAL ACTIVITIES AT 324 BUILDING
CR-2019-3146, REVISION 1

Management Stop Work on Radiological Activities at 324 Building

CR-2019-3146

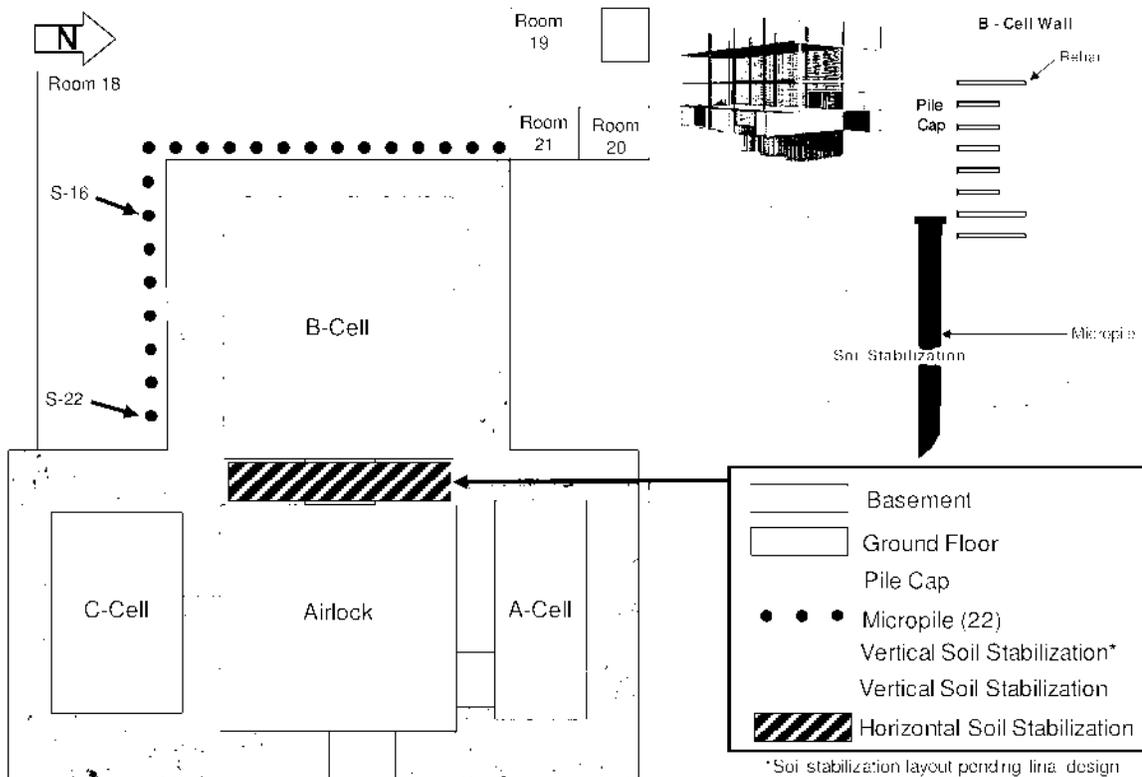
Figure 1. 324 Building Room 18 REC Foundation Support System

In order to avoid damaging the REC structure and components and to minimize slumping of soil, structural modifications are necessary to support the REC foundation. The foundation support system designed for the REC is based upon 22 micropiles (Figure 1) installed beneath new continuous concrete pile caps to transfer the loads to the underlying soil. Additionally, permeation grouting will be used to create a soil stabilization gravity block to stabilize the existing soils remaining along the exterior face of B-Cell. This grouting decreases the risk of potential soil raveling during excavation and removal of contaminated soil below B-Cell.

On March 13, 2019, the Project began drilling the first pilot hole (location S-16 shown in Figure 1) through the Room 18 floor into the underlying soil. The drilling unit operates using compressed air. The engineered control for the drilling unit included a Teflon inner seal in a collar bolted to the floor to mitigate dust and fugitive air from escaping from below grade. Higher than expected Sr-90 contamination levels and radiation dose rates were encountered while drilling the first pilot hole, resulting in an airborne radioactivity release into Room 18. The soil encountered was dune sand, which had not been expected based on previous soil sampling. The Project stopped drilling the first pilot-hole to evaluate the change in radiological conditions. As a result, the Project installed additional engineered barriers and administrative controls to control contamination spread before resuming pilot hole drilling. The ring collar, which was adhered and bolted to the floor, was modified to connect the point source capture device to a negative air machine.
