DEPARTMENT OF ENERGY

Office of River Protection

***Agency Update to
Hanford Advisory Board***
Tom Fletcher, Assistant Manager
Tank Farms Project

Fiscal Year 2013 Priorities

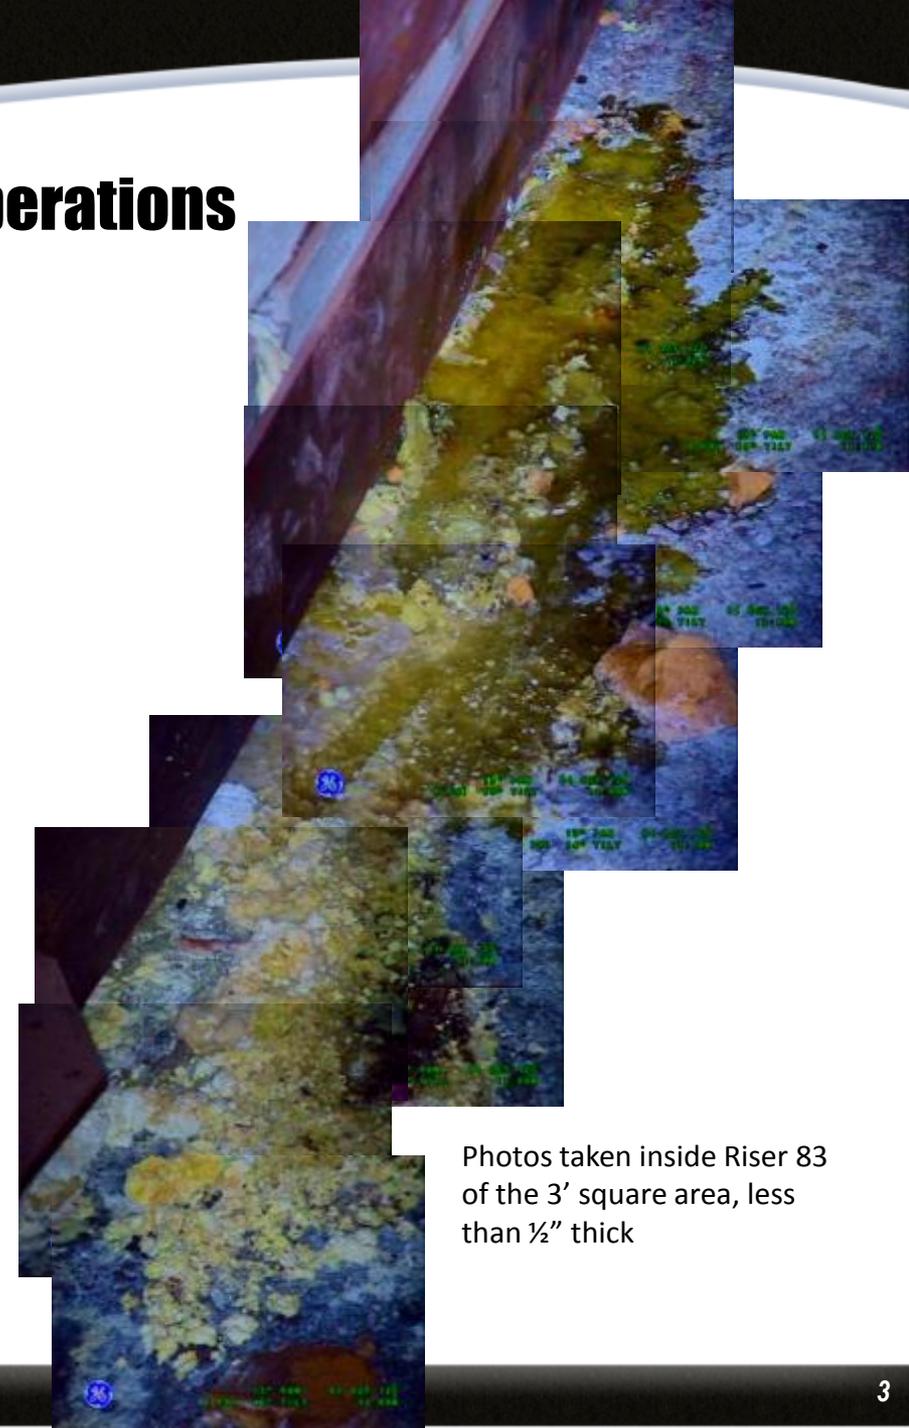
- Recent inspection determined that there is a slow leak of chemical and radioactive waste from the inner tank into the annulus space
- Waste is contained within the annulus and no indication of waste in the leak detection pit, no waste has leaked into the environment
- Sample analysis confirmed:
 - 2 ft. by 2 ft. by 8 inch mound is soil - near Riser 90
 - Suspected soil fell into annulus during construction repairs to the ventilation system
 - 40 square foot area, less than ¼ inch thick – Riser 90 is waste
 - 3 square foot area, less than ½ inch thick – Riser 83 is waste

Photos taken inside Riser 83 of the 3' square area, less than ½" thick

- Continue to perform visual inspections, using a camera, near Riser 83
- Continue to monitor liquid level in primary tank and annulus
- Perform visual inspections of six DSTs with similar construction, as well as operating and processing histories
- Work collaboratively with Ecology on path-forward

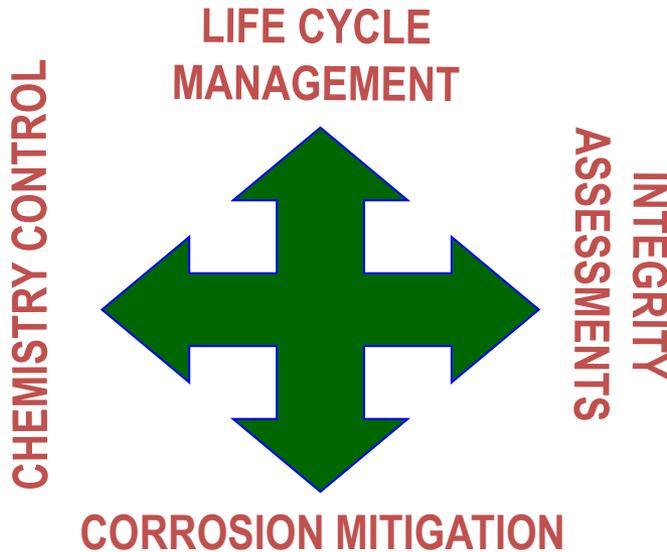
Double-Shell Tank Integrity Project (DSTIP)

- Regulatory Certification of DST System
- Expert Panel Recommendations
- Structural Analysis using Finite Element Analysis

- Chemical Additions
- Tank Chemistry Sampling
- Corrosion Testing
- Corrosion Probe Data Collection and Analysis

- DST UT/Visual
- DST System Videos

- Operating Specifications for Chemistry Control
- Annulus Ventilation System Operation
- Corrosion Probe Development
- Laboratory Testing

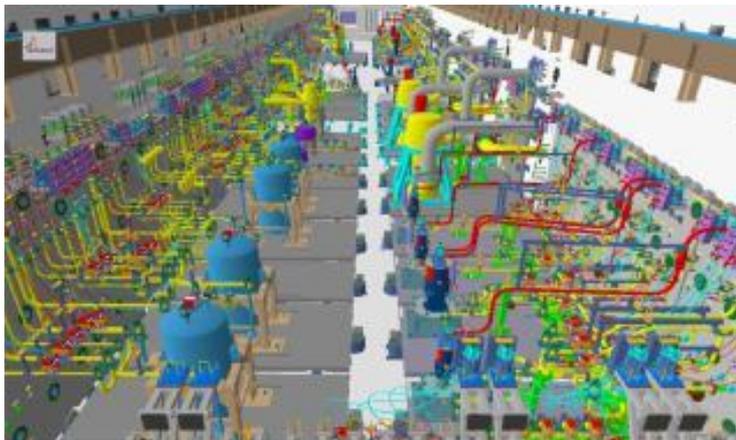
Pretreatment Facility hot cell

- ❑ August 2012, Secretary of Energy Steven Chu assembled a group of independent technical experts to assess the Waste Treatment Plant (WTP) black cells
- ❑ The review involves the WTP's capability, as designed, to detect equipment failure and to repair failed equipment inside the black cells

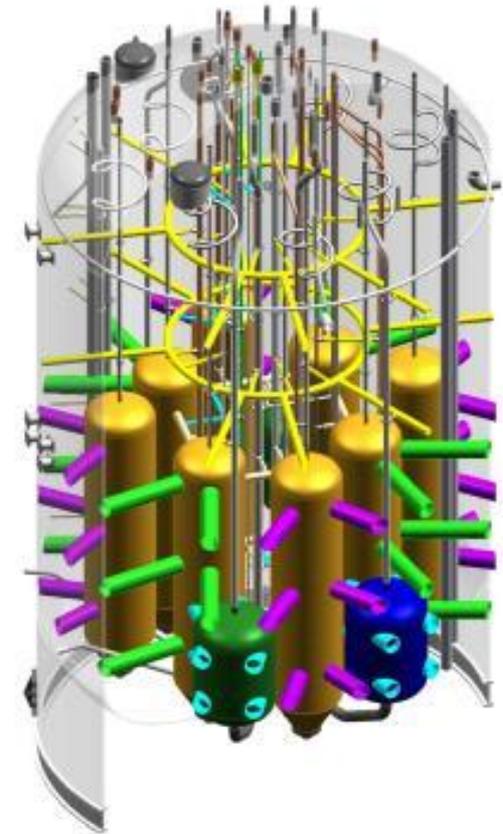
Pretreatment Facility pulse jet mixer

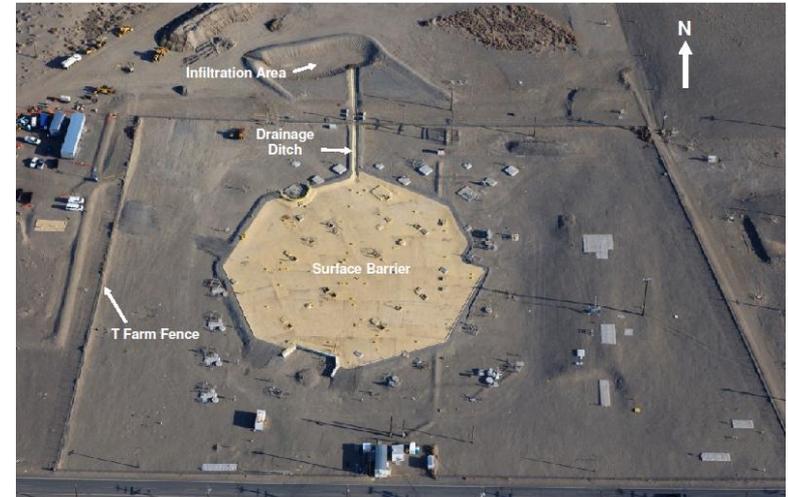
T Farm Barrier Aerial

- ❑ Tri-Party Agreement (TPA) Milestone M-45-92 establishes interim measures to build barriers over tank farms that are scheduled for retrieval in outer years to prevent increased mobility of contaminants in the soil
- ❑ TPA milestone was revised in spring 2012 to include a contaminant removal demonstration at SX Farm in lieu of building two barriers
 - PNNL is developing the process for a field demonstration in SX Farm using Pore Water Extraction – a process that resembles work that successfully removed contaminants from the soil at BC Cribs
 - A work plan is being developed and is due December 31, 2012
- ❑ The field demonstration at SX would both benefit risk reduction by removing contaminants from the soil and show cost savings

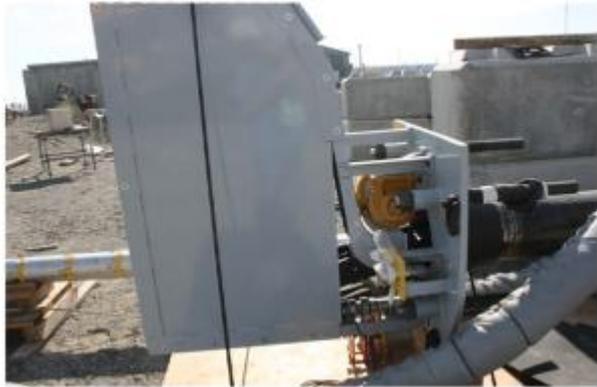
New Pump for
AN-101

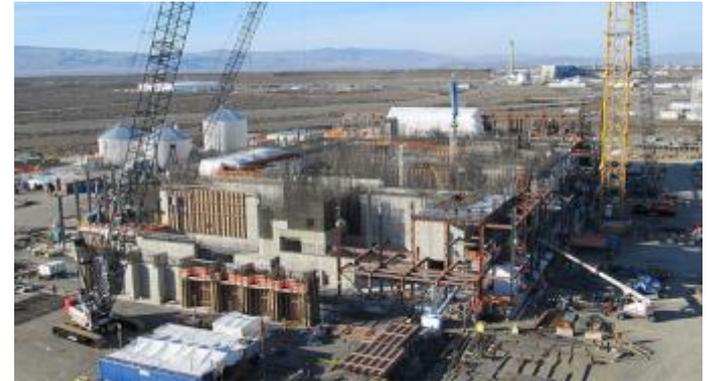
High-Level Waste Facility

- 89% design complete*
- 81 procurement complete*
- 43% construction complete*

- ❑ Installed rinse bogie and decontamination vessel in the canister rinse tunnel
- ❑ Set and aligned the seismic rails
- ❑ Poured 25% of the concrete in the 58 ft elevation walls
- ❑ Completing all concrete slabs on the 37 ft level by December 2012

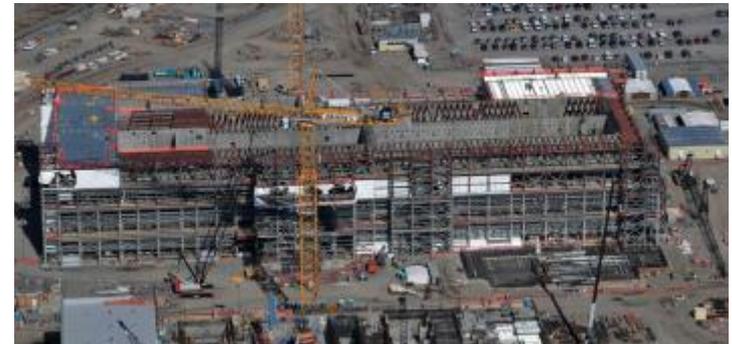
Pretreatment Facility

- 85% design complete*
- 56% procurement complete*
- 43% construction complete*

- ❑ Completed medium scale testing on the Process Vessel Ventilation (PVV) system. Preliminary results for both the small and medium scale tests resulted in an entrainment coefficient smaller than expected, which supports less extensive modification to the PVV system design
- ❑ Completing the remaining Hydrogen Generation Rate calculations in support of resolving the Hydrogen in Piping and Ancillary Vessels in November 2012.
