Spray-on coating upgrades tank-farm process pits

Becky Curtis, CHG

CH2M HILL Hanford Group is applying a substance similar to a spray-on truck bed liner to make upgrades to tank-farm process pits safer, easier and less costly.

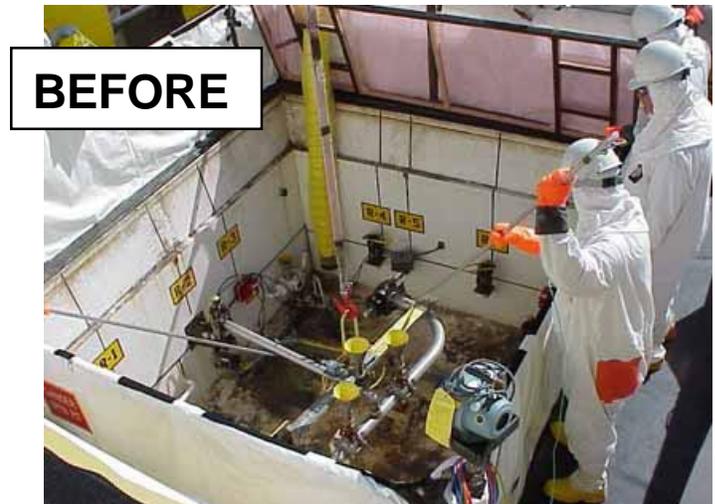
Process pit in AW tank farm

Over the decades since they were built, some deterioration has occurred. Now the pits must be cleaned and refurbished in preparation for future waste transfers to the planned vitrification plant.

Fissures in the concrete pit walls have always had to be ground out, sanded, grouted, sealed and recoated with epoxy to renew secondary containment. Application of polyurea replaces much of this time-consuming procedure, saving money and protecting employees by reducing the duration of work performed in radiation areas. Unlike epoxy — which hardens with age and exposure to radiation — polyurea is elastic and has high tensile strength. It can be sprayed to stretch across gaps and seal pit surfaces providing a durable, abrasion-resistant barrier to the environment.

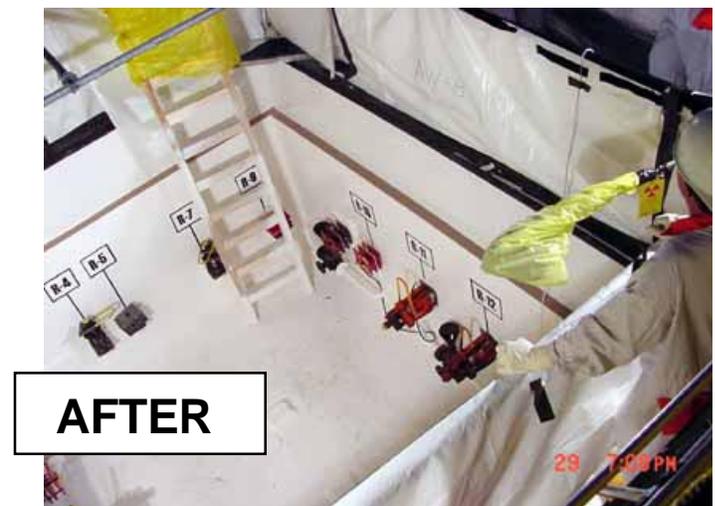
Process pit after polyurea liner has been applied

The first two pits that were sprayed are located in AZ Tank Farm in the 200 East Area. FFS painters were responsible for pre-application preparations. Concrete and metal surfaces in the pit were scored with a grinder or a needle gun so the polyurea would adhere properly. Pieces of equipment that should not be coated, such as nozzles, were carefully masked-off because polyurea, once sprayed, hangs on tight. Then the pit was fogged with polyurea to fix any contamination, and FFS applied the substance a minimum of 1/8-inch thick onto the pit walls and 1/4-inch thick on the floor. In the first pit, fogging and application took only two hours.

Lessons learned on the first job were applied to the second pit in AZ Tank Farm and the third pit in AW Tank Farm. Pre-spraying preparations were streamlined in many ways. For instance, FFS painters suggested that the needle gun, which uses a set of rapidly hammering blunt “needles” to rough-up surfaces, could be made more efficient by using sharp needles. The idea was implemented and proved to save valuable schedule time and to reduce contamination hazards by generating less dust.
