Information Bulletin

Ground Fault Occurs While Removing Electrical Panel Cover

2007-RL-HNF-0031

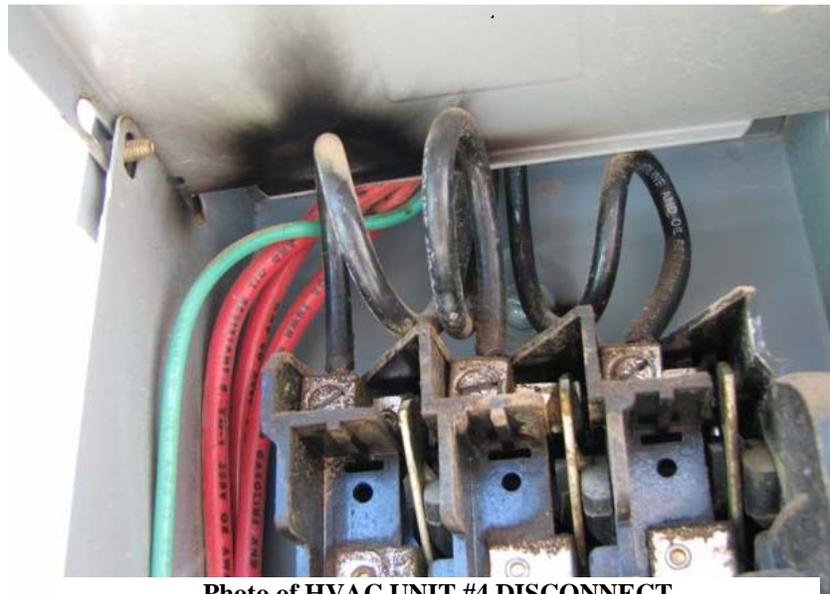
Summary: On July 31, 2007, an electrician opened the cover of a HVAC unit disconnect switch. When the cover was moved a ground fault occurred, tripping the unit's supply breaker. The cause of the event was due to chaffing of the supply wiring by the opening and closing of the cover during frequent routine maintenance activities.

Analysis: An investigation determined the safety switch cover had damaged the insulation on one of three incoming feeder conductors, causing a fault to ground which tripped the supply circuit breaker. The installation of the conductors (wire training) used a loop (see picture) to accommodate extra wire length in the panel. The repeated opening of the cover wore away the insulation on the conductor. Evidence of chaffing was visible on the other two conductors. It was noticed that this particular type of disconnect panel cover has caused chafing to occur in other locations. However, other events have occurred where wires were not configured in a manner to prevent chafing or inadvertent contact with screws placed in the panel/cabinet covers leading to arcs.

Photo of HVAC UNIT #4 DISCONNECT

1. Conductors in electrical panels should be configured to avoid a condition where normal operation or opening the covers can cause an electrical hazard.
2. When opening electrical panels, a visual check should be made to identify evidence of chaffing of conductors, or other conditions that could lead to a hazardous condition at a later date. Repair any identified problems as soon as practical.
