Tank AP-106

Hanford Double-Shell Tanks (continued)

DST Integrity Program

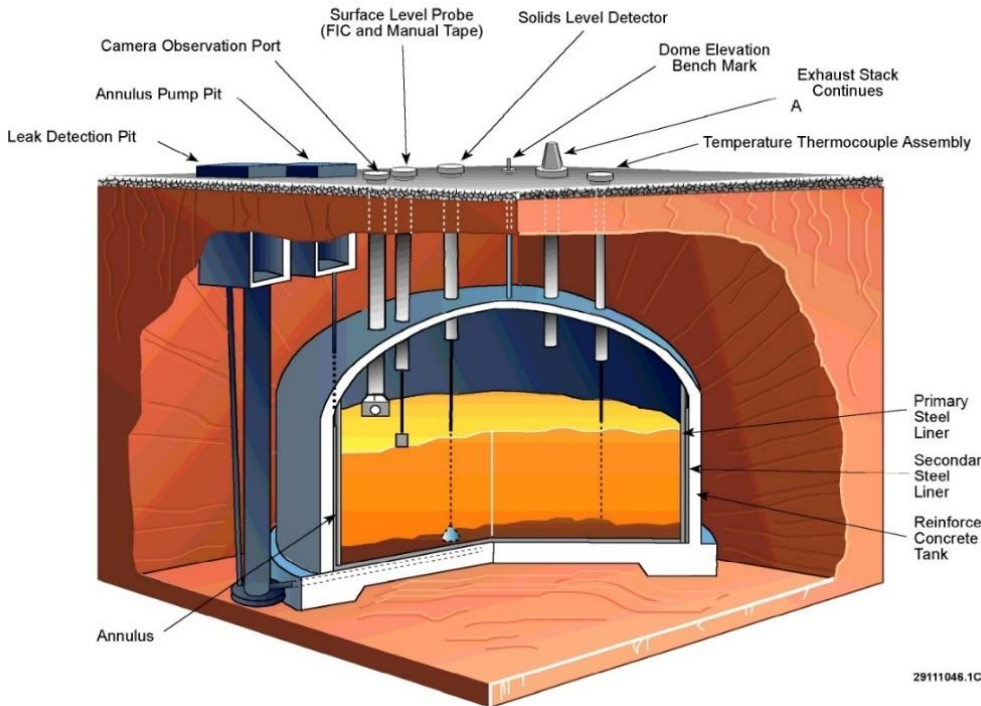
Each DST consists of a primary carbon-steel tank inside a secondary carbon-steel liner, surrounded by a reinforced concrete shell. The primary tank rests atop an 8-inch insulating slab, separating it from the secondary steel liner and providing air circulation / leak detection channels under the bottom of the primary tank. An 30-inch-wide air space called the annulus exists between the secondary liner and primary tank walls. This annulus supports various inspections of the outside of the primary tank and inside of the secondary liner. Tank monitoring technologies including use of robotic equipment for visual and ultrasonic inspections of the walls and tank bottoms.

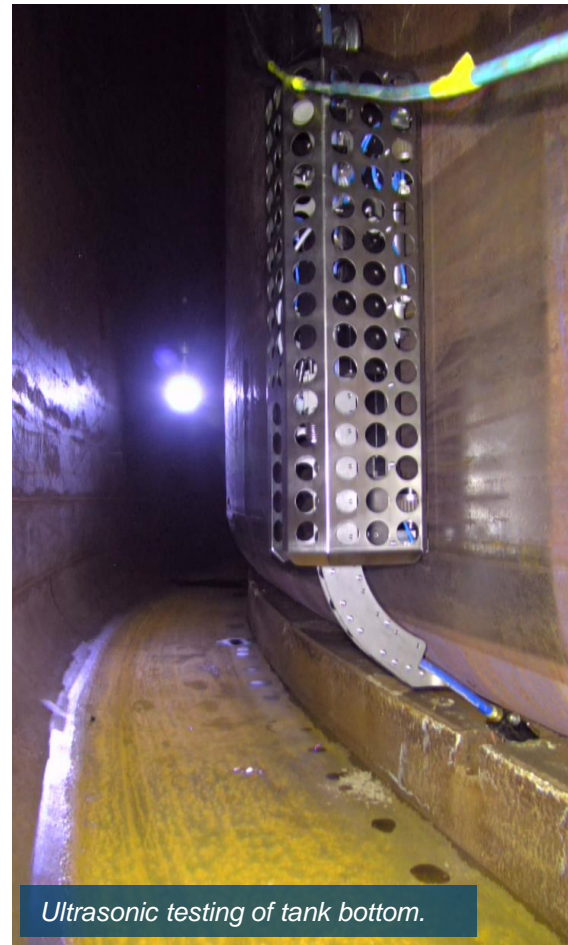
Ultrasonic testing of tank bottom.

In 2020, WRPS completed ultrasonic inspection of the primary tank bottom of a DST. The nondestructive examination technique sends out sound waves to detect flaws in the tank's carbon-steel liner, and will be used to conduct periodic thickness measurements of a DST's primary tank bottom. Engineers used a robotic crawler that inserted an inspection sensor into an air slot under the primary tank to obtain thickness readings at multiple locations on the tank bottom.

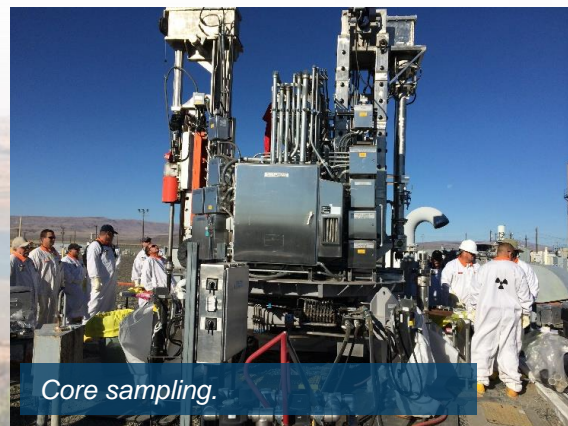
Core sampling.

WRPS also performs core sampling to gain a better understanding of the waste in contact with the primary tank bottoms. Scientists analyze the waste samples for compliance with corrosion specifications that address general corrosion, pitting and cracking. Core samples help engineers learn more about corrosion rates, corrosion potentials and propensity for pitting, which in turn aids in the development or modification of mitigation strategies that can extend the service lives of DSTs.
