HANFORD EMERGENCY INFORMATION

Event Summary 5/10/2017, 11:21 PM
HANFORD SITE EMERGENCY TERMINATED

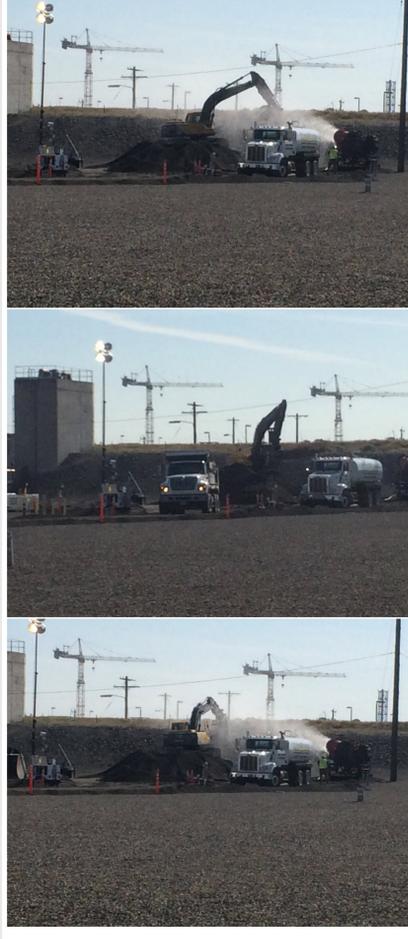
Workers have begun to fill the hole in the tunnel, located near the PUREX Plant in the 200 East Area of the Hanford Site, with soil. Approximately 50 truckloads of soil will be used to fill the hole. There is a mixing machine on the right side of the photo that is being used to control dust. The operator in the cab of the excavator is wearing a protective suit and a filtered air mask.

Crews have begun filling a collapsed section of a rail car tunnel on the Hanford Site, located next to a former chemical processing facility known as the Plutonium Uranium Extraction Plant, or PUREX. The hole is being filled with soil using heavy equipment. Approximately 50 truckloads of soil will be used to fill the hole.

Hanford personnel worked throughout the night to stabilize site conditions near the collapsed section of the PUREX tunnel. Crews constructed a gravel road that leads to the tunnel's collapsed section, which provided a stable and clear path for workers to fill the hole in the tunnel.
