Five-Year Surveillance Report for the 105-C, 105-D, 105-H, 105-F and 105-N/109-N Safe Storage Enclosures

Document Type: RPT

D. G. Ranade
Mission Support Alliance

Date Published
March 2016

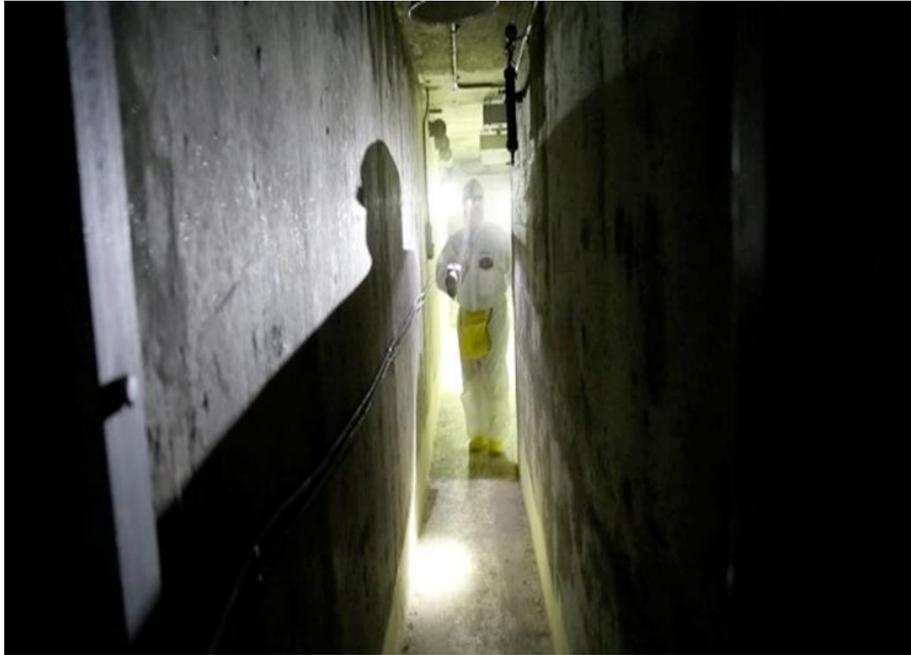
Radiological surveys of internal and external conditions were conducted at each SSE in accordance with applicable program and procedures. Figure 4 shows an internal radiological survey being conducted. The survey data and results are provided in Appendices A through E. The radiological survey results for each SSE are consistent with the results from previous surveys. No unexpected radiological conditions were encountered. Radiologic postings observed in the SSEs are appropriate for the conditions observed. Exterior radiological surveys

Figure 4. Radiological Survey at 105-F SSE.

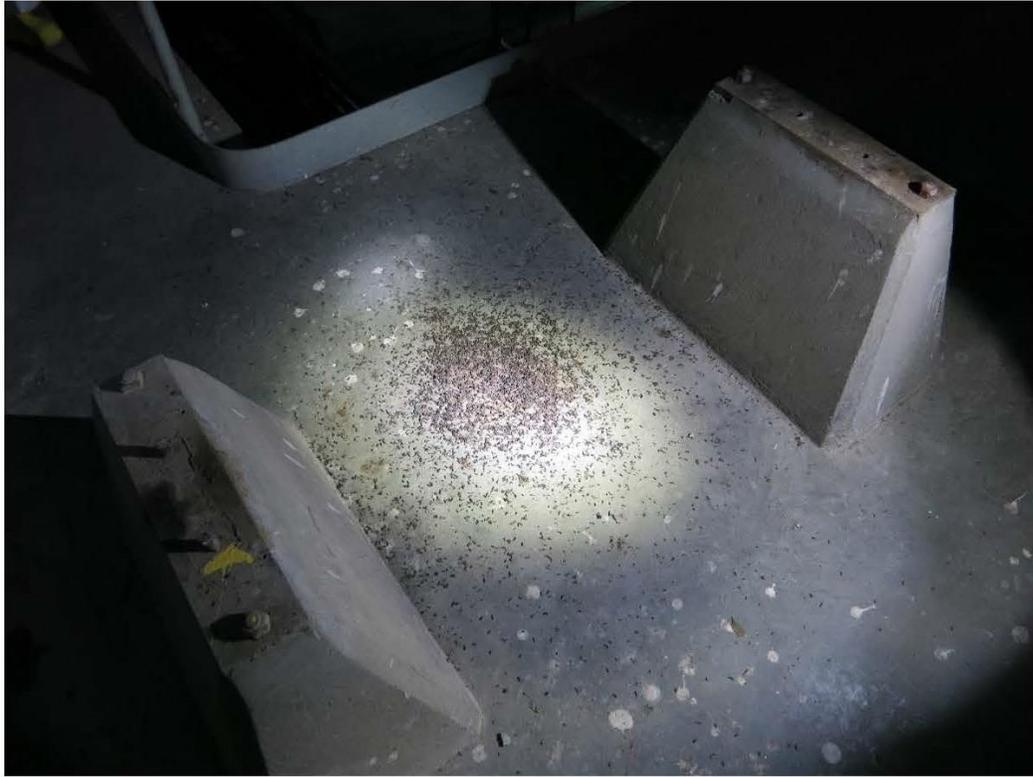
Figure 1. Accumulation of Bat Guano on floors during reactor entry

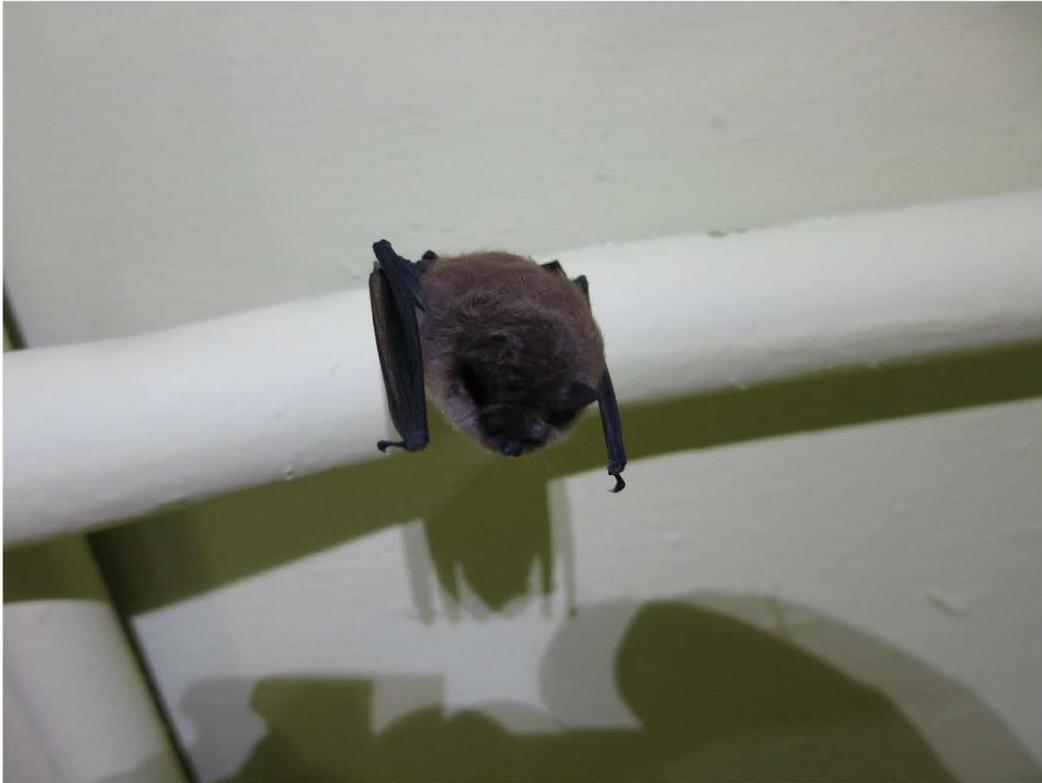
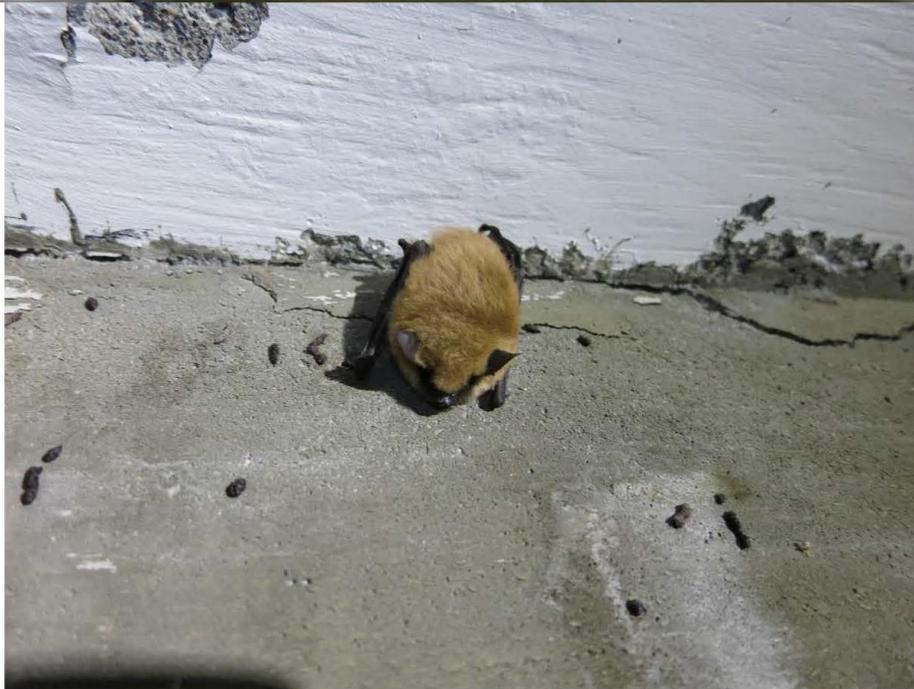
Figure 2. Bats located inside the 100C reactor

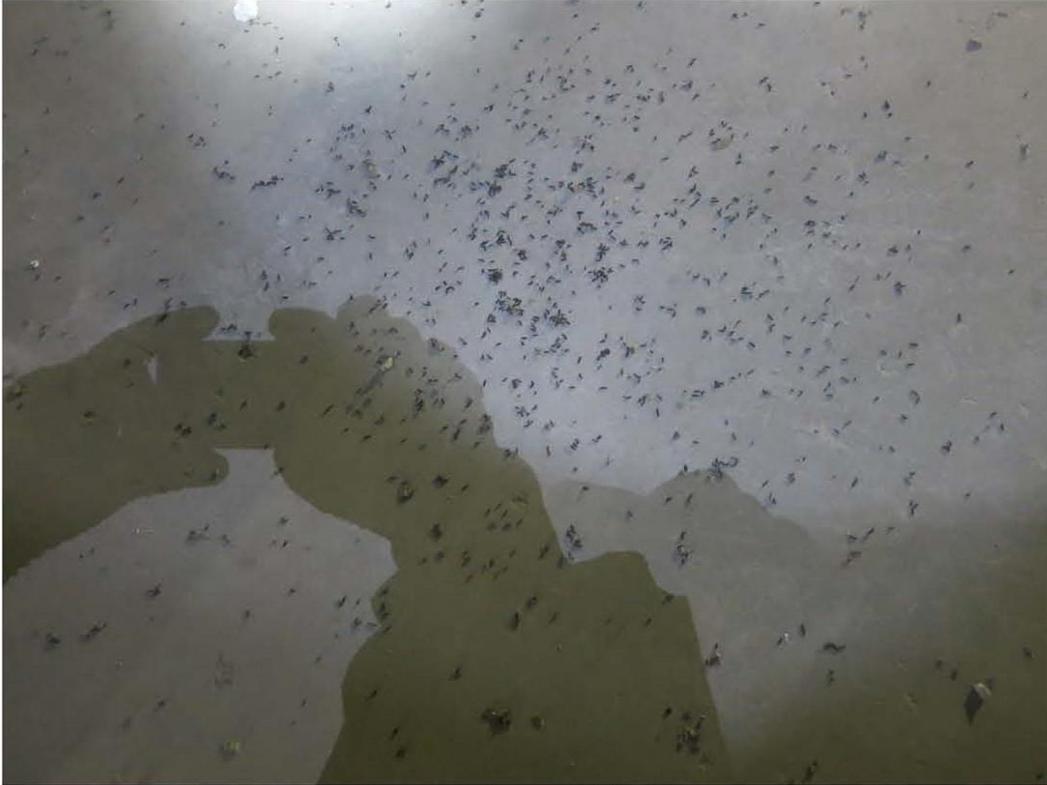
Figure 1. Accumulation of Bat Guano below a Light Fixture in the 105-F Reactor SSE

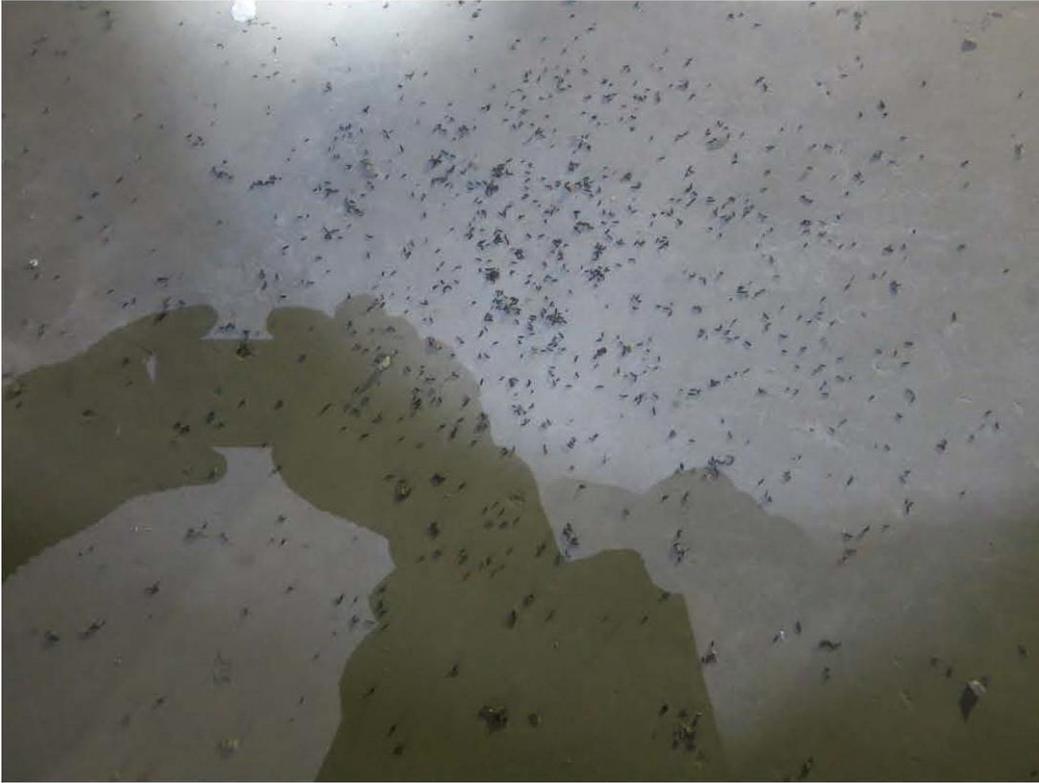
Figure 1. Accumulation of Bat Guano below a Light Fixture in the 105-F Reactor SSE

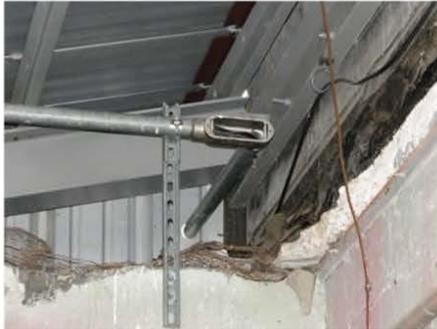
3579 Open junction box in vestibule

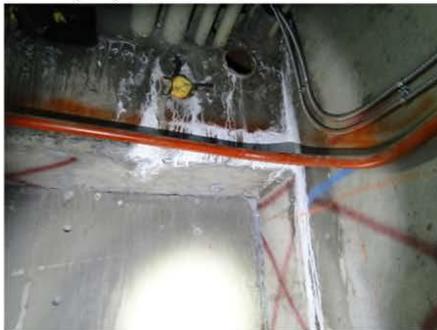
3581 When chipped off, a small chunk of this white deposit had a water drop inside. Somehow from recent water (rain). Also found some of this deposit on outside of bldg at same location

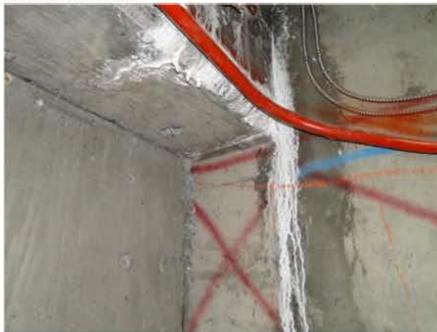
3582 white deposit on building interior

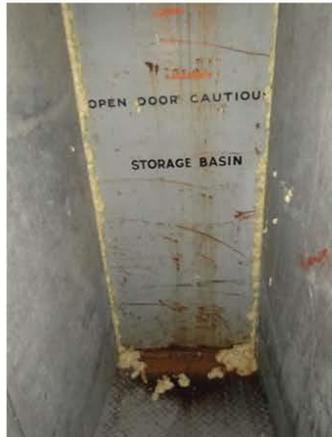
3594 Match THIS PICTURE WITH #3646
Evidence of water/rust at bottom of door

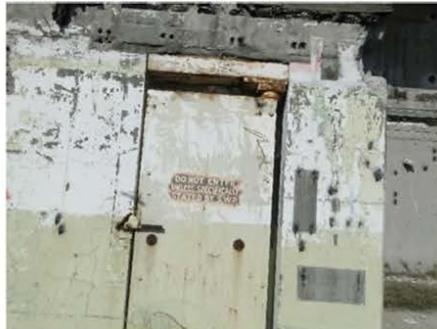
3646 Rear face shield door.. Evidence of rusting inside Possible weather protection issue

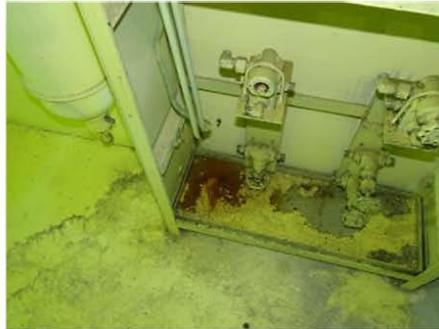
7. Hydraulic fluid is present in the equipment pan and on the floor (Appendix B, Photos 3601 and 3605).

3605 Hydraulic fluid is staying well within the equipment pan. Entire area 2' x 3'

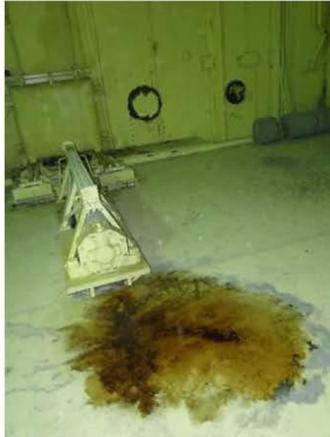
3601 Fluid on floor from overhead winch

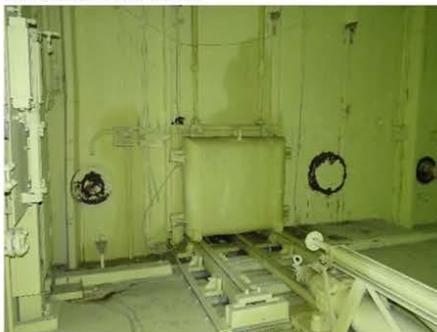
3607 Hydraulic fluid from this op system for this shield door dripping in pic 3605

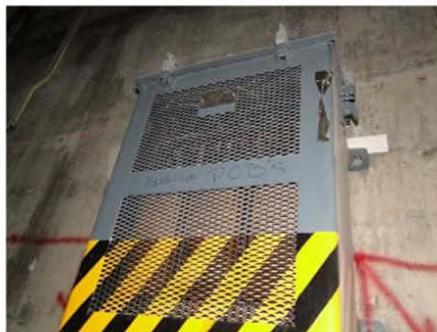
3628 Possible PCB in transformer

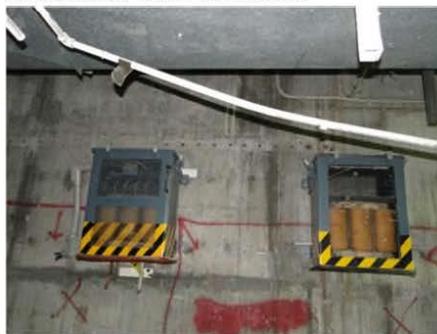
3629 Possible PCB in transformer

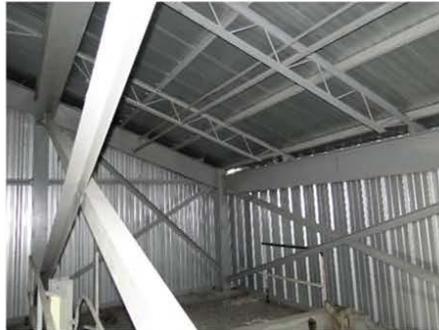
3622 Other than openings at corners—structure in very good condition.

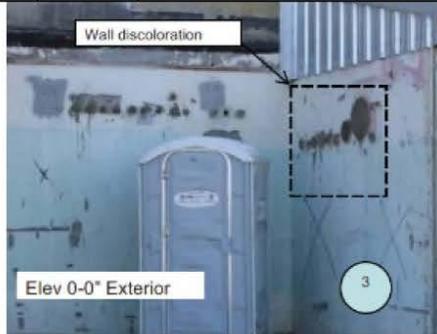
Item 3 –2008 Detail Exposed ISS Closure Details SW Wall of Building Exterior minor corrosion

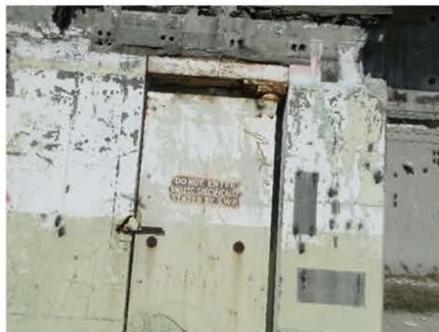
Item # 20 2008 Detail – Existing Metal door @ SE of Exterior building Elevation 0'0"

Item # 20	3646 3647	Existing Metal Door at SE of Exterior Building, Rear face shield door	Exterior, Elev. 0'-0"	Continue to observe, repair or replace with a pourback or plate if significant corrosion continues	See #3594 at 0" interior, minor corrosion

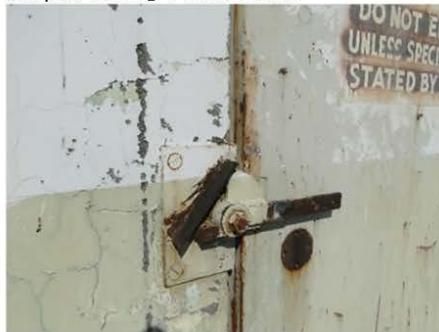
4. Attachment C-1; photo 3594 and 3646, and item 21 from 2008, show the interior and exterior of a steel door on the rear face that exhibit a good deal of corrosion on the outside at its base and some dampness and corrosion on the inside at this location.

3646 Rear face shield door. See picture # 3594. Possible WEATHER Protection issue
See pic # 3594 @ 0' level interior

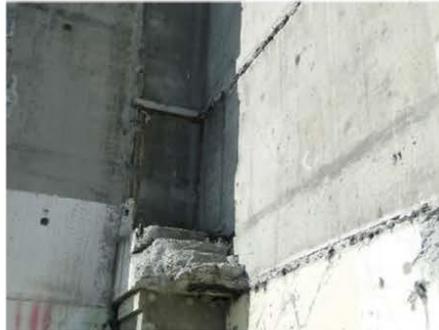
Item 21 – 2008 Detail Existing Reactor Metal Door at SE of Exterior Building Area , Elev. 0'-0", minor corrosion, soil removal recommended

Item # 21	No new picture	Existing Reactor Metal Door at SE of Exterior Building Area	Exterior, Elev. 0'-0"	Soil removal recommended	Minor corrosion
Item # 27	3642	Exposed Aggregate at E Corner Wall of Building	Exterior, Elev. 0'-0"	Periodically remove dirt from ledge to reduce likelihood of growing grass	Grass growing on ledge provides an attractive habitat

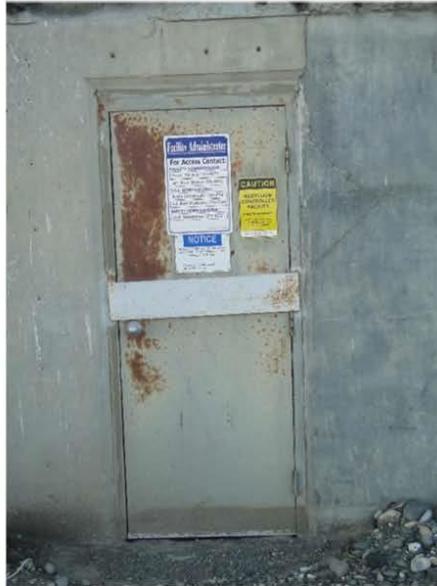
Item 33 – 2008 detail Metal Door at N Wall of Building Exterior, Elev. 0'-0", mild corrosion.

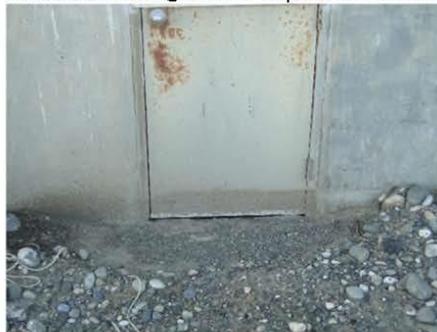
3640 Metal door @ N wall. Depression near door and mild corrosion

Item # 33	3640 3641	Metal Door at N Wall of Building Exterior	Exterior, Elev. 0'-0"	Area of soil removal needs to be more of a gradual slope rather than a hole funneling right to the bottom of the door jam	Mild corrosion

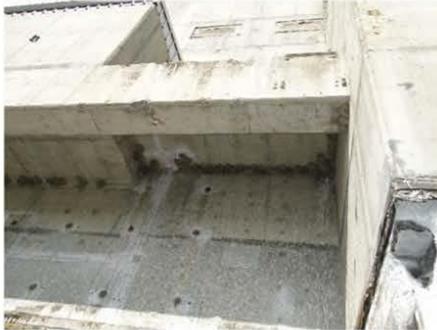
3644 swallow nests under ledge

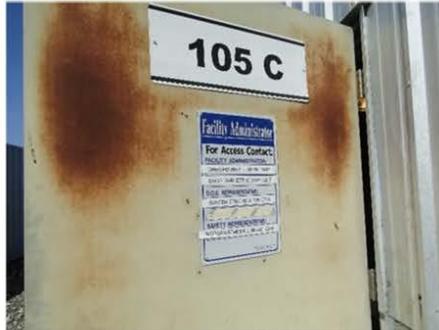
3656 Postings on main vestibule entrance outdated

3638	Swallows nesting	Exterior, Elev. 0'-0"	Recommend continued observation	
	3656	Main Vestibule Entrance	Exterior, Elev. 0'-0"	Update posting	Postings on main vestibule entrance outdated

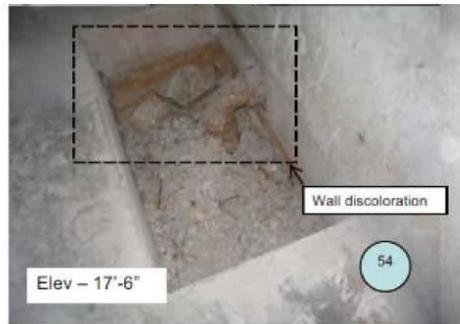
Item # 54 2008 Original Building Structure Floor Detail, Elev. -17'-6", moderate corrosion

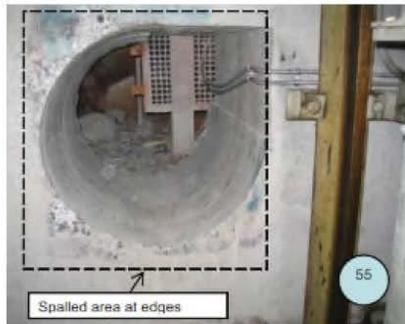
Item # 55 2008 detail spalling

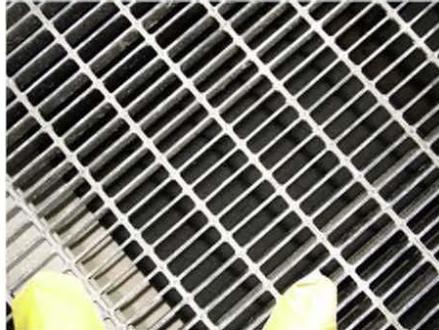
3590 -10' level Dried mud several feet below grating floor (@ -17' grade). Mud dried like tile pattern...cracked mud floor..very dry for a long time.

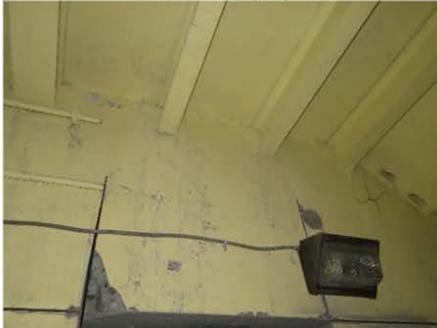
3591 No spalling—piece came out during saw cut of doorway

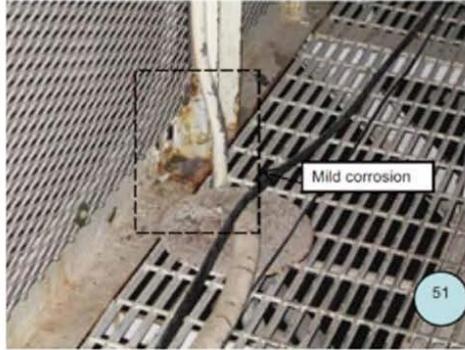
Item # 51 2008 Original Building Structural details @ building interior moderate corrosion

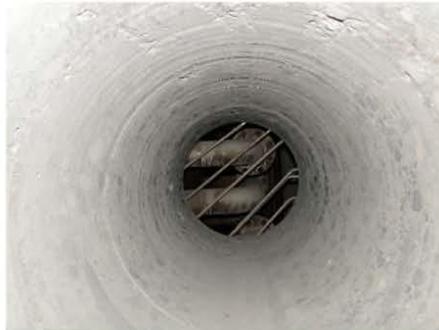
3599 Cutout to rear face

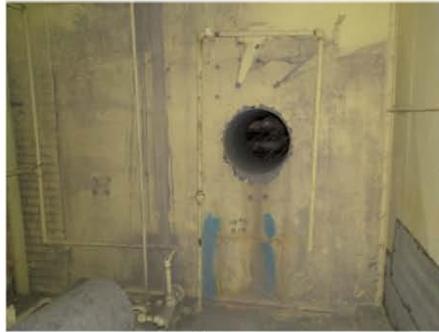
3600 Cutout to rear face

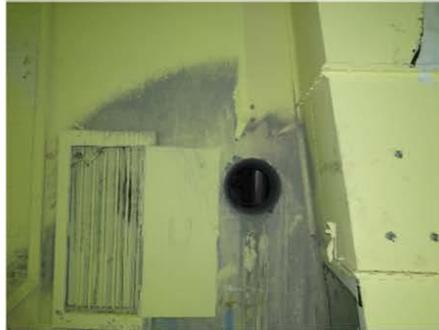
3603 Cut out to rear face

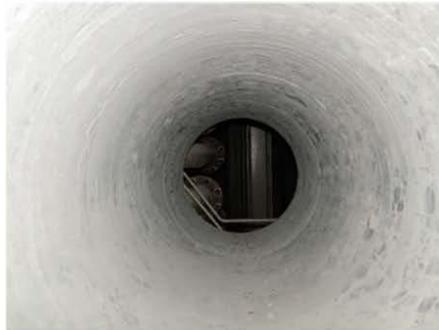
3604 Cut out to rear face

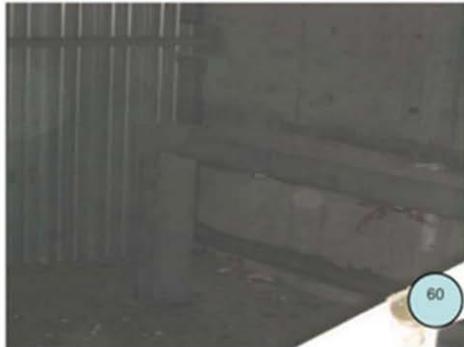
Item 60 –2008 Detail ISS Details, walls & girts, Elev. 45'-2 1/4", no visible structural defects

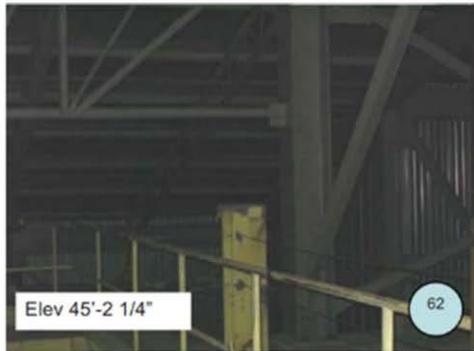
Item 62 2008 Detail – ISS Details, Columns & Beams, Elev. 45'-2 1/4", no visible structural defects

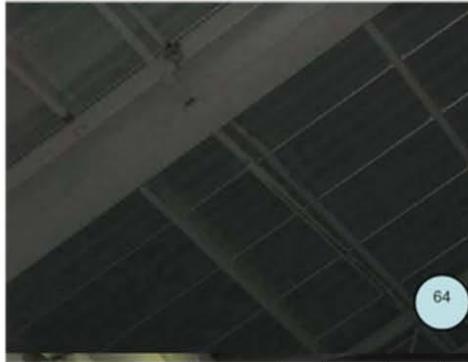
Item 64 – 2008 Detail SS Details, rafters, Elev. 45'-2 1/4", no visible structural defects

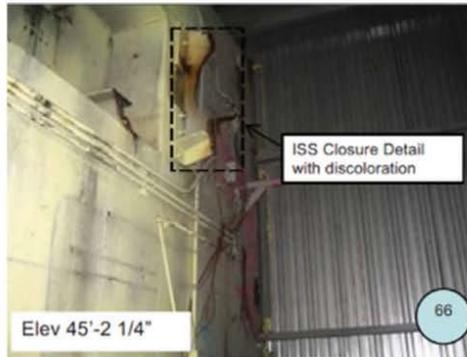
Item 66 – 2008 Detail ISS Details, Original Beam, Elev. 45'-2 1/4", no further structural degradation

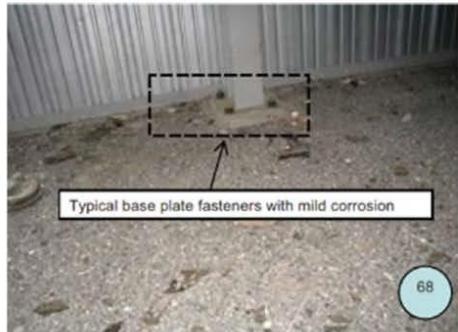
Item 68 –2008 Detail ISS Details, column base plates & bolts, Elev. 45'-2 1/4", no visible structural defects

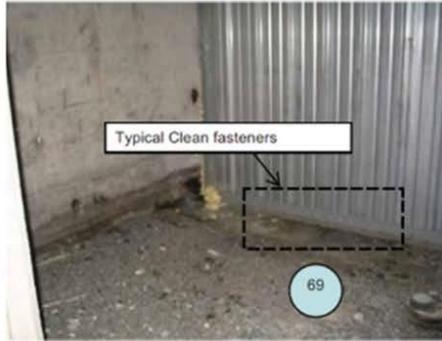
Item 69 – 2008 Detail ISS Details, fasteners, Elev. 45'-2 1/4", no visible structural defects

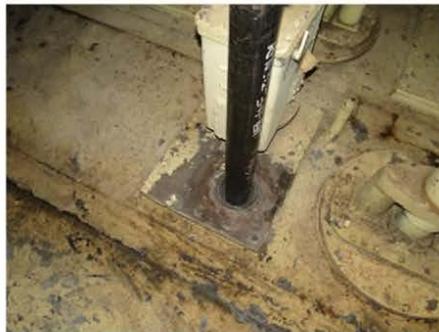
3611 vent penetration to top of reactor block / below HEPA filter housing

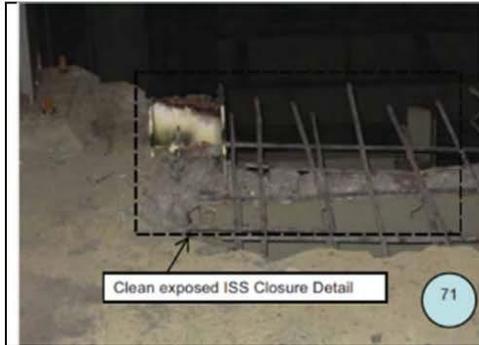
Item 71 –2008 Detail ISS Details, removed original structure, Elev. 59'-4", no further structural damage

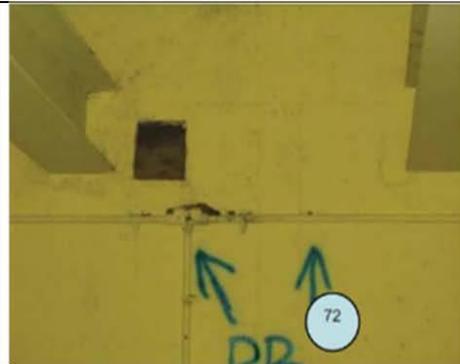
Item 72 – 2008 Detail ISS Details, pourbacks, Elev. 59'- 4", no visible structural defects

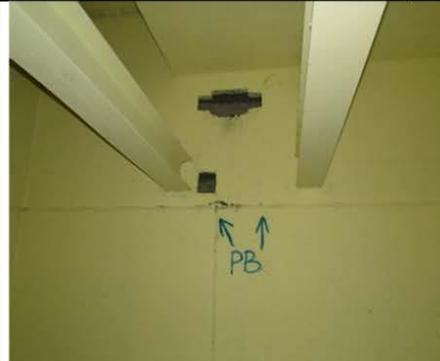
3624 No change to condition

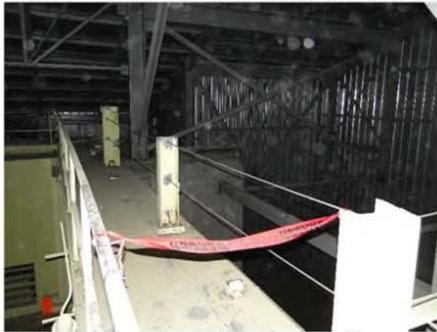
3619 Demolition beyond access boundary

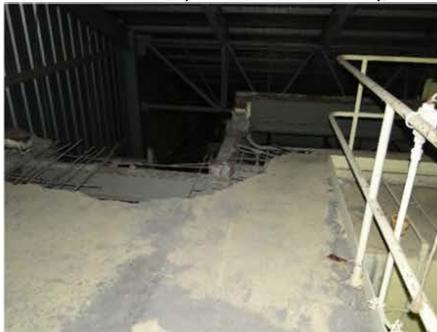
3620 Demolition beyond access boundary

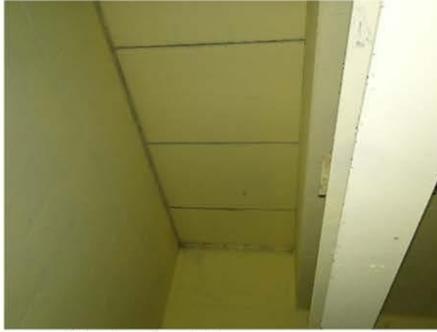
3625 old ceiling/roof plugs

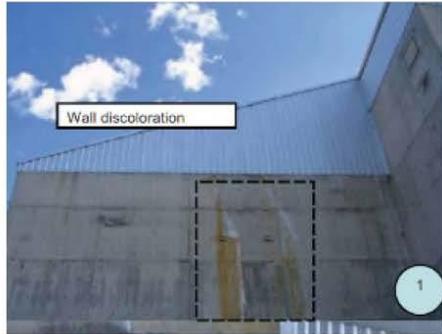
Item 1 – 2008 Detail Wall Discoloration at SW Wall of Building Exterior, Elev. 0'-0", minor corrosion

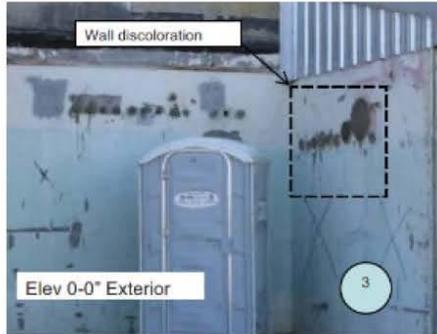
Item 3 –2008 Detail Exposed ISS Closure Details SW Wall of Building Exterior minor corrosion

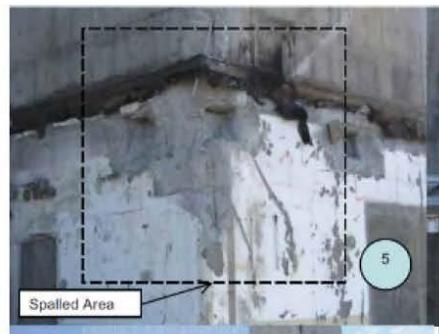
Item 5 – 2008 Detail Exposed Aggregate and Rebar at S Wall of Building Exterior, Elev. 0'-0", minor corrosion, and spalling

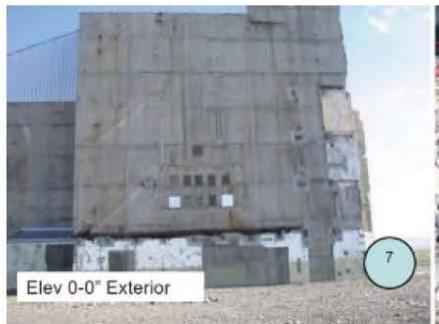
Item 7 – 2008 Detail View of South Wall, Elevation 0'-0"

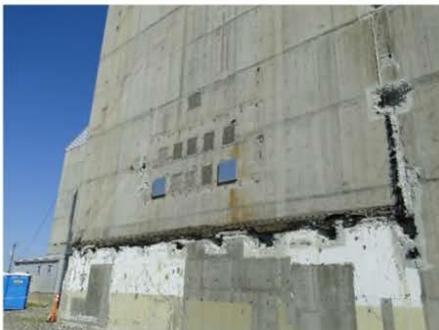
3652 HEPA Filter covers on south side of building, HEPA filter noted on interior +15' Experimental Room

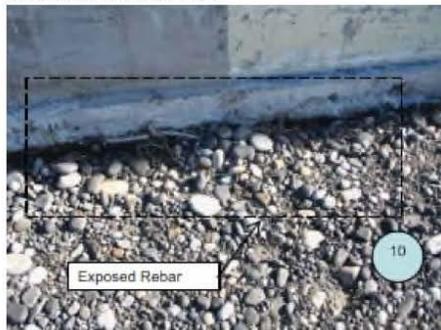
Item 10 –2008 Detail Exposed Foundation/Floor Rebar at S Wall of Building Exterior, Elev. 0'-0", recommend soil removal

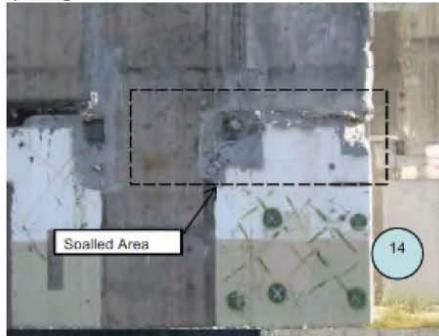
Item 14 2008 Detail– Exposed Aggregate at SE Wall Corner of Building Exterior, Elev. 0'-0", spalling

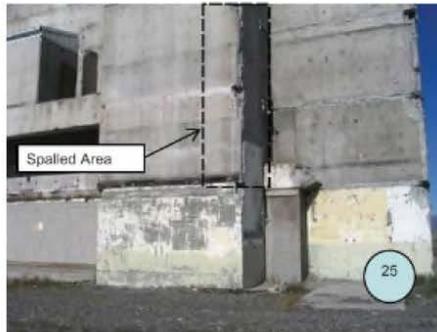
Item 25 –2008 Detail Exposed Aggregate at E Corner Wall of Building Area , Elev. 0'-0", spalling

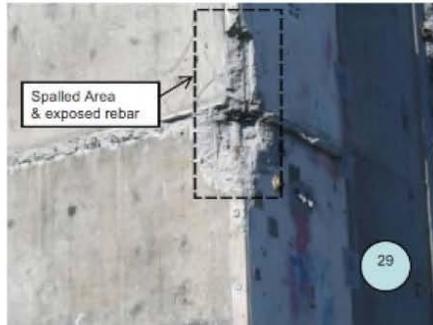
Item 29 –2008 Detail Exposed Aggregate at NE Corner Wall of Building Exterior, Elev. 0'-0", spalling

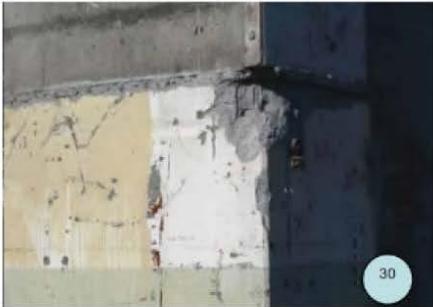
Item 30 – 2008 Detail Exposed Aggregate at NE Corner Wall of Building Exterior, Elev. 0'-0", spalling

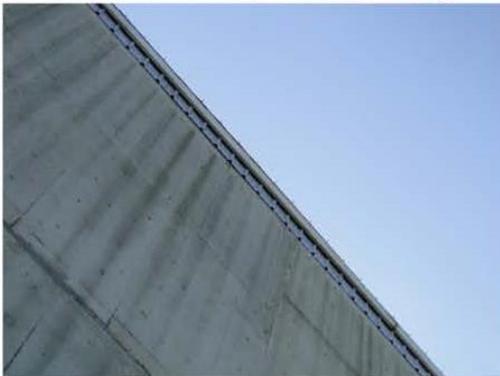
3630 general building exterior discoloration

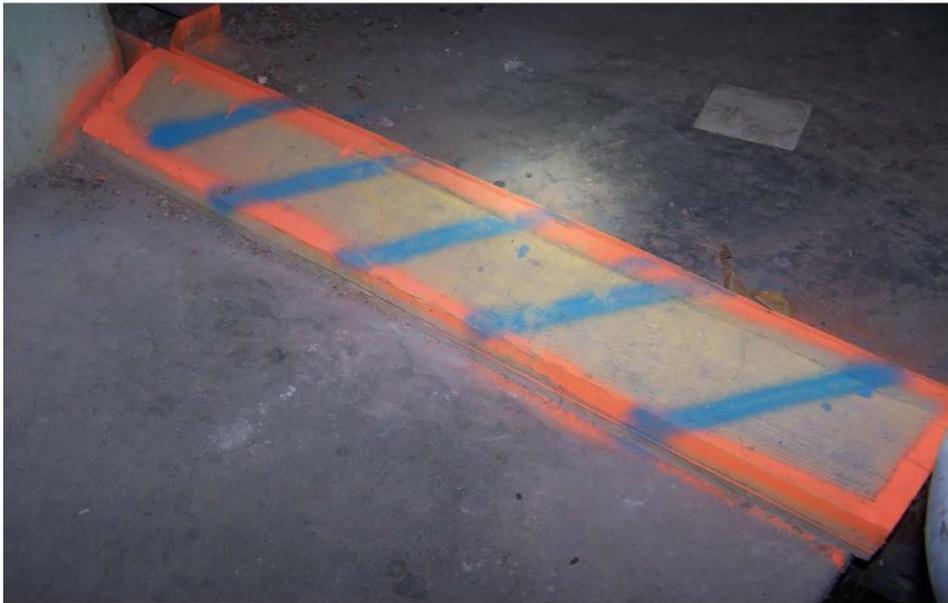
Photo 3

- Trip hazard at the top of the stairs leading into the room (Painted Orange). (Photo 3)
- Tray protruding into walk way (Painted Orange). (Photo 4)
- Metal floor seam pulling apart and curling up posing a trip hazard, this is not painted orange but can be avoided by staying on the walk path.
- Trip hazard at bottom of stairs leading up to the 42' level. This is the metal flooring turns up like a "drip pan" (Painted Orange). (Photo 5)

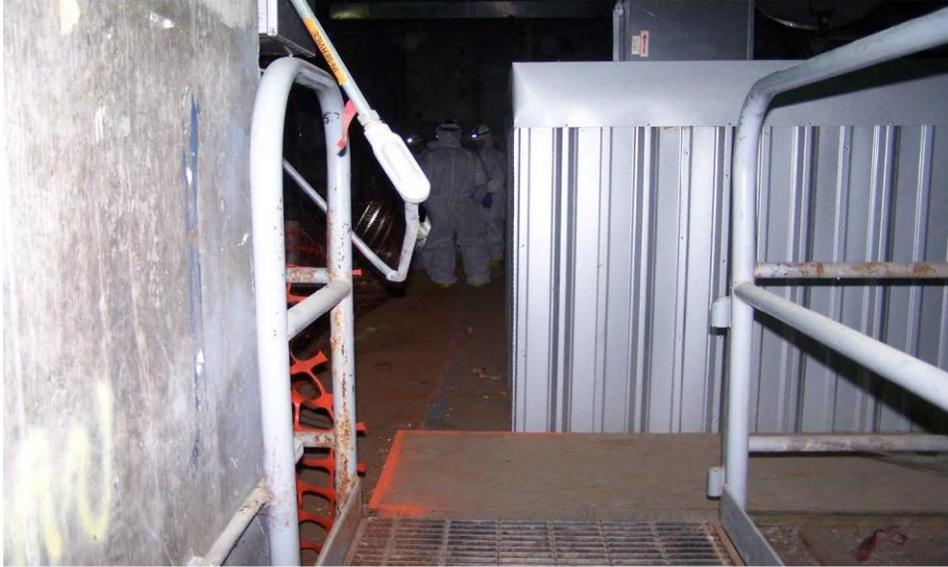
Photo 6

- Rise on top steps of bridge are taller than normal making this small stair case ununiformed.
- Conduit protruding into walkway while crossing the bridge between the stairs and "top hat" floor. (Photo 6)
- Wooden platform covering "top hat" floor has step down on west end of "top hat" posing tripping hazard (Painted Orange). (Photo 7)

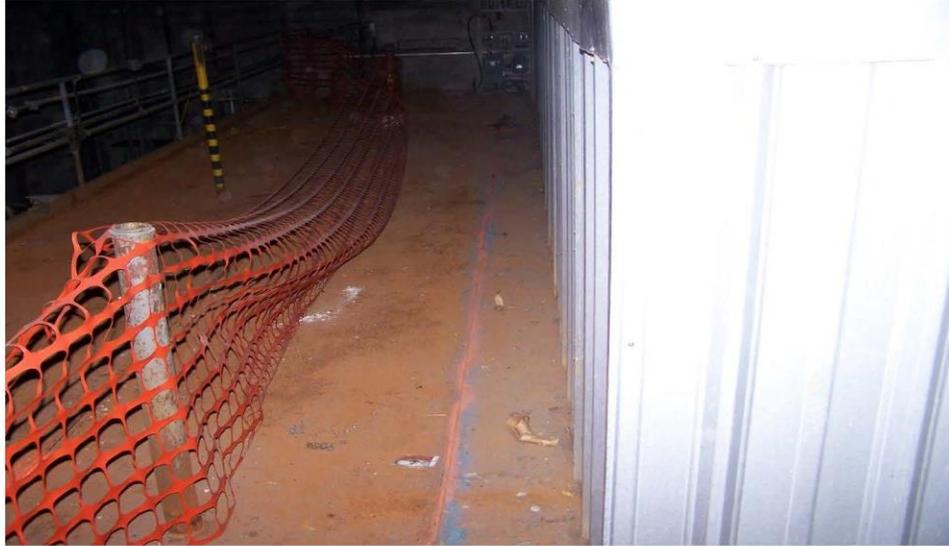
Photo 8

- “Top hat” floor has approx. 1” rib at seam posing a tripping hazard (Painted Orange). (Photo 8)
- Back side of tank on SE corner of top hat has a picking eye protruding into the walkway posing a struck against hazard (Painted Orange). (Photo 9)

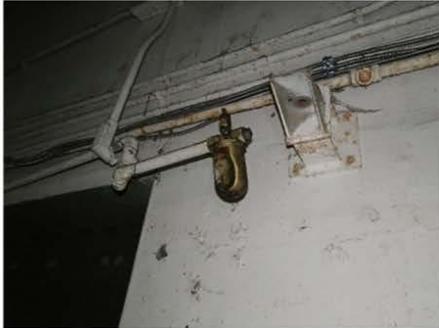
3538 Air line filter has residual fluid dripping from it

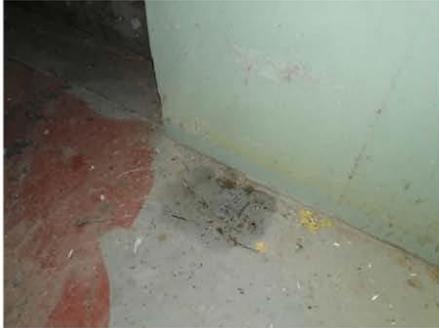
3539 floor below air line filter

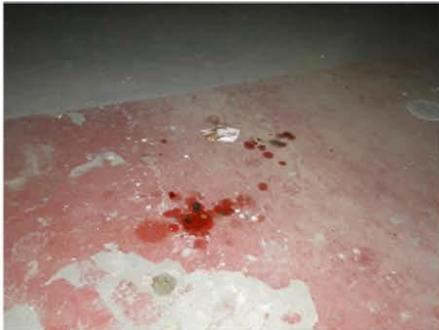
3540 under dripping winch from 40' level

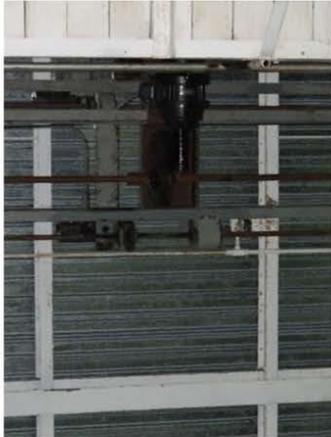
3542 looking up from 0' level up to 40' level above drip on floor..front face

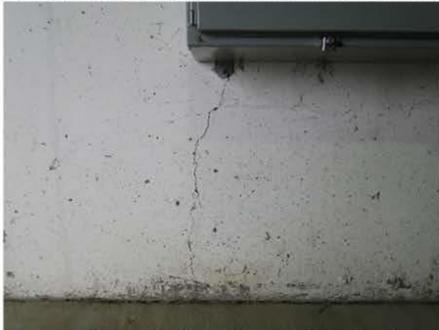
3543 inside vestibule crack on wall under electrical box

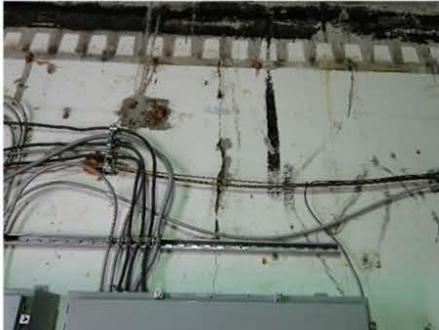
3544 vestibule crack

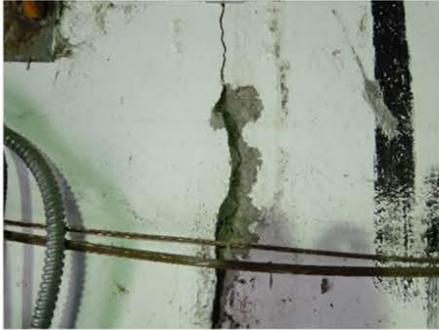
3545 vestibule crack

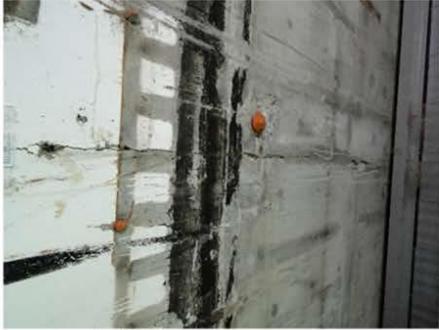
3546 vestibule crack

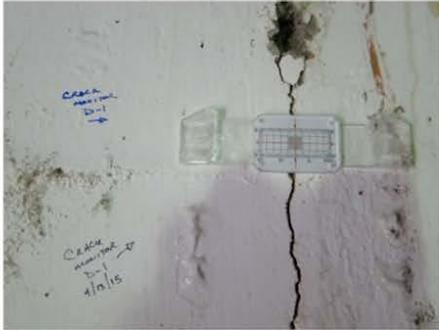
3561 crack monitor installed in vestibule on concrete wall crack

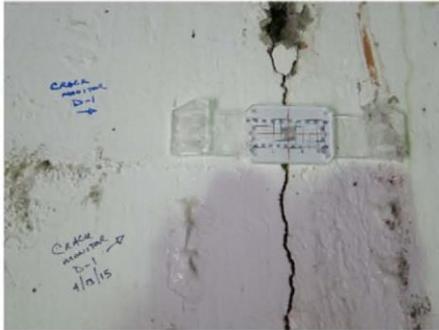
3562 Crack monitor installed in vestibule on concrete wall crack

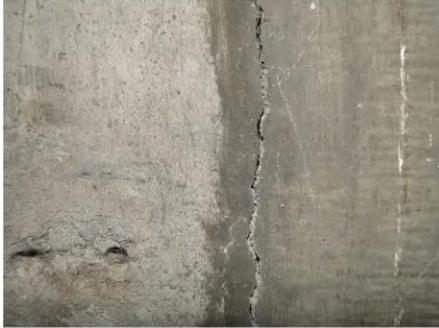
3659 Wall crack inside facility other side of vestibule wall

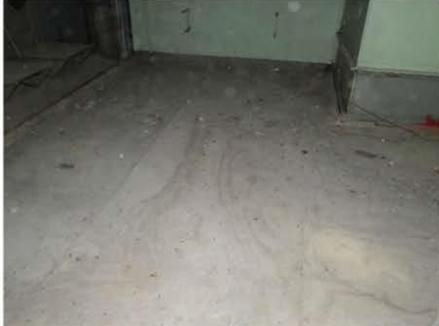
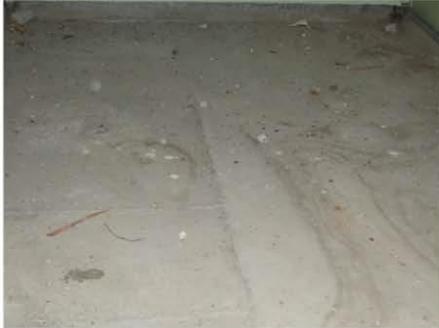
Item #	New Photo #	Description	Area / Location	Future Inspection/Maintenance Recommendations
14, 14A	3505 3506 3507	Floor	Interior – Elev. 13'-0"	Floor panel previously just discolored, now seems to be lifting at edge Recommend continuing observation

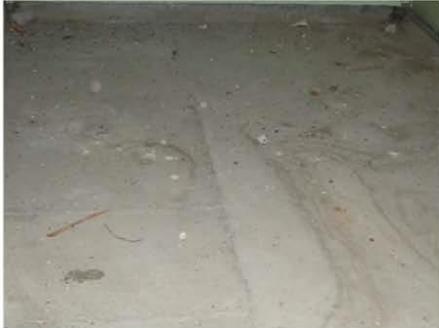
14 2015 Detail

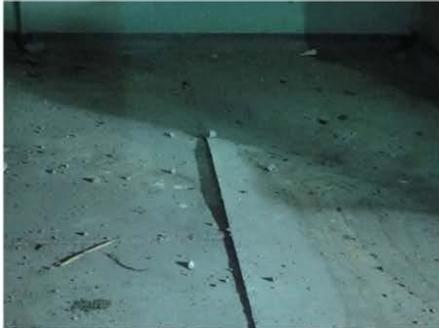
3507 floor panel lifting at edge

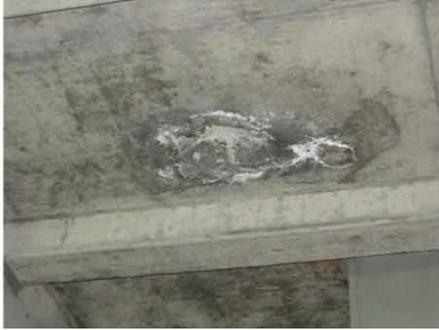
3509 White discoloration on surface of concrete looking up at ceiling in multiple locations

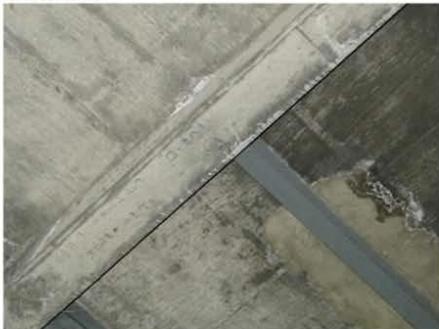
3508 White discoloration on surface of concrete looking up at ceiling in multiple locations

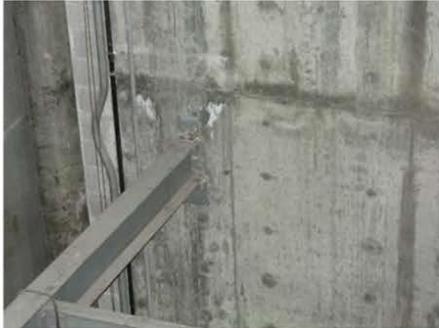
3510 White discoloration on surface of concrete looking up at ceiling in multiple locations

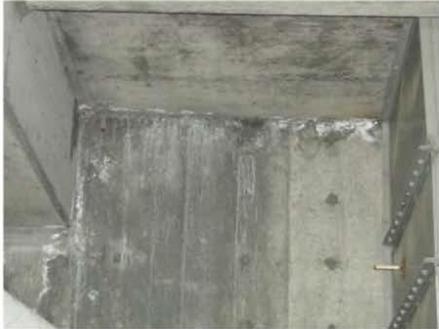
3511 White discoloration on surface of concrete looking up at ceiling in multiple locations

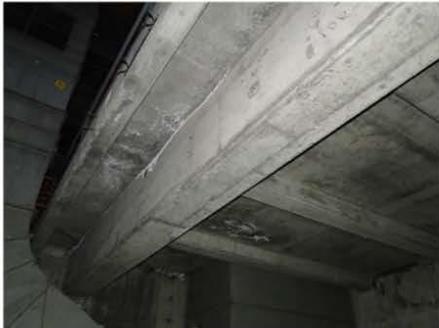
3512 White discoloration on surface of concrete looking up at ceiling in multiple locations

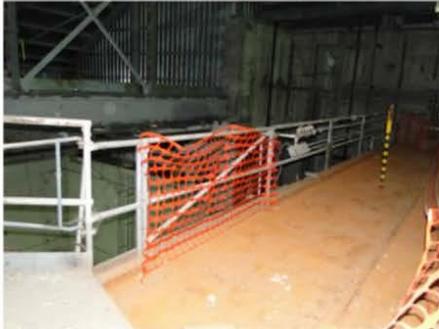
Item #	New Photo #	Description	Area / Location	Future Inspection/Maintenance Recommendations
19, 19A	3513	Guard Rails	42' 4 5/8"	Fall Hazard
	3516	Mechanical equipment blocking Surveillance path	42' 4 5/8"	S & M plan needs to be revised to show proper path. Unable to get all around top hat
	3530	Under side of floor above	42' 4 5/8"	42' elevation looking up under 56' elevation...several "holes" in floor with darkness around them... Same type of "holes" on other side of bldg. at exact same place....previous equipment used these penetrations Recommend continuing observation

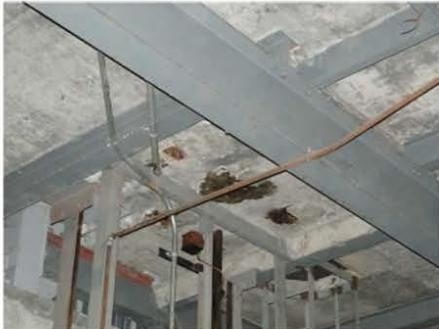
3530 at stairwell @ 42' elevation looking up under 56' elevation...several "holes" in floor with darkness around them... Same type of "holes" on other side of bldg. at exact same place....previous equipment used these penetrations

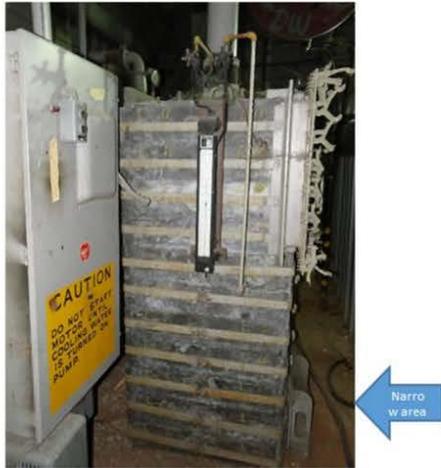
3516 On the current surveillance route behind the top hat on the west side... route should be revised so as not to walk "behind" the top hat. Very narrow area.

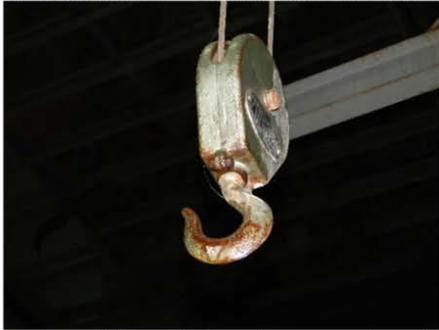
3515 Winch located above the reactor above the 80' elevation is leaking soil/grease. Oil/grease is dripping down chain/hood and floor below chain/hood which can be seen while standing in northwest portion of 56'4" level looking up.

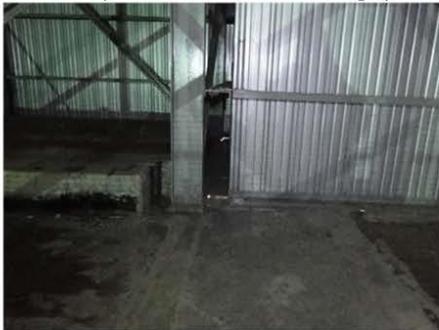
3519 On ease side of structure, various locations were observed in which light from the outside could be seen through gaps

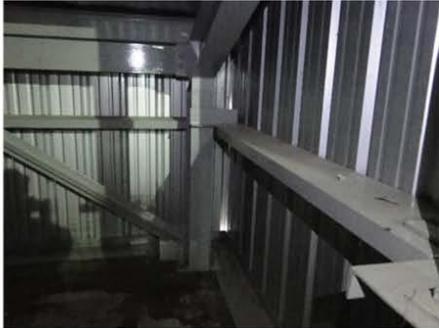
3520 On ease side of structure, various locations were observed in which light from the outside could be seen through gaps

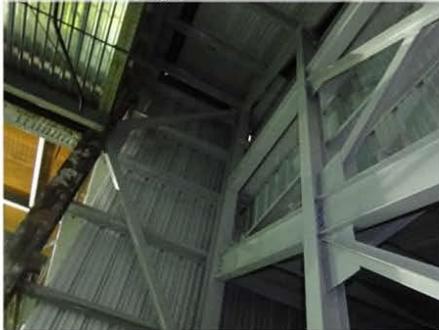
3521 On ease side of structure, various locations were observed in which light from the outside could be seen through gaps

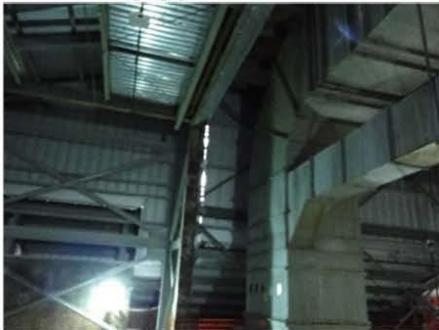
3522 On ease side of structure, various locations were observed in which light from the outside could be seen through gaps

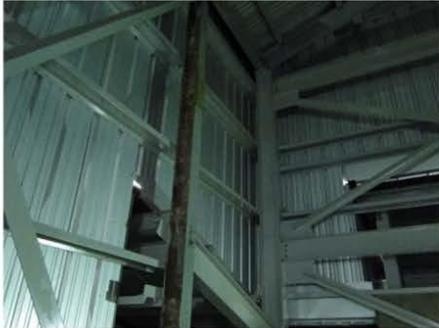
3523 On ease side of structure, various locations were observed in which light from the outside could be seen through gaps

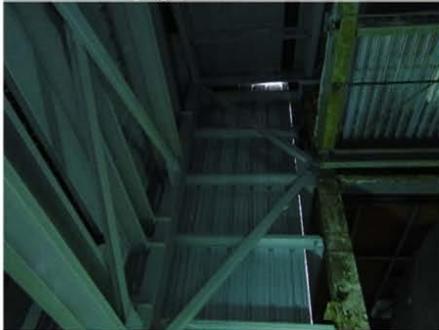
3524 On ease side of structure, various locations were observed in which light from the outside could be seen through gaps

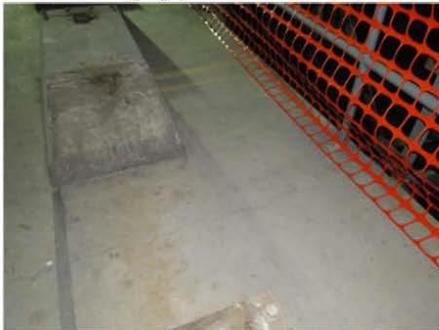
3525 Hairline cracks in concrete across "catwalk" around top hat. Several cracks exist, most across entire width of walkway. No crack visible from underside of concrete from stairway underneath. Vibrations felt on walkway when outside trucks drove by. No way to know if cracks have been there for duration due to past equipment use, or if they are newly appearing.

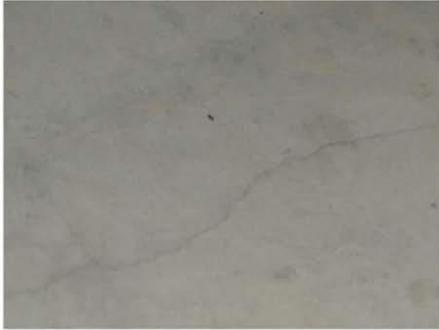
3526	Concrete "catwalk" area around top hat		Several hairline cracks in concrete in an area only a few feet long. Recommend continuing observation

3526 Same explanation as 3525—all cracks within a few feet of each other.

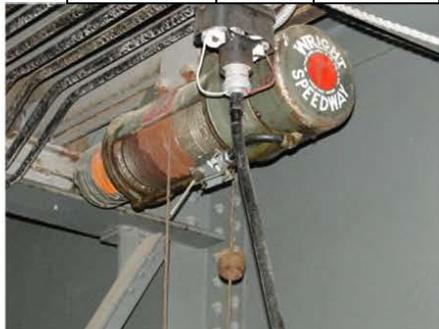
Item #	New Photo #	Description	Area / Location	Future Inspection/Maintenance Recommendations
	3527	Fluid dripping Winch	Elev. 80'-5 1/4"	Recommend continuing observation

3527 Winch located above the reactor above 80' elevation is leaking oil/grease. Oil/grease is dripping down chain/hook and floor below chain/hook which can be seen while standing in northwest portion of 56' elevation looking up

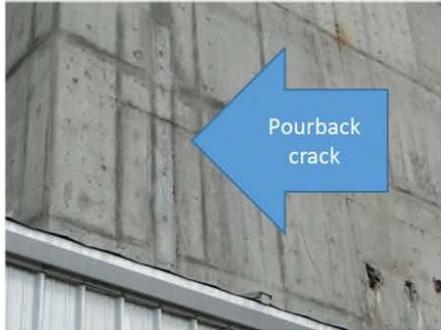
Item #	New Photo #	Description	Area / Location	Future Inspection/Maintenance Recommendations
	3547, 3548	Pourback above vestibule	Exterior Elev. 0'	Pourback appears to have begun to crack. No notations or pictures to show previous condition Recommend continuing observation
	3550, 3551	Metal roofline	Exterior Elev. 0'	Missing foam insert (both pics same location) West side of front face Recommend continuing observation
	3674	Pourback wall crack	Exterior Elev. 0'	See evaluation in Attachment A
	3676	Pourback wall crack	Exterior Elev. 0'	See evaluation in Attachment A

3547 outside above vestibule concrete pourback leading to crack in vestibule wall

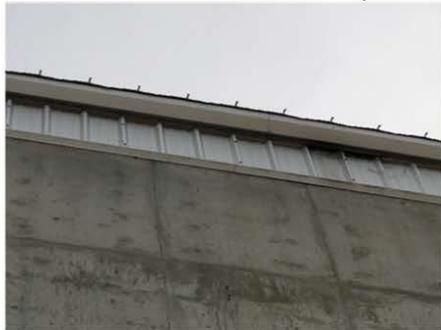
3550 Missing foam insert on west side of front face

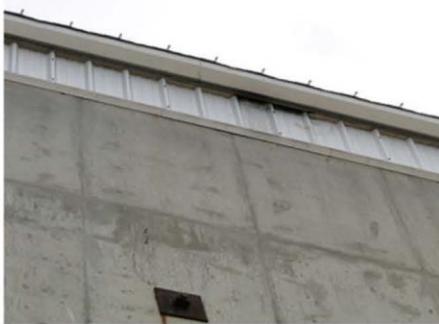
3551 Same spot as pic 3550 Missing foam insert on east side of front face

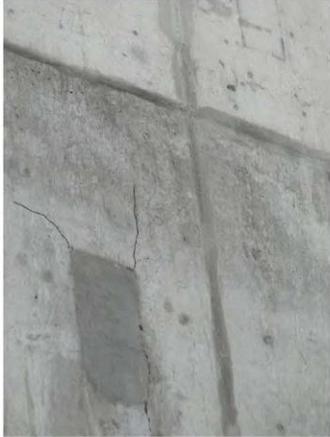
3674 Upper portion of cracked wall at pourback location

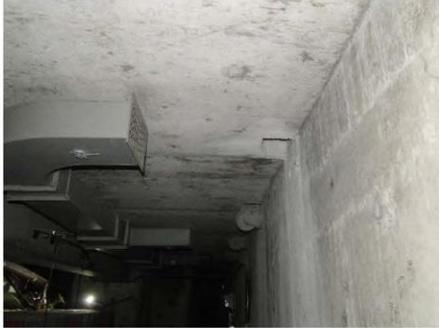
3500 General area condition. No visible issue
