Five-Year Surveillance Report for the 105-C, 105-D, 105-H, 105-F and 105-N/109-N Safe Storage Enclosures

Document Type: RPT

D. G. Ranade
Mission Support Alliance

Date Published
March 2016

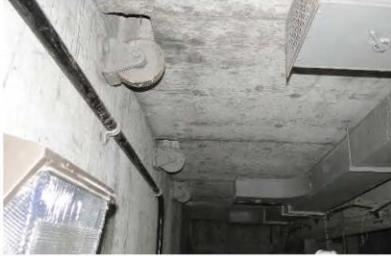
3501 General area condition. No visible issue

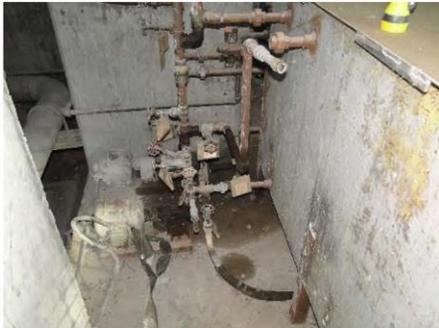
3502 General area condition. No visible issue

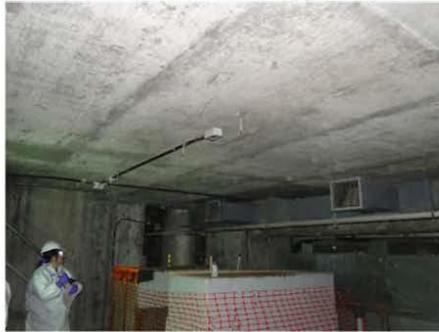
3503 2nd section of -15 elevation.. thru 0' elevation floor and down "2nd" set of stairs General area condition. No visible issues

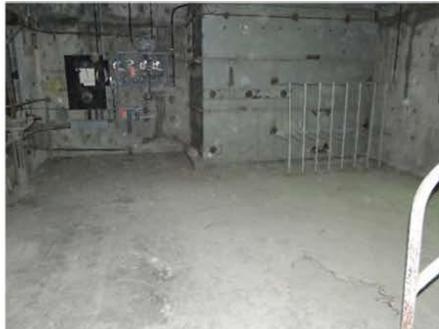
3504 General area condition.. Good

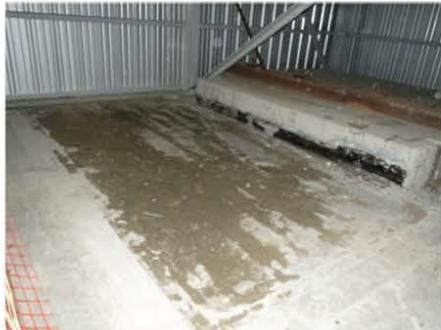
3517 Possible old roofing area with residual adhesive from previous roofing material (asphalt)???

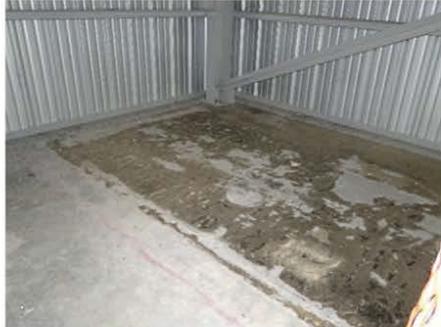
3518 same detail as 3517

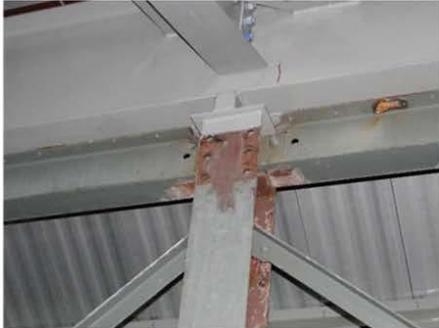
3528 Old pics 41, 41A, 42a 42b 42c Series of beams missing bolts.. appear to be unused structurally. Have been replaced with larger beam above and taken out of service

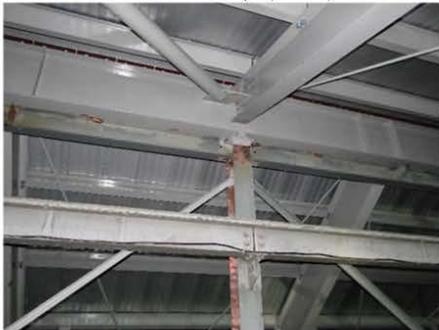
3529 Series of beams missing bolts.. appear to be unused structurally. Have been replaced with larger beam above and taken out of service 41 2015 Detail

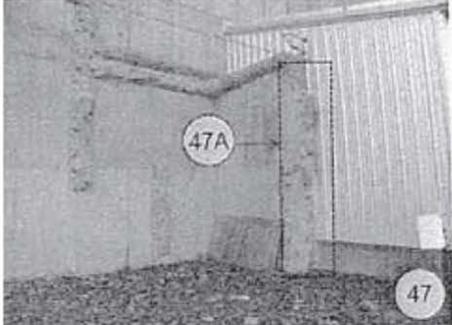
47A 2009 Detail - Elev 0'-1", Concrete Wall, Existing Exposed Aggregate. No change to area condition

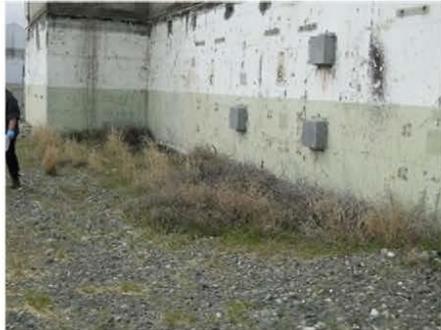
3555 tumbleweed accumulation and exposed rebar at dirt level on east side of SSE Old pic 48

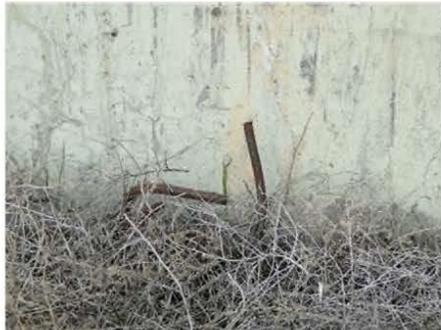
- B. Exterior Conditions
 - i. Swallow nests were noted at various locations on the exterior of the facility. Locations of the nests don't appear to be a current problem. Photos are shown in Attachment D, Photos 3497, 3549, 3552, 3553, 3554, 3558, and 3559.
ASSESSMENT / RECOMMENDED ACTION: If recommended actions for Item in Section A, vi, suggest removal of nests.
 - ii. Foam insert appeared to be missing on the west side of the SSE (outside of front face) located on the bottom edge of the siding. Photo is shown in Attachment C, Photo 3550.
ASSESSMENT / RECOMMENDED ACTION: Same recommended action as Section A, vi.
 - iii. Tumbleweed accumulation on east side of SSE. Photos are shown in Attachment D, Photos 3556 and 3557.
ASSESSMENT / RECOMMENDED ACTION: Periodic removal of tumbleweeds is suggested.

3556 same rebar as pic 3555 on east side of facility.

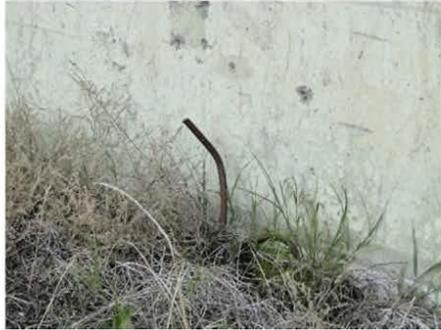
3557 same rebar as pic 3555 on east side of facility

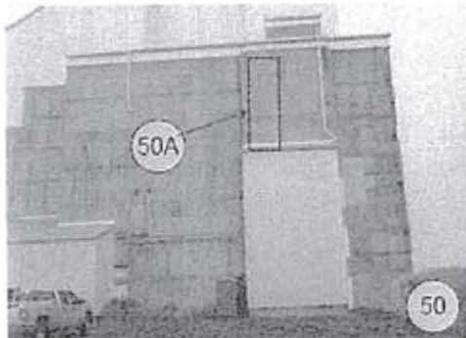
50A – 2009 Detail Exterior, Concrete Wall, Minor Corrosion No change to condition See pics 3547 3548 for vicinity area of concern...

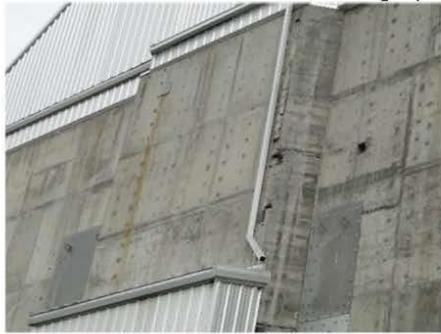
3560 Rust discoloration on south side of SSE

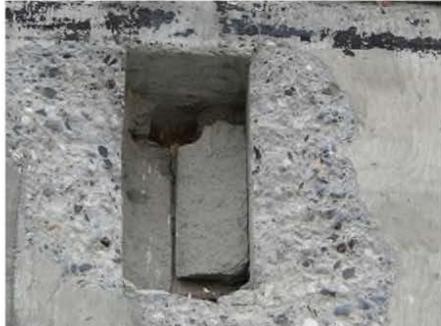
3497 Swallow nest inside beam cavit. On west side of front face wall.

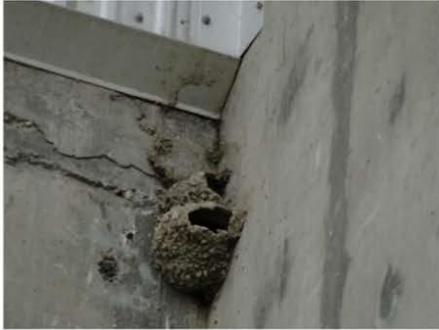
3552 bird nests

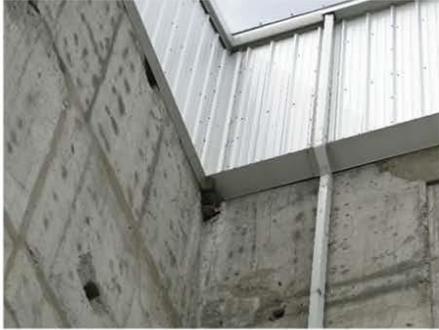
3553 bird nests

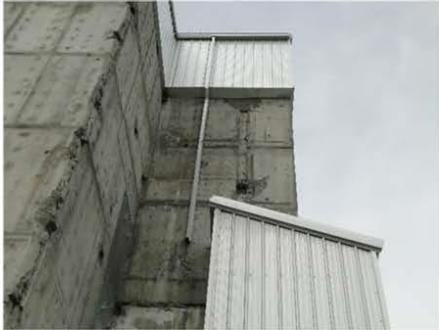
3554 bird nests

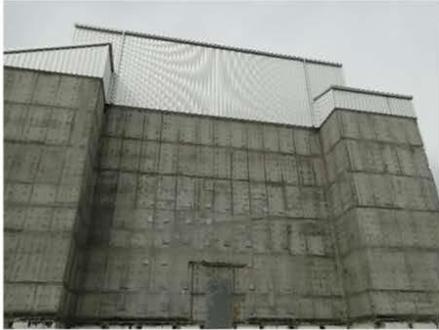
3558 bird nests

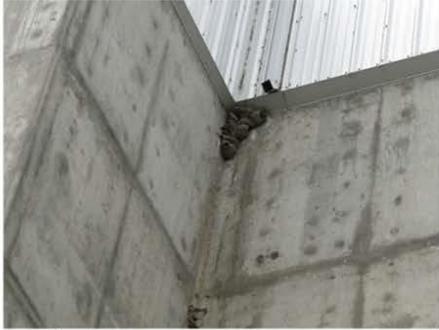
3559 bird nests

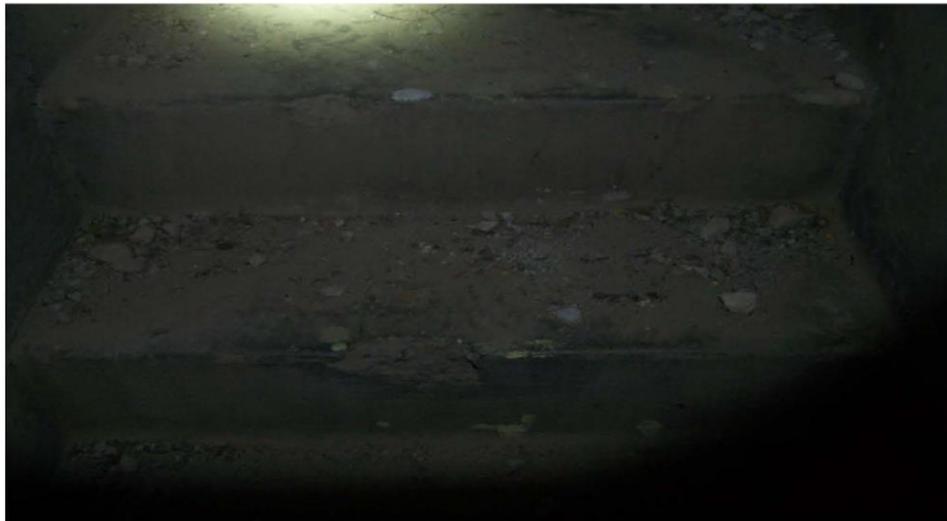
Photo 1

- **North Vestibule-** Lamp burnt out. As a team we determined that based on the portable lights being used at the time of surveillance entries, there is plenty of light in this area and it was not worth the risk of putting an electrician in to re-lamp one light. There is concrete spawling on the steps leading into this basement area. (Photo 1)

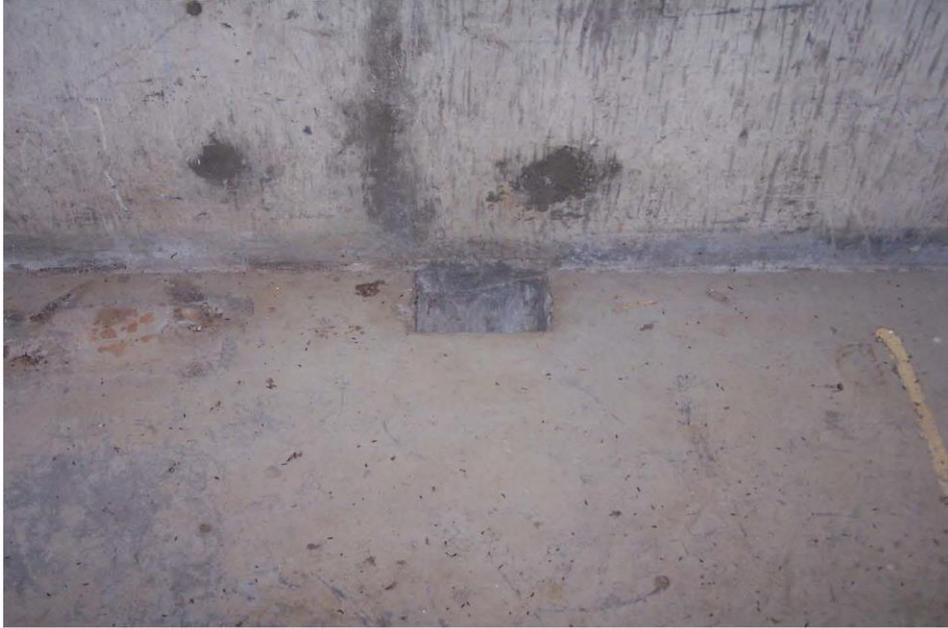
Photo 2

- The ground level was found to be clear. There are 4 holes along the vestibule side wall which are large enough for a foot. They are off of the walk path but worth noting. (Photo 2)

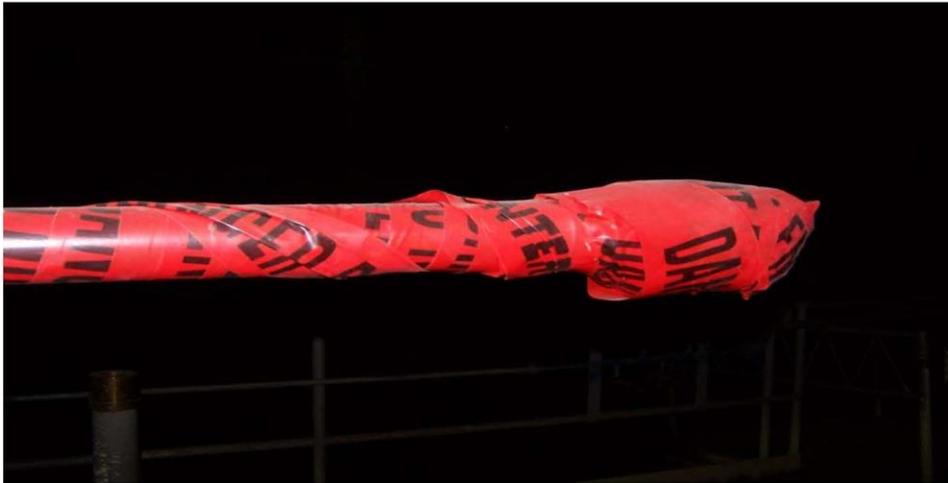
Photo 3

- Rise on top steps of bridge are taller than normal making this small stair case ununiformed.
- Speed rail extends out past bridge when crossing onto the "top hat" area. Rail padded and covered in Red "Danger" tape. (Photo 3)
- "Top hat" floor has approx. 1" rib at seam posing a tripping hazard (Painted Orange). (Photo 4)

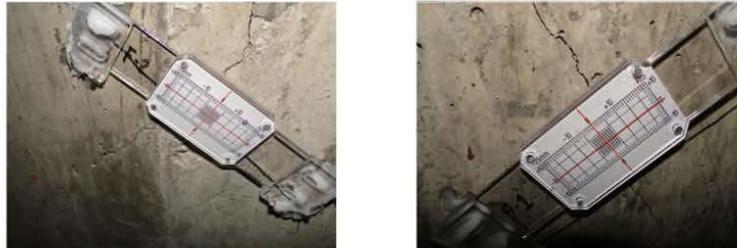
Figure 2 – Affixed Crack Monitors F-2 and F-1 (some parallax is evident in the photos, but straight on flash photos are unusable because of the glare of the flash on smooth plastic surfaces)

ASSESSMENT / ACTION – The fact similar infills / patches appear at all three original production reactor buildings indicates a common purpose (unknown) and design of the infill at some previous point in the facilities life span. This fact also eliminates any concern these cracks were caused by demolition of portions of the reactor building and or construction loading from the SSE.

To confirm that no significant movement is still occurring (or to quantify any future movement) a crack monitoring gauge was affixed on each crack as part of this inspection effort. Initial readings on both gauges (F-1 on the north side and F-2 on the south as shown in Figure 1 above and Attachment C-2 photos 3119, 3124, 3125) was 0-0 as shown. These readings are documented on the close-up photos of F-1 and F-2 shown in Figure 2 following affixing the crack monitors to the concrete wall with epoxy. Photos of the exterior area above the vestibule (similar to Attachment C-6, item 57 and photo 3015) are recommended on the annual inspection and it is strongly recommended that on every subsequent interior surveillance inspection collect and record the readings on these monitors to ensure that this is a stable situation or to quantify any current movement.

1. SSE Structure – address numerous small openings in the steel siding prior to extending the time between inspections.
2. SSE Structure – annually visually monitor the crack above the vestibule and compare to earlier photos.
3. SSE Structure – record crack monitor quantitative information with each SSE entry in the future and evaluate building movement if any reading other than 0 – 0 is observed.
4. Include annual visual monitoring and quantitative record crack monitor readings (items 2 and 3 above) in the S&M Plan requirements when revised.
5. Future use of surveillance routes and S&M Plan revision should be considered to reflect actual conditions / maps in the SSE and to provide guidance when and how Routes 4 and 5 shown in the S&M Plan should be used.

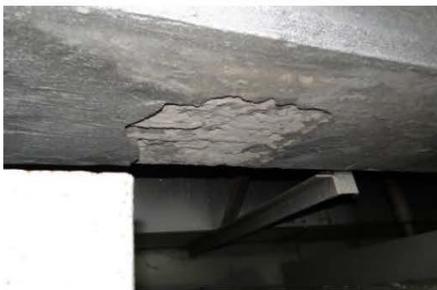
3020 Originally pictured crack in beam unverifiable. Evidence of spalling on underside of beam. Beam to ceiling joint intact. No indication of sagging of beam

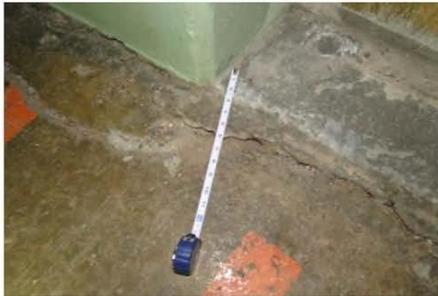
3032 No significant change since 2008

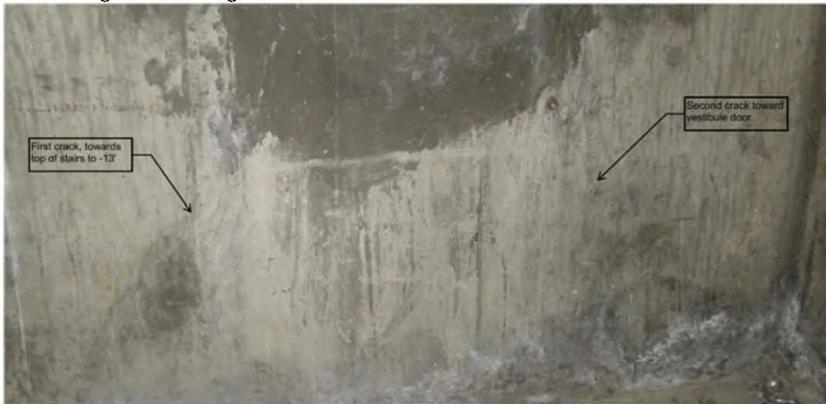
3031 No significant change since 2008.

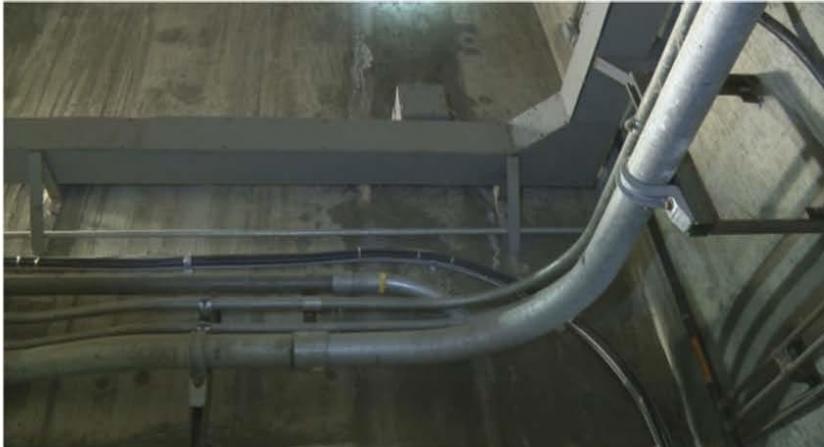
2982 Crack about 8 ft off floor

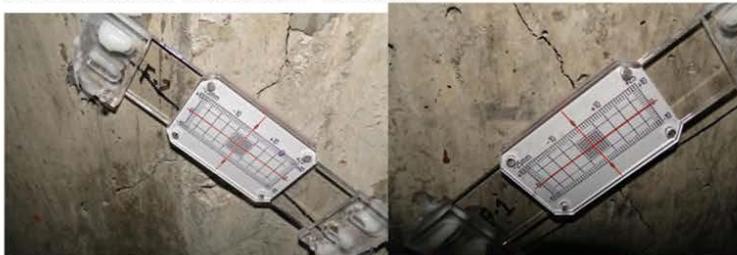
2014 Photo # 2984 Crack about 12 ft off floor

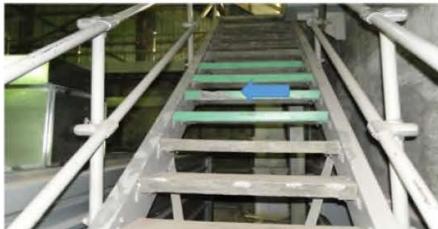
3050 No change since 2008. Safety and structural inspection concur stair is acceptable. Tread measures 10 ½ x 29 ½ x 2 ½ if tread replacement is ever planned.

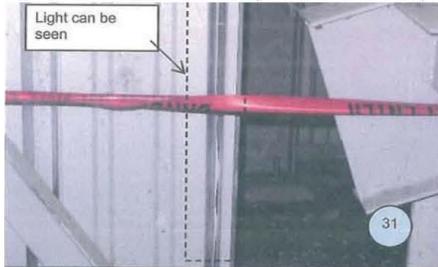
3052 No change since 2008. Safety and structural inspection concur stair is acceptable. Tread measures $10 \frac{1}{2} \times 29 \frac{1}{2} \times 2 \frac{1}{2}$ if tread replacement is ever planned.

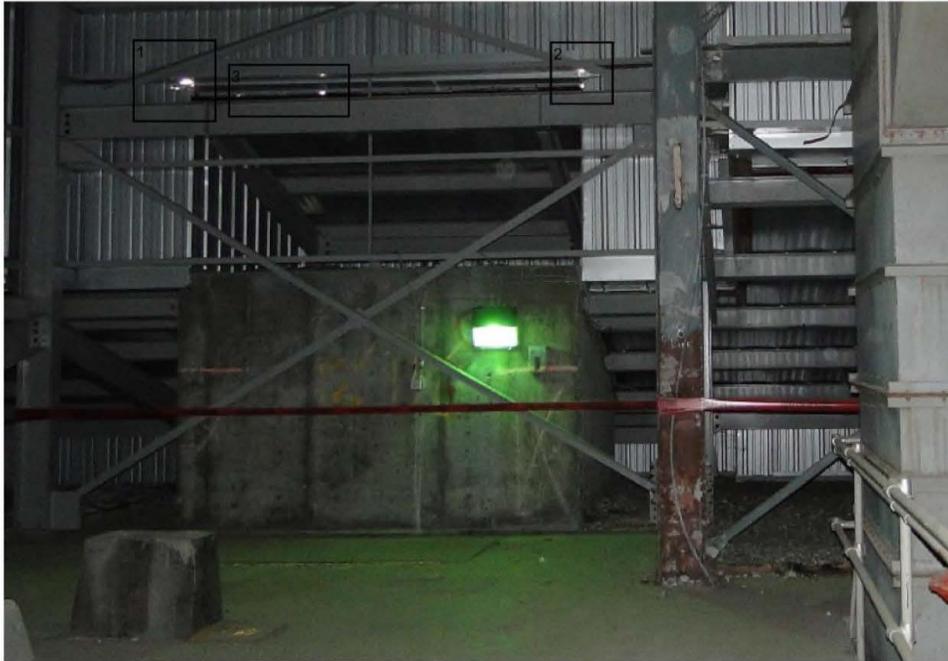
2014 Photo # 3087

2. Observation of SSE metal sheathing at the 56' and 80' levels showed multiple openings at junction points where outside light could be seen – evidence of a possible access point for small birds, bats, insects, spiders, etc. While not every pinpoint of outside light is big enough for bird or bat access, there is ample evidence of some bats being in the structure. If any closure of these openings is considered, timing is an issue with the biological team, but a program of maintenance may be recommended to close off the identifiable openings with a wire mesh or metal fabric from the outside. Adhesive or self-tapping screws with a non-corrosive metal mesh or metal fabric would seem to provide an effective and fast way to inhibit further entries, this approach would presumably use an articulated man-lift of significant size. Additionally, consideration for galvanic corrosion with the galvalum roof / siding materials must be accounted for when selecting a material for closure. The area shown in Attachment C-5, Items 31-34 and photo 3087 are typical instances. Scheduling of any maintenance program should be considered based on the Ref 4 input, and is recommended to be completed prior to extending the SSE surveillance periodicity.

Markup of photo 3087 showing 6 bright spots (outside light in 1 – large, 2- medium and 3-small spots) which are SSE openings to the outside for bat intrusion along one vertical to sloped siding junction. This photo is from the D Elevator area, 56' elevation, and looking west. This particular location shows a bit higher density of openings, but is somewhat typical of various sizes of openings that were observed at the 56' and 80' elevations.

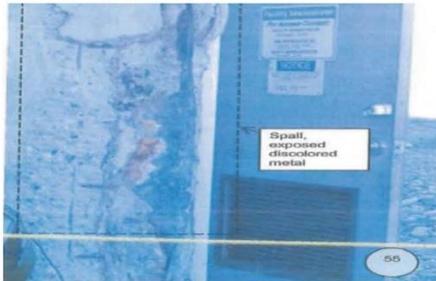
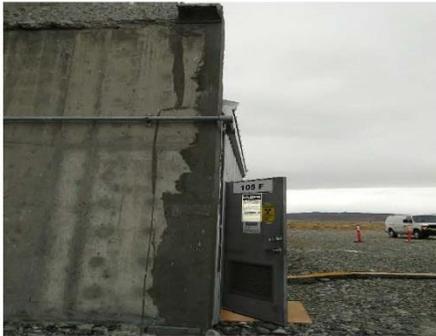
3012 Repair completed between surveillances. Concrete repair not holding up. Patch chipping away in places

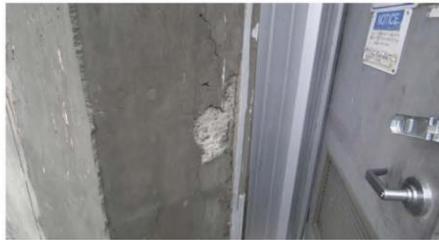
3013 Repair completed between surveillances. Concrete repair not holding up. Patch chipping away in places

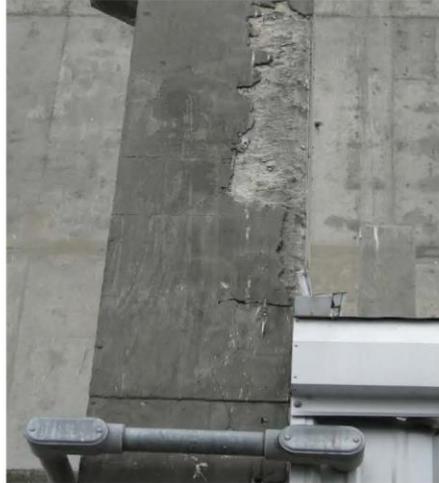
3014 2nd example of same patch failing, just above vestibule door.

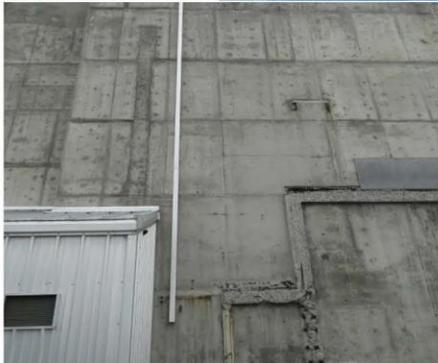
3015 Almost full length crack of south side of pourback. Next to downspout at vestibule. Concrete infill doesn't seem to be adhering to old wall. Crack goes all the way to interior. Refer back to 20A for further information.

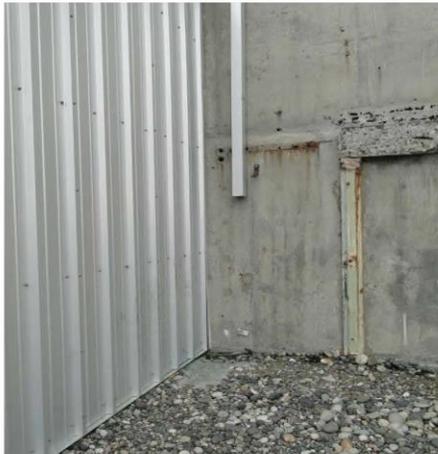
3016 Downspout at corner of building. Interior is dry.

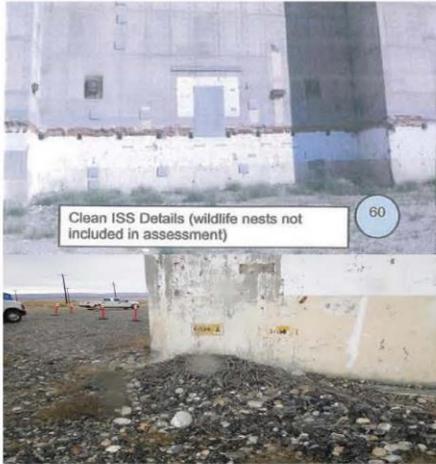
2995 No changes to building condition. Downspouts drain immediately adjacent to building from approx. 75'.

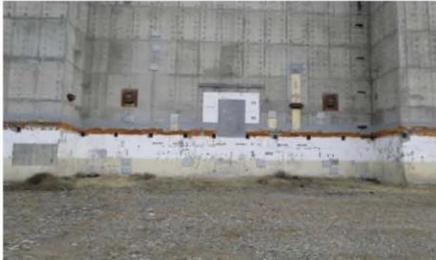
2996 No changes to building condition. Downspouts drain immediately adjacent to building from approx. 75'. Wildlife nests not included in assessments.

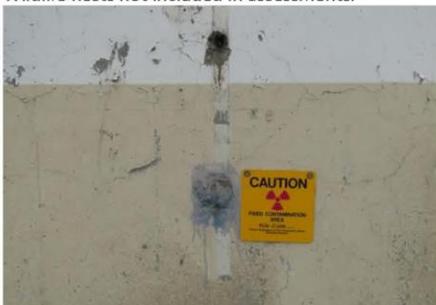
3019 Contamination spot (FCA-F-0001) on south wall. E of fuel discharge area.

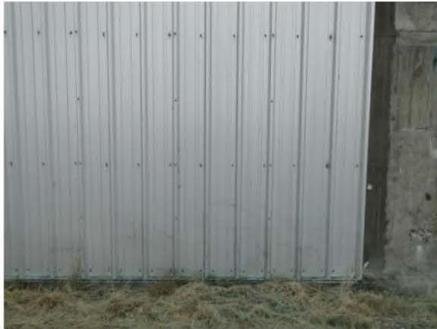
2991 Structural Steel around Route 4 access point was inspected for pattern suggest that "Man Door Knock Out" shown on 0105FDCC0005 / H187254 SHT01

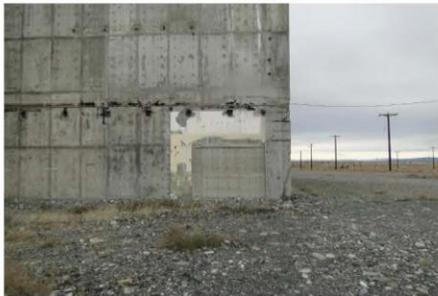
66	3004	Exterior wall detail - existing crack	0'0"	No change since 2008. Verified corner inside front face was dry. Beam pockets. Recommend continuing observation

3004 Verified corner inside front face dry inside . Beam pockets no change

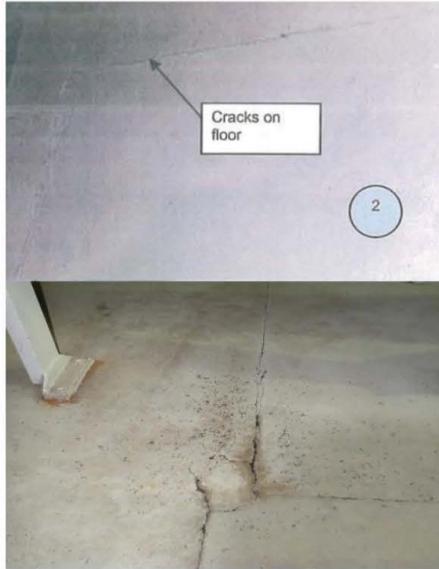
3023 Crack from 2008 was not obvious. No water stains on floor.

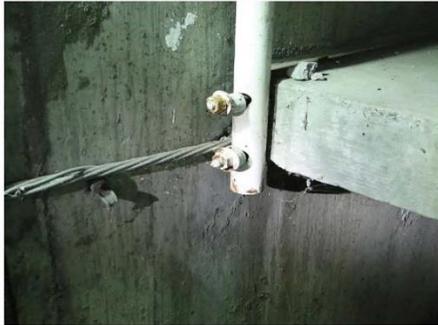
3025 No change. Remove from surveillance.

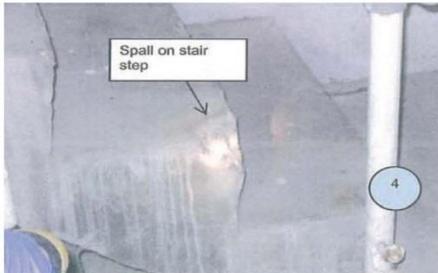
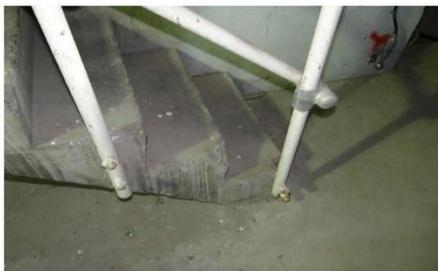
3026 No change since 2008. Remove from surveillance.

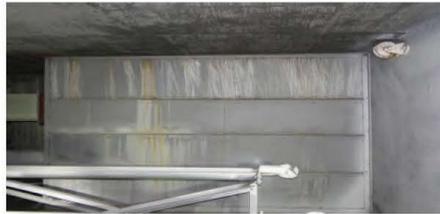
3027 No change since 2008. Remove from surveillance.

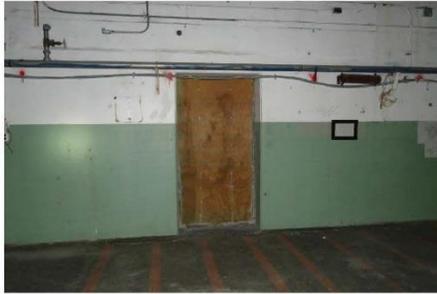
3029 No change since 2008.

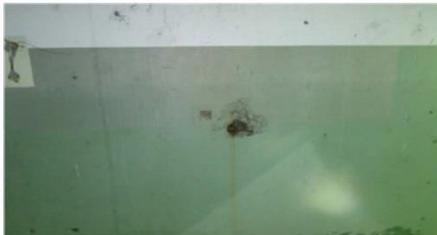
3034 No change since 2008. Remove from surveillance

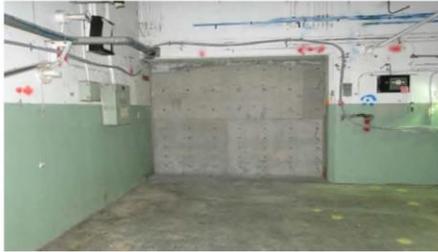
3035 No change since 2008. Dry all around and in corner.

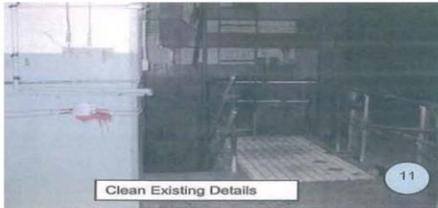
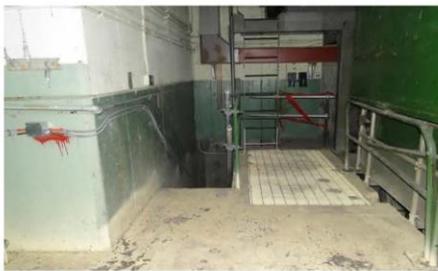
3037 No changes since 2008.

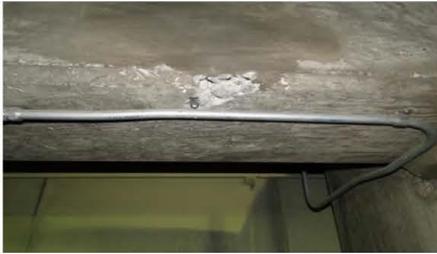
New Item 11A

3038 New spalling location to add to surveillance. No evidence this is new condition. Was not on surveillance route prior to 2014.

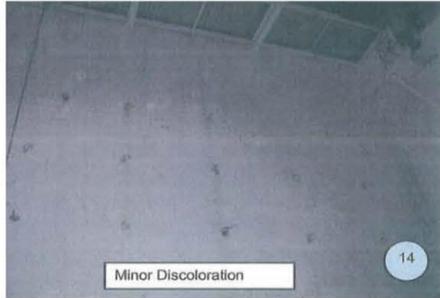
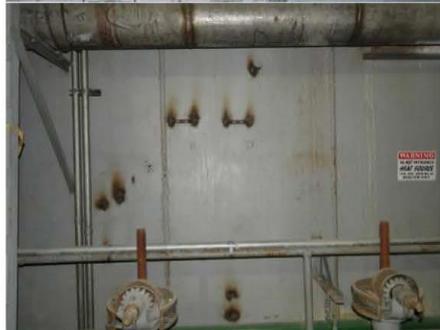
3040 No change since 2008.

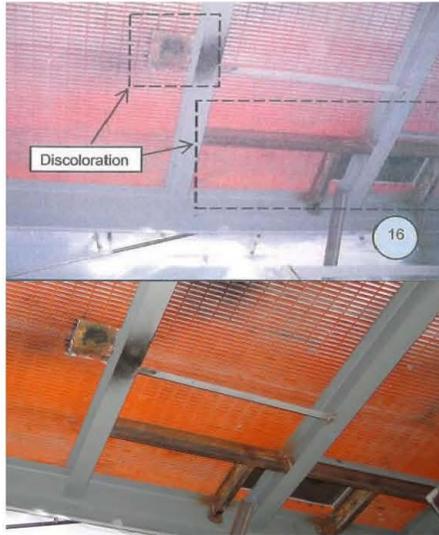
3031 No change since 2008

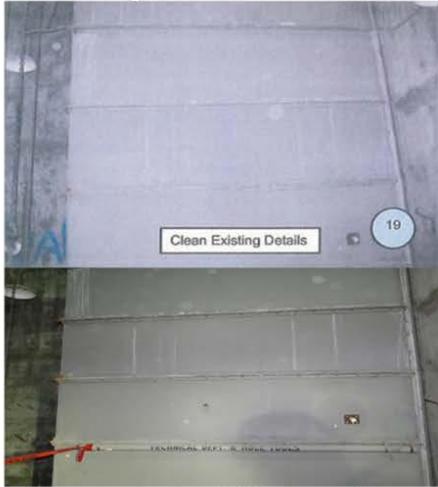
3044 No changes since 2008. Remove from surveillance.

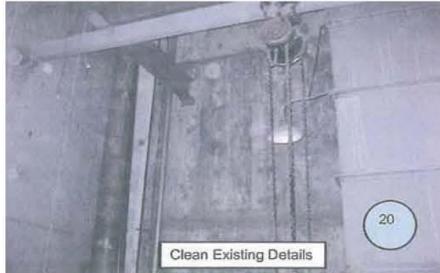
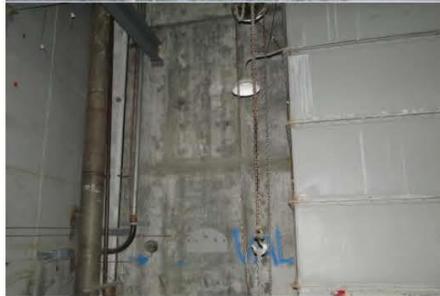
3045 No changes since 2008. Remove from surveillance.

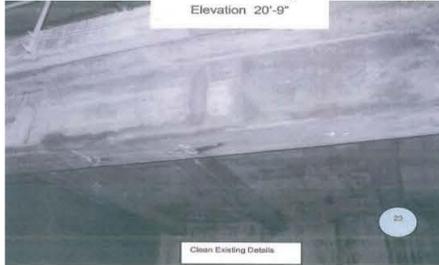
No new photo. No change since 2008. Remove from surveillance.

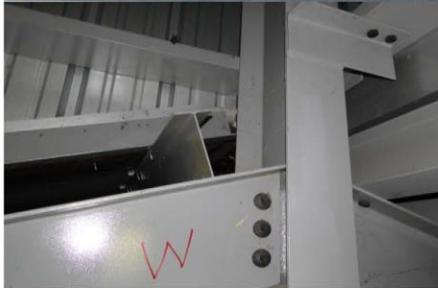
3053 No change since 2008. Opening to exterior

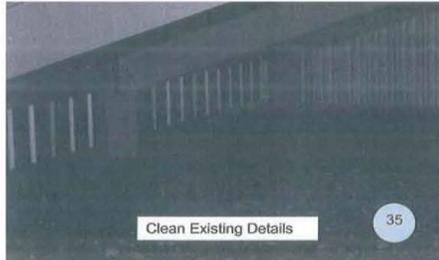
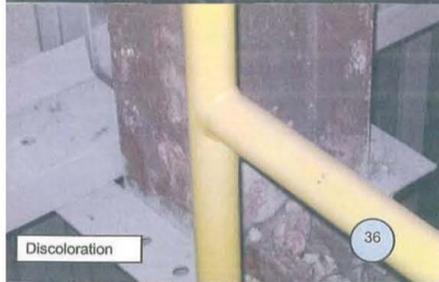
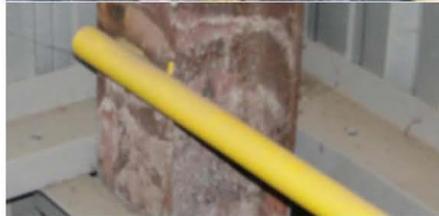
3058 Discoloration is determined to be grout stains from CMU infills. No change since 2008. Remove from surveillance.

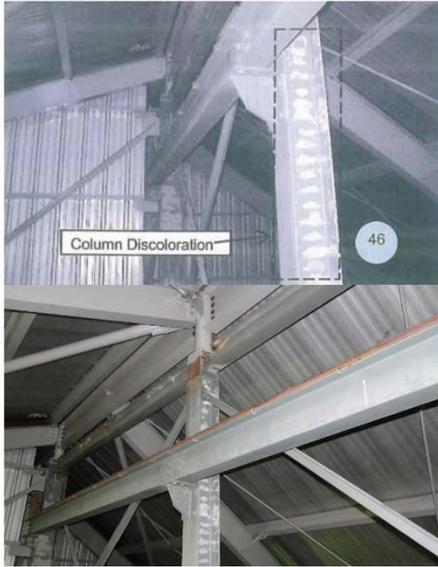
3066 no change since 2008. Discoloration confirmed to be grout stains from original CMU infill or Aged Red Lead coating. Remove from future surveillance.

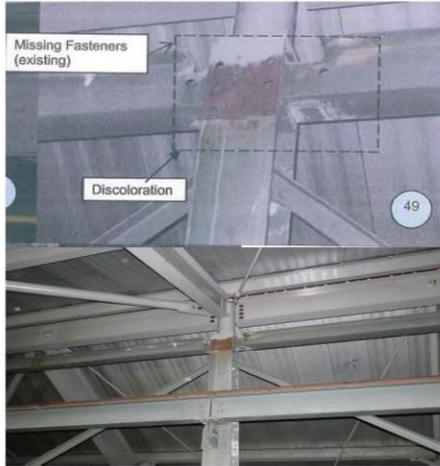
3067 Rivots removed as part of SSE Construction. No change since 2008

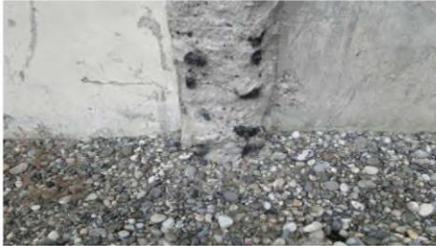
3008 Sometime between surveillances work was completed to cut rebar ends and paint the ends

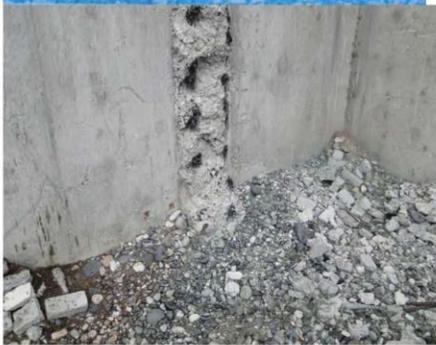
3009 Sometime between surveillances work was completed to cut rebar ends and paint the ends

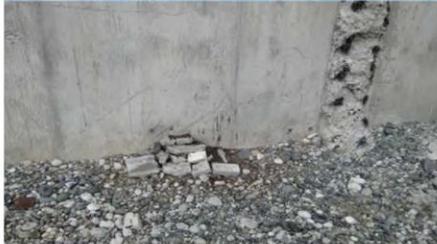
3010 Picture shows location better than previous... Work completed between surveillances buried rebar under concrete debris and guano from bat habitat.

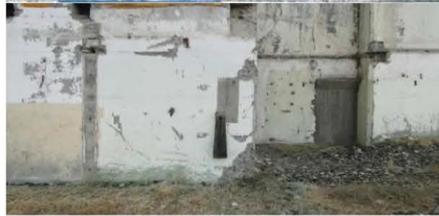
3018 No change in building condition. No reason to continue future surveillance. Birds nest on SW corner of building.

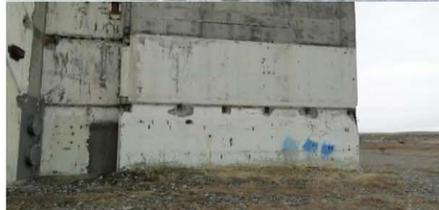
2997 No change since 2008

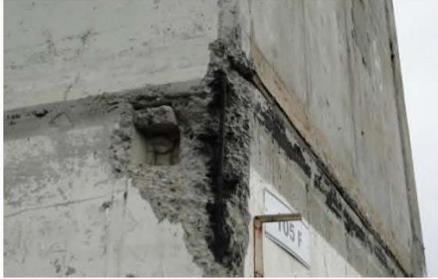
2998 No change to spalling at beam pockets. Rebar exposed at corner in very good condition painted black.

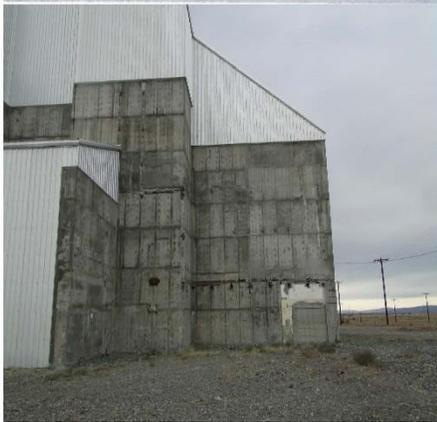
3001 Rt 5 Access very good shape.

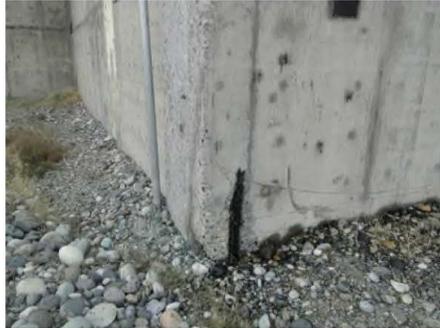
3005 No change since 2008. Verified corner inside front face was dry. Beam pockets.

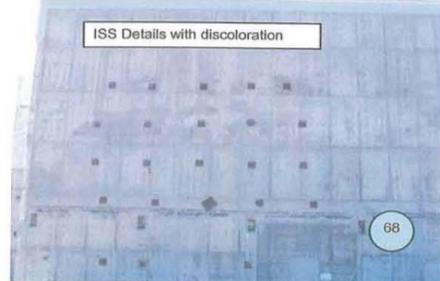
3006 No change since 2008. Verified corner inside front face was dry. Beam pockets.

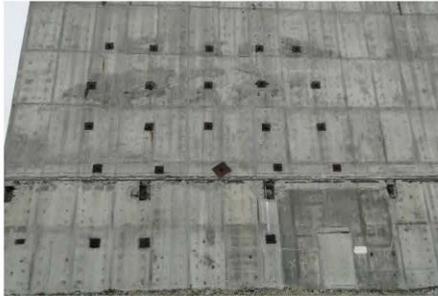
3007 No changes since 2008

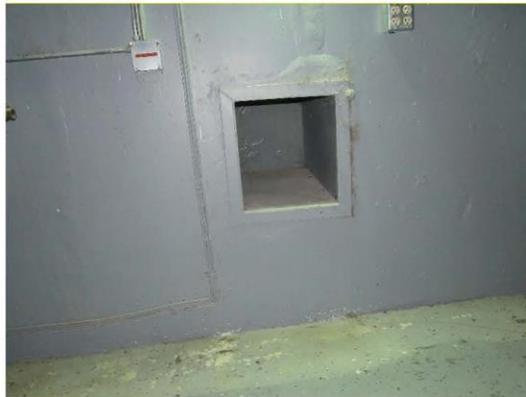
Figure A-1 – Front Face opening interior

- Attachment A Figure A-1 and Attachment C-1 photo 3464 shows a 24" by 24" opening in the concrete west wall of the front face that is only closed by a bolted plate (just N of the vestibule). With a wrench or ratchet, the plate could be removed in a very short time and access to the interior of the SSE could be gained. Per Section 2.1.5 of Ref 4, any remaining entrances will be welded shut. It is recommended that this item be addressed in the near term.

construction did not remember any reason for or approval of a deviation to plate this opening versus a pour-back that would have met the SSE design criteria listed in Ref 4 for an opening of that size within 10' of outside grade elevation. This area was photographed in the previous WCH inspection report – with no record of concern for this item. It may be that the previous inspection team had good reactor and structural knowledge, they lacked the historic background and security basis for the pourback versus plate decision making used during design and construction of the SSE.

ASSESSMENT / RECOMMENDED ACTION – While there is a risk of unauthorized access introduced by this item, and regulator and public confidence issues would result from an authorized entry, significant public safety risk (real health and industrial / radiological safety harm) is minimal given the very good conditions inside the SSE. However, there are easy actions to remove the risk completely short of installing a concrete pourback per the original design. Polestar recommends that when the SSE is closed, the same weld material used for the doors in

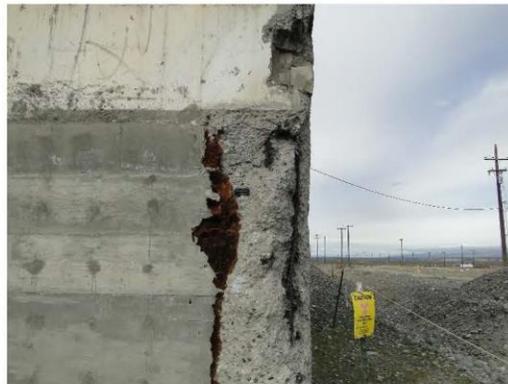
Figure A-3 – Foam Entrained in Pourback at Northeast Corner of SSE

1. The pourback at the front face on the NE corner of the building (shown in Figure A-3 and included in Attachment C-5 Item # 68 and new photo 3491) includes a portion that is polyurethane foam and is badly weathered. This is not a structural issue since the inside of this pourback was observed to be dry and well-sealed. Rather it only begs a question since it is so obvious and upon close inspection is weathered so badly. At some point, scraping out the old foam and painting this area may be a prudent action just to preclude future questions.

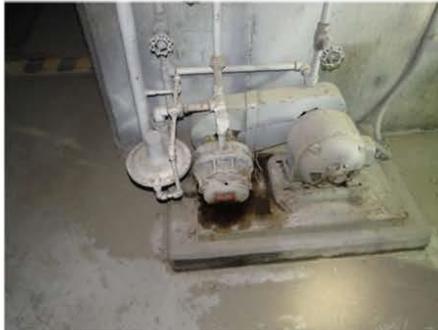
3405 Decon Room @ 0' - Minor oil weeping into tray

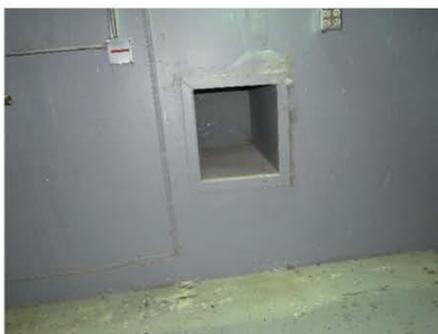
Item # 1 2010 Detail Interior Elev. 0'0 Wall

3464 Possible unauthorized personnel access point to front face.

#	New Photo #	Description	Area / Location	Future Inspection/Maintenance Recommendations
Item # 1	3464	Wall	Interior Elev. 0	Recommend welding 2 opposing bolts on exterior face. Possible unauthorized personnel access point to front face.
Item #6	3466	Pipes and Wall	Interior Elev. 0	Includes netting @ ceiling that catches debris above front face area Recommend continuing observations
	3405	Decon Room @ 0'	Interior Elev. 0	Minor oil weeping into tray Recommend a catch bowl with absorbent
	3467	Plywood glued and bolted to ground to cover CA	Interior Elev. 0 Front Face	Recommend continuing observations Note** no picture but dry at bottom of C elevator shaft
	3468	Wall vent and ceiling structure/vestibule	Interior Elev. 0 Vestibule	Possible Weather Protection issue. Previous evidence of water intrusion but no entry point seen. Could be weather protection issue

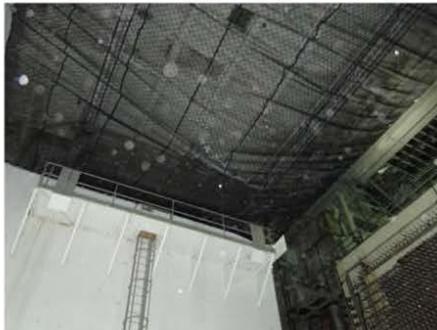
3466 Includes netting @ ceiling that catches debris above front face area.

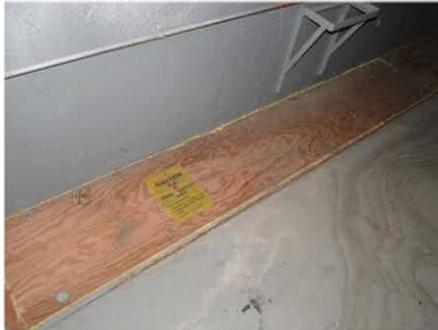
3467 Plywood glued and bolted to ground to cover CA
Note*** no picture but dry at bottom of C elevator shaft

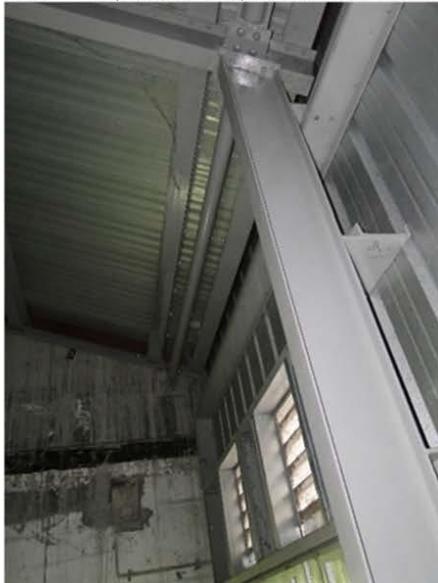
3468 wall vent and ceiling structure in vestibule—previous evidence of water intrusion but no entry point seen.

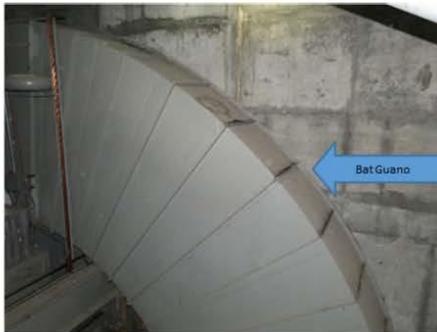
#	New Photo #	Description	Area / Location	Future Inspection/Maintenance Recommendations
	3422	Bat Guano accumulating on vent duct flange from stairs on way up to 42' level	Elev. 42' 5"	As seen from stairway to 42' elevation Recommend continuing observations.

3422 Bat guano accumulating on vent duct flanges.

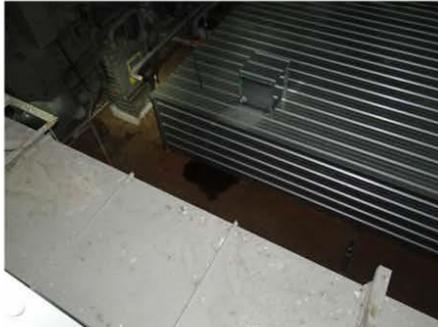
3441 wet spot @ 42' from dripping winch @ 80' level as seen from 56' walkway

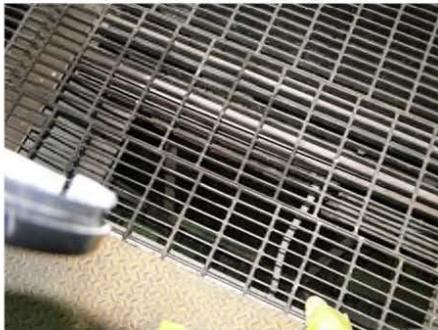
3456 Leaking winch @ +79 elevation below NE corner of diamond decking @ 80' elevation

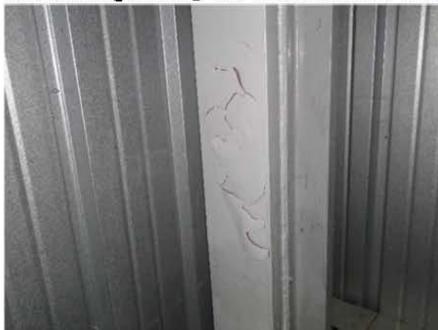
3445 Peeling paint on beam along east wall.

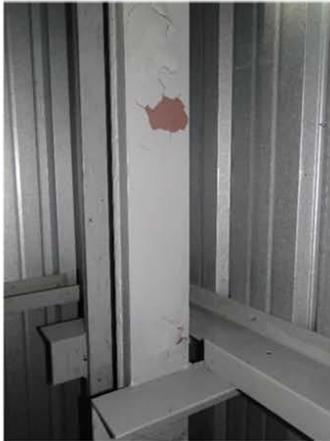
3446 Red undercoat in good condition after large blister picked off.

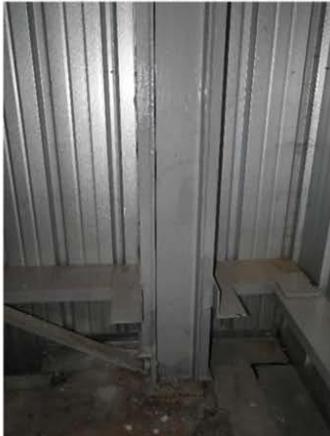
3447 Blistering/peeling grey paint. Detail of original column with modifications as part of SSE.

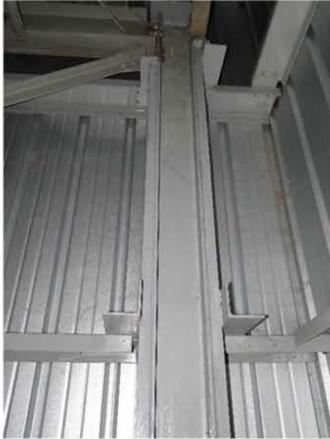
3448 Detail of original column with modifications as part of SSE.

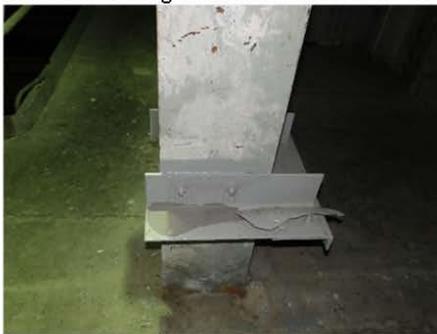
3450 Peeling paint on support. Red undercoat in good condition.

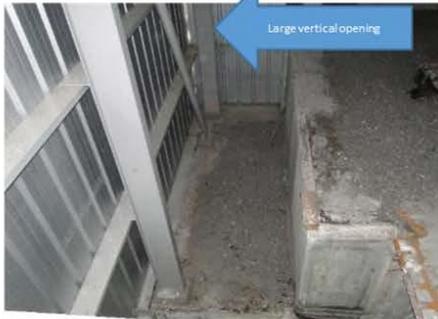
3454 Prior Roof sections east side from 80' elevation. Space is clean and dry with no visible issues other than siding issue.

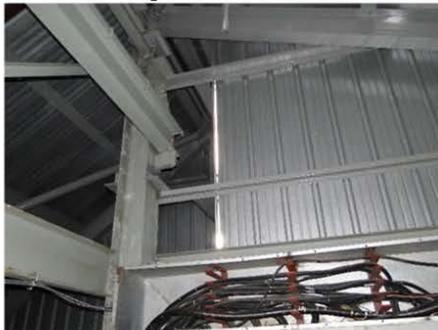
3455 10-12 feet long x 1" open gap at interior corner of structure. Animal/bird/pest intrusion point

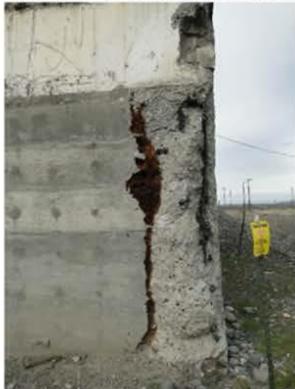
3491 - No visible change to condition. Suspected existing foam joint material. No evidence inside of deteriorating condition.

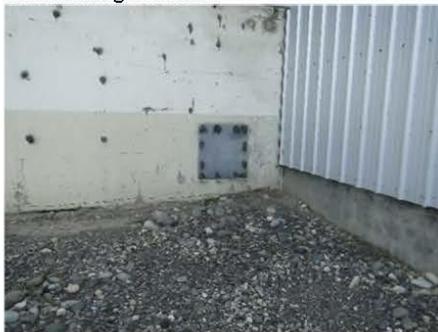
3. **West Wall of the Front Face**
 CONDITION - Through the 3' thick SSE wall just to the North end of the vestibule structure (Figure A-1 and left side of Figure A-2) is a metal plate affixed to the outside over a full penetration opening that is about 24 inches square. This raises a security issue (and a deviation from the original design criteria of the SSE) since simply unbolting this plate would provide unauthorized access to the SSE interior. This area is shown below and is included in Attachment C-1, photo 3464 (inside) and in Attachment C-5 photos 3476 and 3477 (outside).
 INVESTIGATION – The Bechtel Hanford construction Subcontract Technical Representative (Daryl Schilperoort) that covered the construction contract for the SSE

3476 exterior of view 3464 not sealed properly. At least 2 opposing bolts need to be welded shut.

the vestibule be applied to form a complete weld around the exposed threads (Figure 2) on three bolts on this plate – evenly spaced on the North side, top and South side of the plate. No strength is required of the weld material on the Hilti-bolt / nut junction, rather the weldment would damage the threads enough to prevent easy removal of these three nuts, thus effectively removing the possibility of a quick unauthorized entry. Grinding weldment and a wrench could still remove the plate with more planning and time – but then it’s more an act of planned vandalism than a quick entry with as little as an adjustable wrench available on many boats in the river.

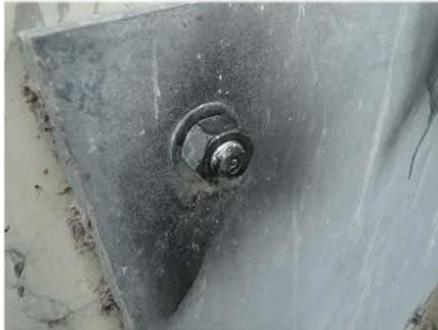
3477 bolt on metal cover plate. Recommend welding.

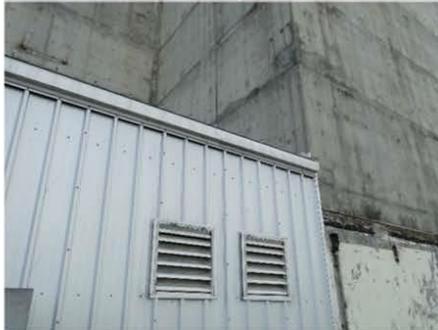
3478 exterior view of 3468
Reported water entry—no defects seen.

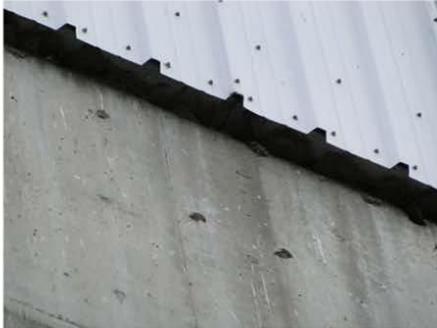
3481 100's of birds building mud nests under ledge at seam locations around entire bldg.

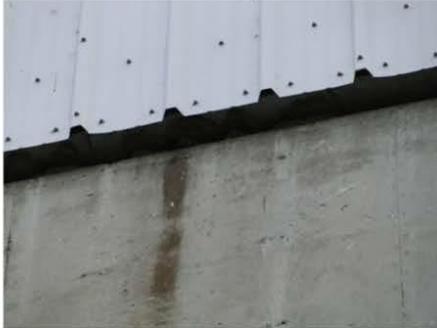
3481	Seam of roof/concrete structure	Exterior perimeter	100's of birds building mud nests under ledge at seam locations around entire building.
	3482	Seam of roof/concrete	Exterior perimeter	100's of birds building mud nests under ledge at seam locations around entire building. Recommend continuing observations
	3484	Cracked concrete on pourback	SW corner	Cracked concrete on pour-back. Does not appear to be an issue but should be watched. Recommend continuing observations
	3485	Bird feces on metal cap	Building exterior	Lots of bird feces on metal cover caps Recommend continuing observations
	3489	Birds on building seam	Building exterior	Birds nesting on seam between metal roofing and concrete Recommend continuing observations

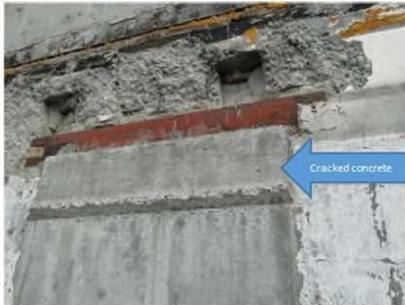
3484 cracked concrete on pour back-does not appear to be an issue but should be watched.

3484 Blow-up of crack on pour back near SW corner of building.

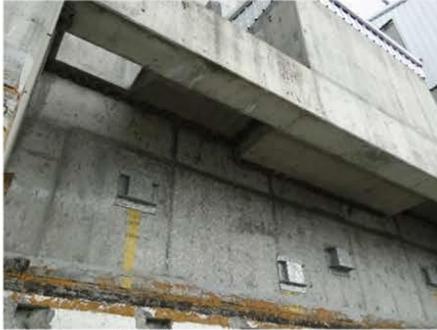
3485 Lots of bird feces on metal cap covering.

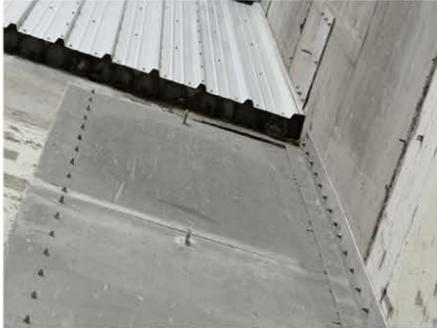
3489 Metal cover plate with birds nesting above.

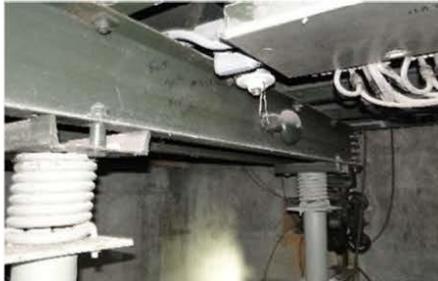
3400 No visible issues

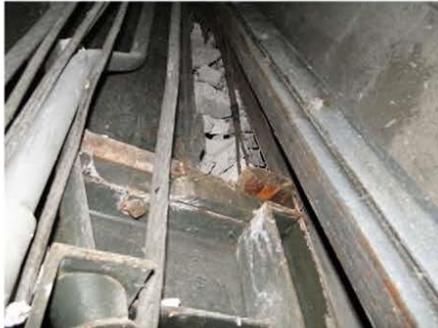
3401 Rubble at bottom of elevator shaft Looking up shaft

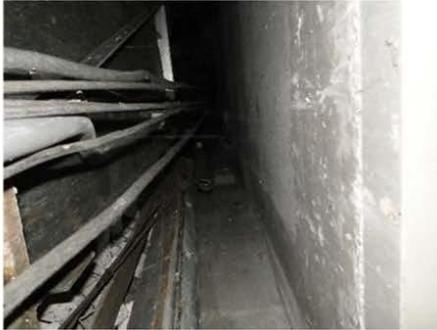
3402 Looking up Elevator shaft. No visible issues.

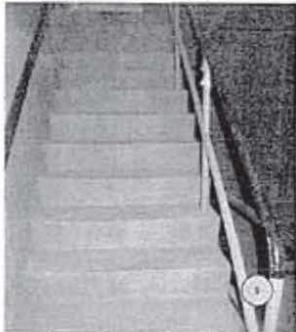
Item # 9 2010 Detail Below Grade 1 -15' Interior Stairs, No visible issues

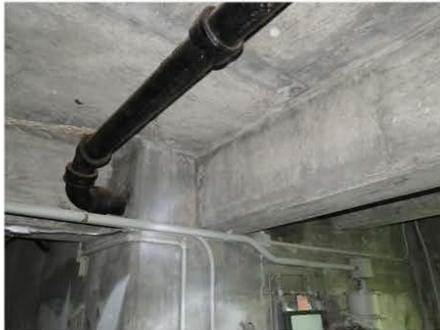
Item # 13 2010 Detail Below Grade 1 -15' Ceiling to wall Joint, discoloration
