Five-Year Surveillance Report for the 105-C, 105-D, 105-H, 105-F and 105-N/109-N Safe Storage Enclosures

Document Type: RPT

D. G. Ranade
Mission Support Alliance

Date Published
March 2016

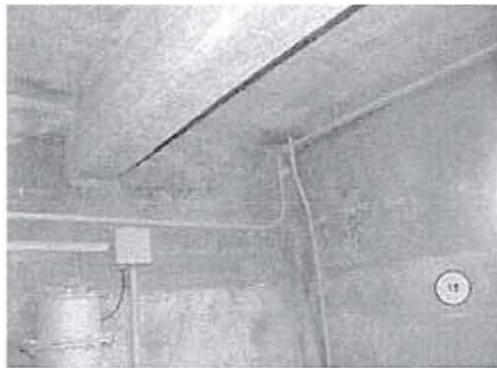
Item # 14 2010 Detail Below Grade 1 -15' Ceiling and Wall, No visible issues

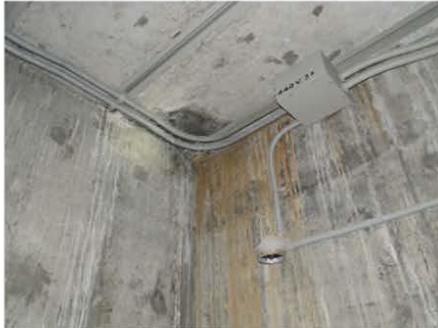
Item # 15 2010 Detail, Below Grade 1 -15' Ceiling Beam and wall, no visible issues

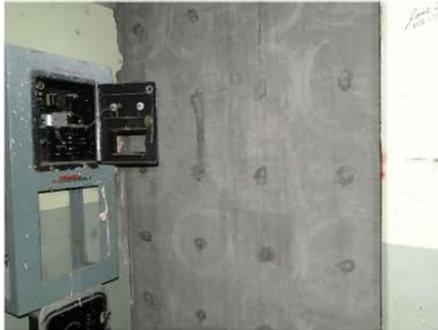
3406 Pour back in good condition

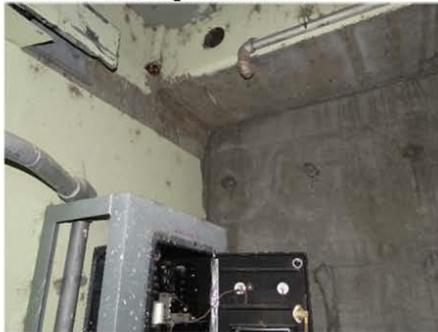
3407 Interior very dry

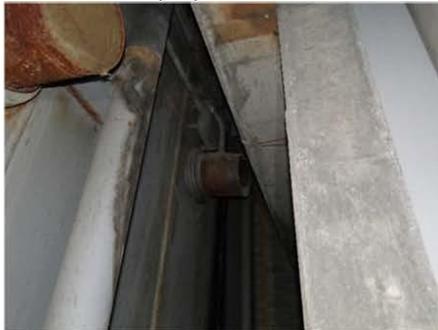
3409 Block isolation Reactor to rear face. No visible issues.

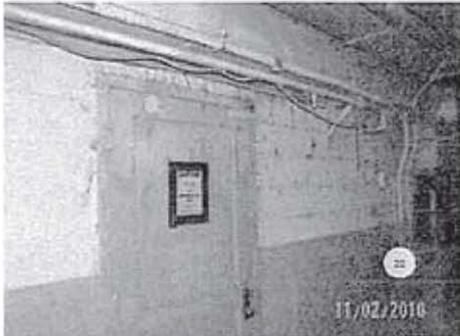
Item # 19 2010 Detail elev. 0, Ceiling Beam and Wall, No visible issues

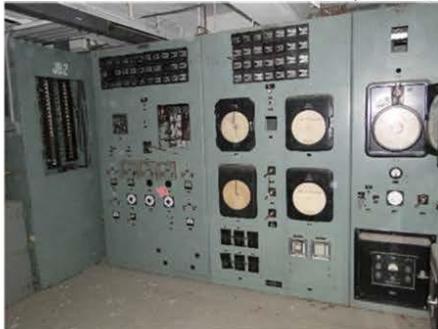
3414 12' Elevation. No visible issues.

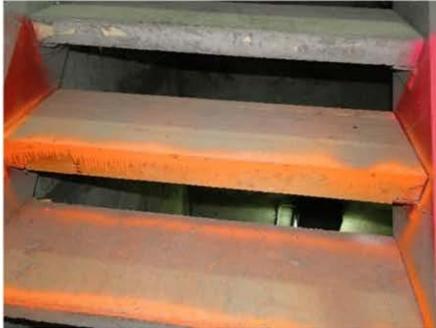
3415 on way up to 22 foot level. Wood stair in good condition

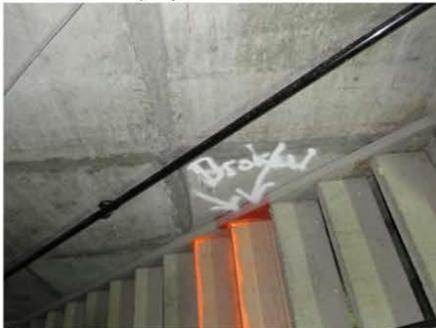
3417 Historic mark on wall. Stair has been replaced and is in good condition

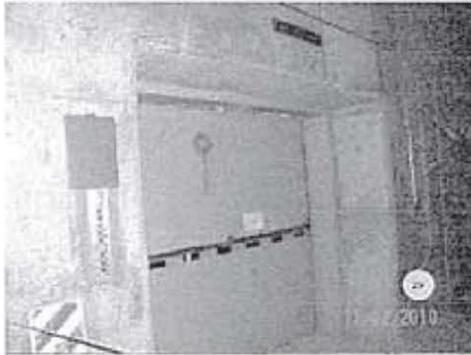
Item # 29 2010 detail Elevator No visible issues

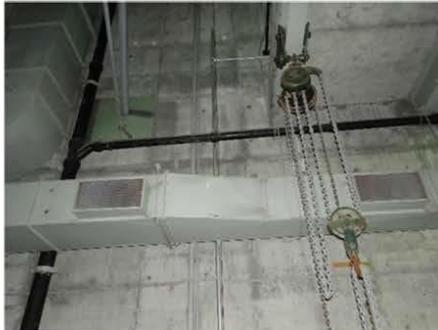
3419 Dry/Clean with no visible issues.

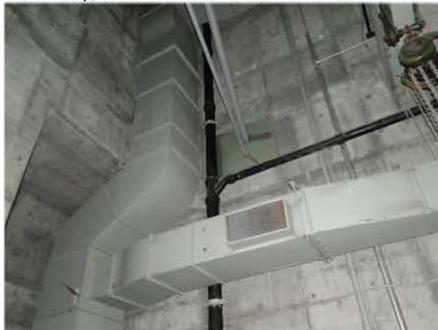
3420 Dry/Clean with no visible issues.

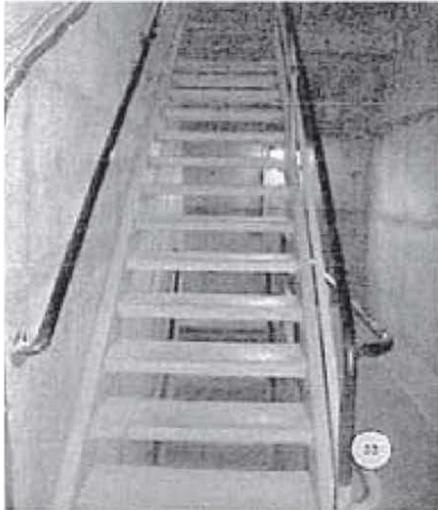
Item # 33 2010 Detail Stairs, loose steps

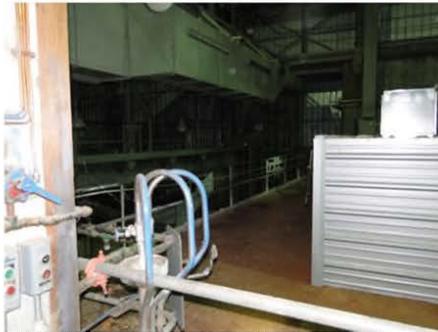
3425 42' level detail No visible issues.

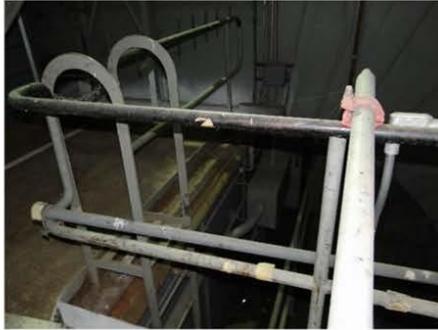
3426 42' level detail No visible issue.

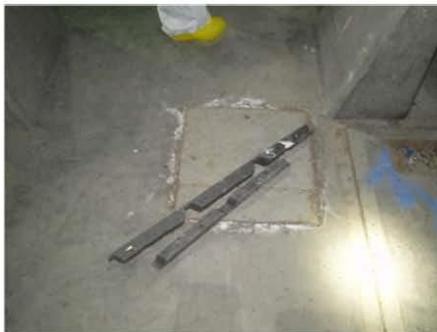
3428 Foam pieces on floor from roofing project.

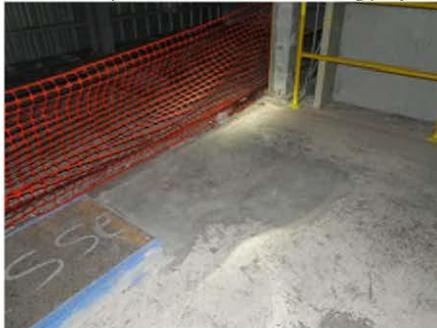
3429 Detail of roofing/floor construction. No visible issues. Comparable condition in a number of SSE Structures.

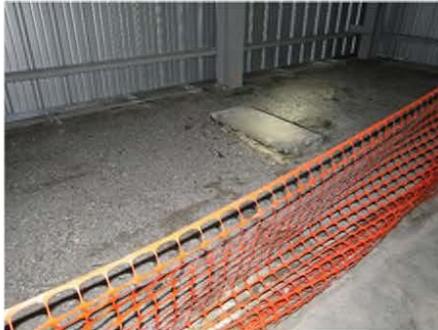
3430 detail of roofing/floor construction. No visible issues. Comparable condition of a number of SSE Structures

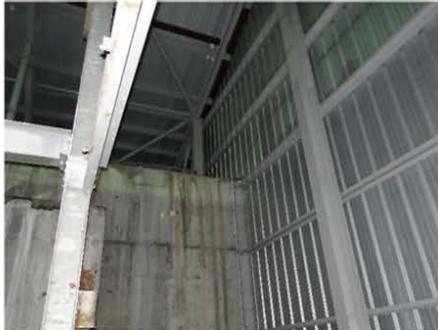
3432 Clean and Dry. No visible issues.

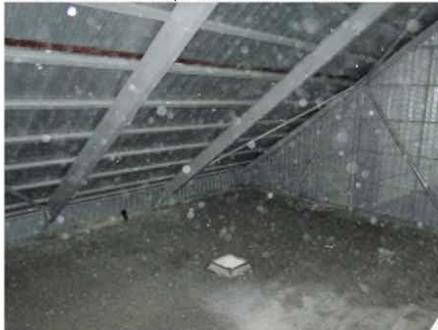
3433 Looking down onto old roofing structure—dirt in the air. No visible issues.

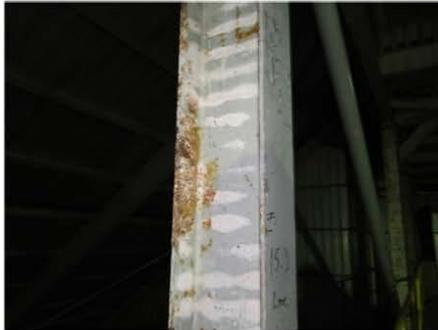
3440 Beam detail with mortar stains from masonry infills. No visible issues.

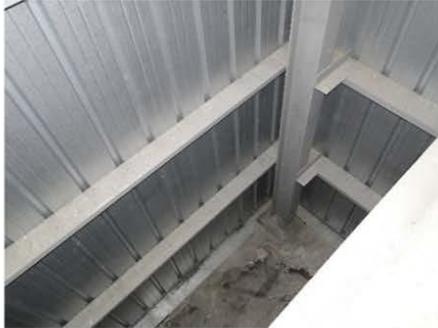
3444 Clean/Dry interior detail. NE corner along E wall 42" elev. As seen from 56'

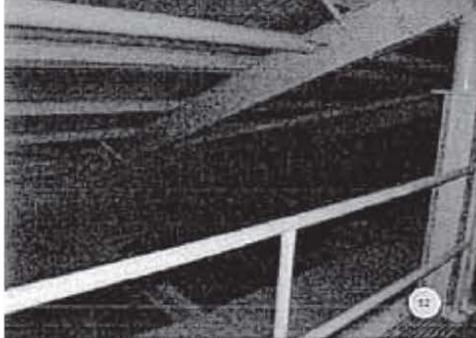
Item # 52 2010 Detail ISS Steel Column, Roof and Beam Detail, No visible issues

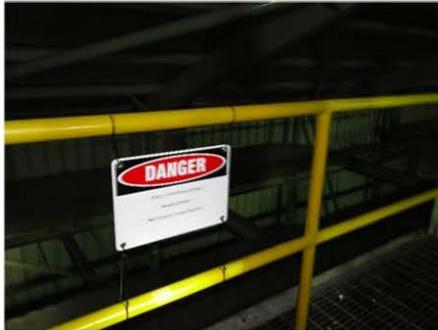
3451 Old pics 52, 53, 54, 55 general area detail. No visible issues

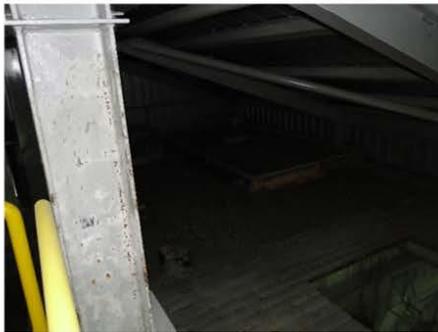
3452 80' elevation. General area detail. No visible issues

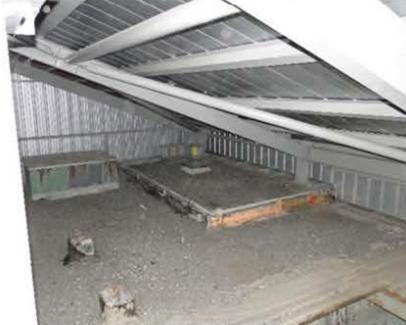
Prior roof SE corner from 80' elevation. Clean/Dry No visible issues.

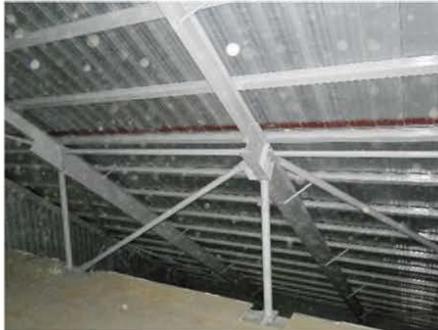
3457 General area detail. Clean/Dry. No visible issues.

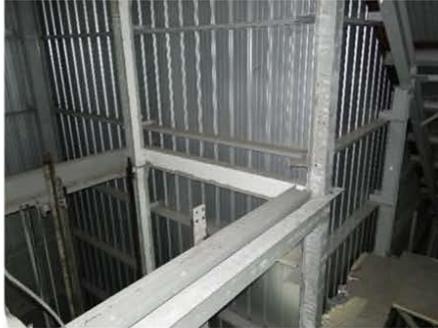
3458 General area detail Clean/Dry. No visible issues.

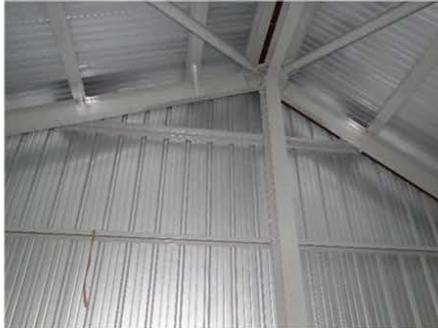
3459. General area structure. Clean and Dry. No visible issues.

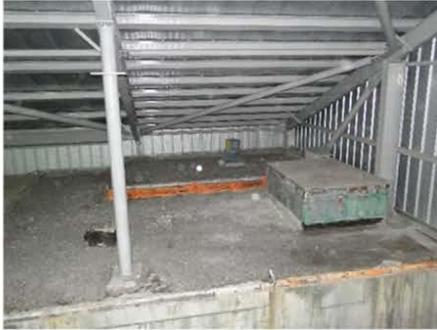
3460 Prior Roof SW corner as seen from +80' elevation. No visible issues.

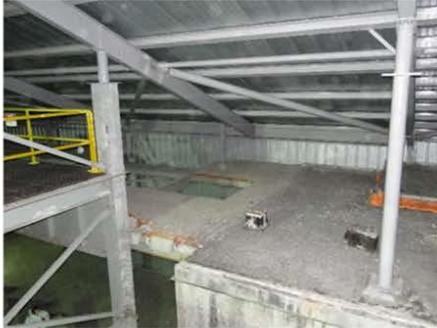
3461. Prior Roof W corner as seen from +80' elevation. No visible issues.

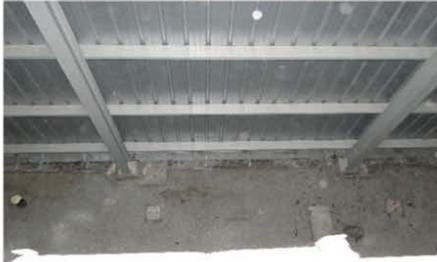
3462 Prior roof W corner as seen from +80' elevation. No visible issues.

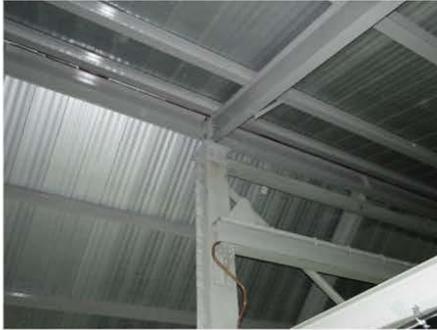
3463 General area structure detail. Clean and Dry. No visible issues.

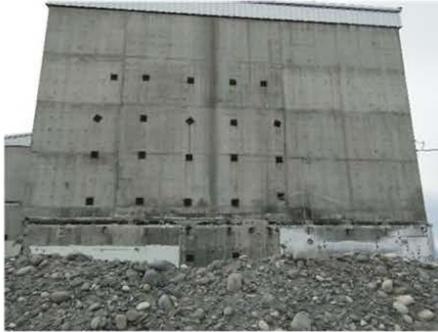
3493 No visible change to condition

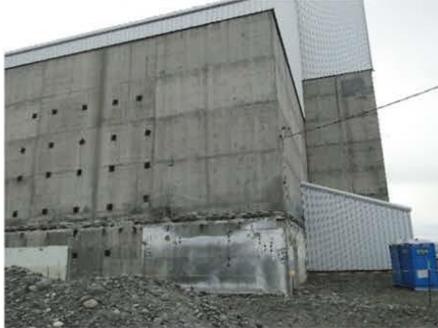
3494 No visible change to condition

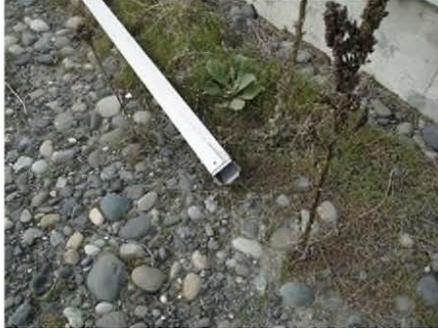
3495 Close up of fallen downspout piece. Connection piece still intact. No visible change

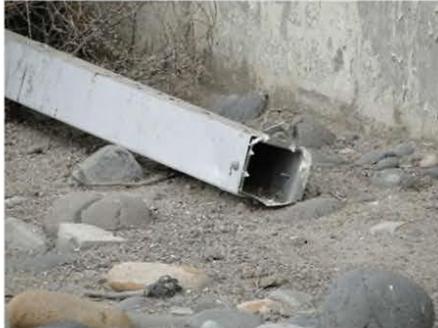
3496 Close up of fallen downspout piece. Connection piece still intact. No visible change

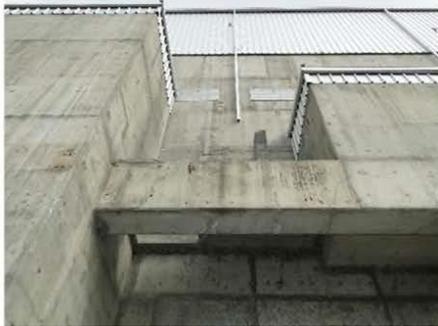
Item # 73	3487	Possible weather protection issue. Small amount of erosion from downspout runoff..
Item # 74	3488	Possible weather protection issue. Small amount of erosion from downspout runoff..

3487 Possible Weather protection issue. Small amount of erosion from downspout runoff

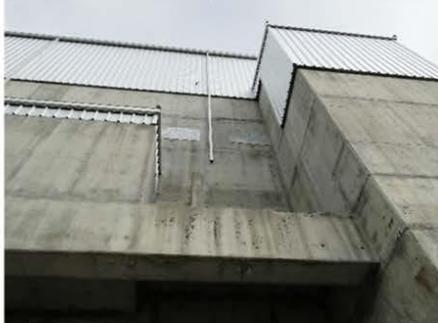
3488 Possible weather protection issue. Small amount of erosion from downspout runoff

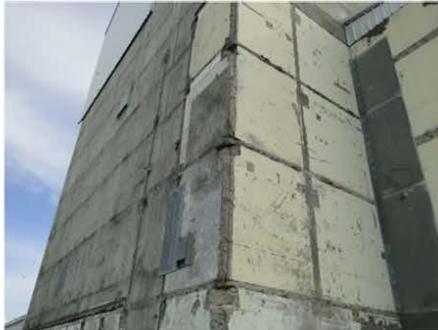
3483 spalled concrete around entire building in very good shape, no noticeable degradation/excessive rebar corrosion since original project.

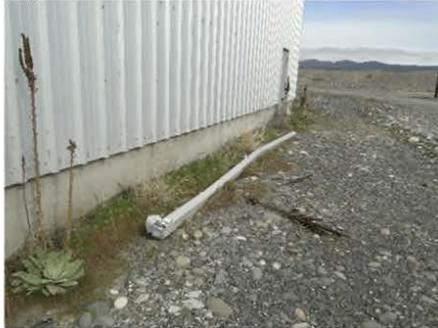
3490 2nd piece of broken downspout from S exterior wall

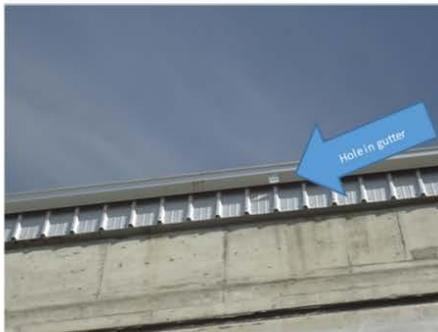
4989 shows hole in gutter where downspout was placed on left side of bldg

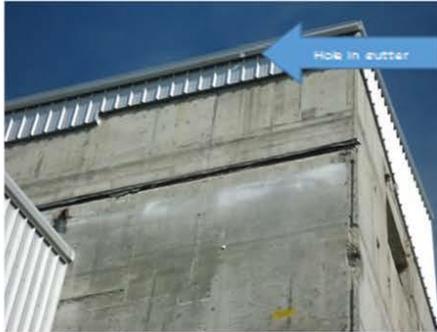
4986 shows hole in gutter where downspout was placed on left side of bldg

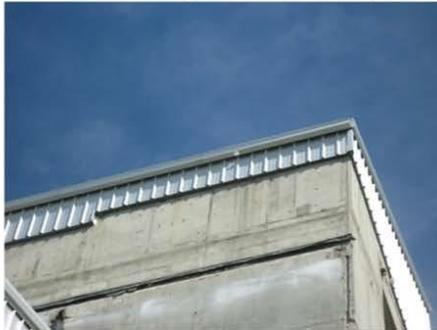
4986 shows where downspout should be returned to left side of bldg.

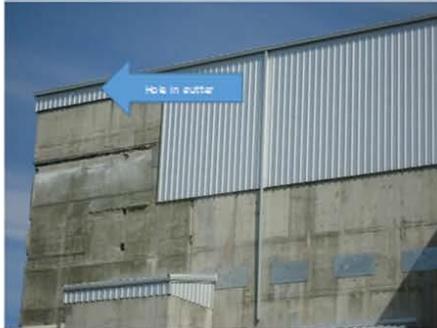
4983 shows hold in gutter where downspout was placed (on right side of bldg)

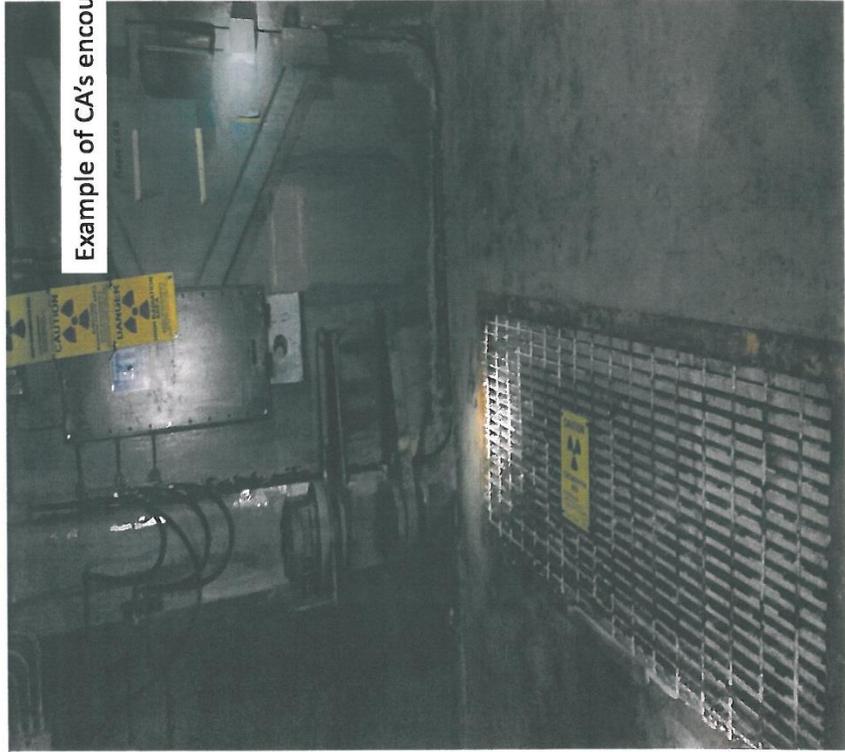
Example of CA's encountered through out facility inspection

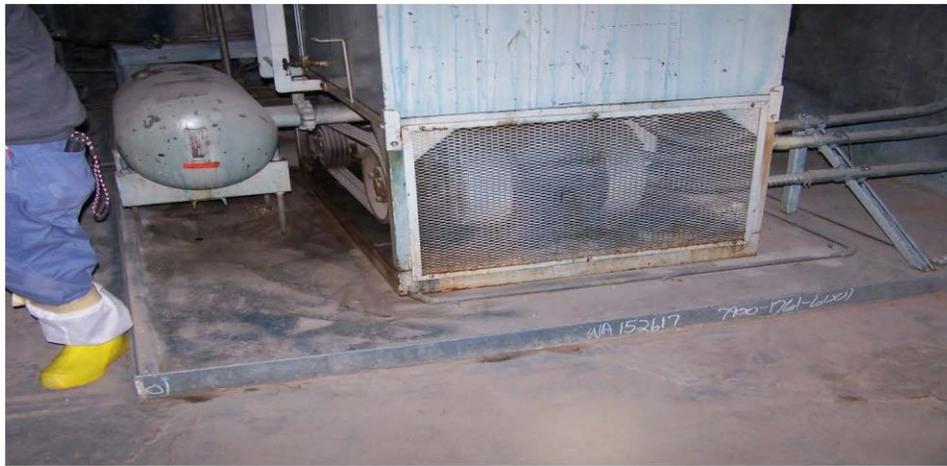
Photo 1

- Trip hazard around equipment caused by drip pan. (Photo 1)
- Trip and struck by hazards around piping. (Photo 2)
- Struck by and sharp object hazards from 2 step platform. (Photo 3)

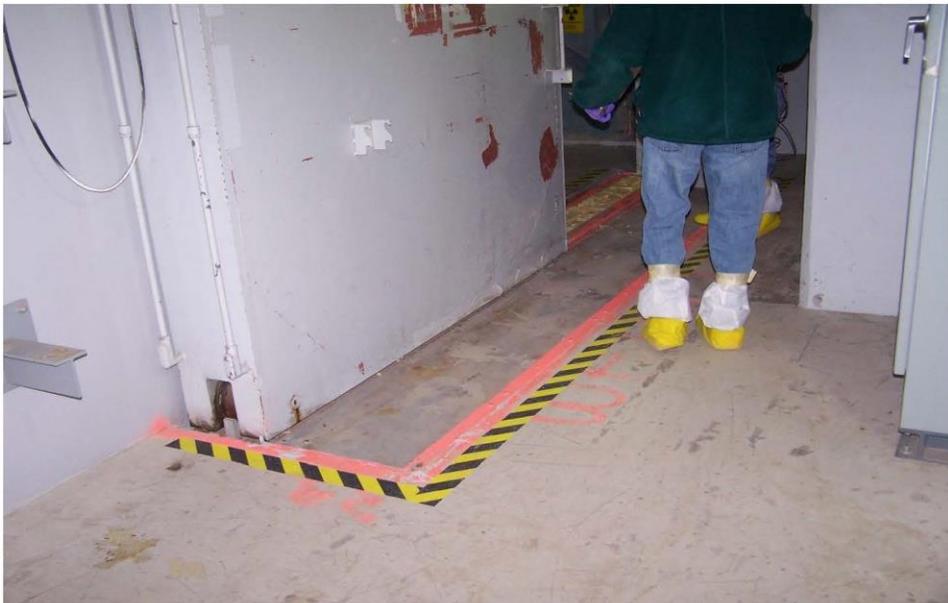
Photo 4

- (Room 401)- Tripping hazard caused by trough for door 403. (Photo 4)
- Overhead hazard caused by piping in stair well between 28' and 40' elevations. (Photo 5)

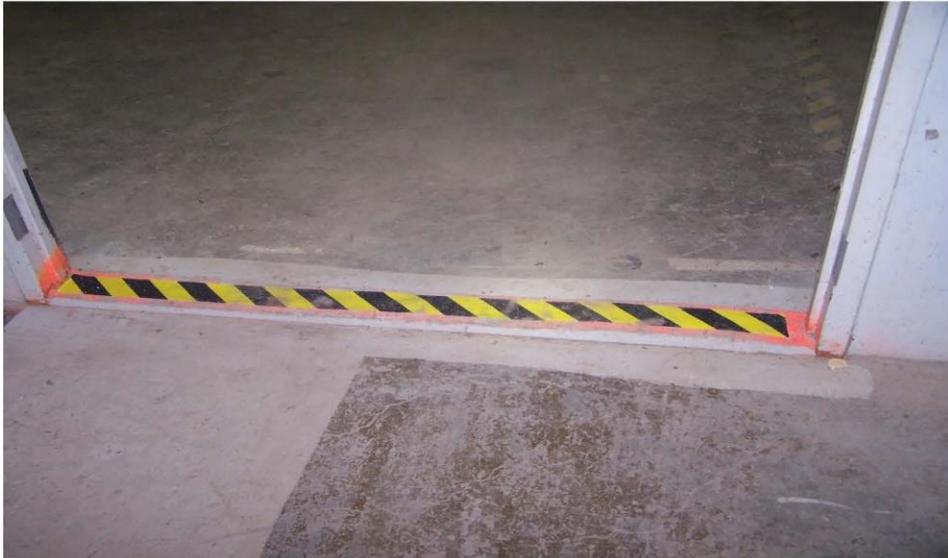
Photo 6

- Trip hazard leading into the room 503 (Painted Orange). (Photo 6)
- Numerous trip hazards and sharp edges on roof area above 109 N (many identified with orange paint, but many are not identified). (Photo 7)

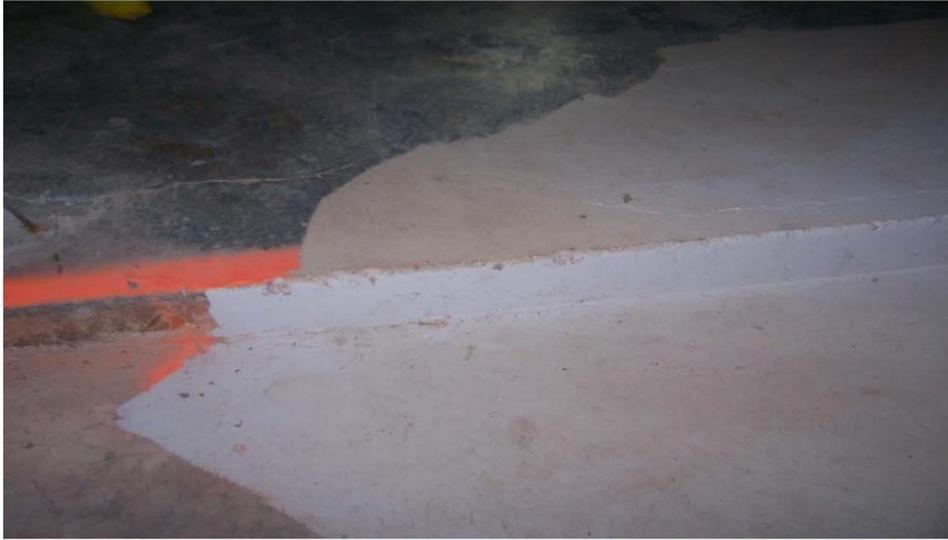
Photo 9

- Lamp burned out in room 610, with mandatory flashlights or head lamps, and other lighting in the area, this does not pose an issue at this time.
- Fire water piping running between rooms 601 and 610 is low hanging causing an overhead hazard.
- Numerous cross bracing throughout room 607 causing struck by and overhead hazards (Identified with Caution Tape). (Photo 8)
- Unexpected step down in room 607 causing a trip hazard (Painted Orange faded). (Photo 9)
- Large cable tray in the path between rooms 607 and 611. (Photo 10)

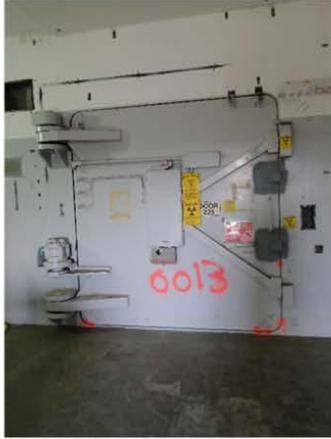
3738 Zone 1 door. welded closed yet breeze coming through

Turnover Photo #	New Photo #	Description	Area / Location	Future Inspection/Maintenance Recommendations
	3738	Zone 1 door, welded closed yet breeze coming through	105N +5'	Need to evaluate if this type of leakage is acceptable from a radiological and environmental (inside the SSE and external "release").
	3737	Zone 1 door, welded closed yet breeze coming through	105N +5'

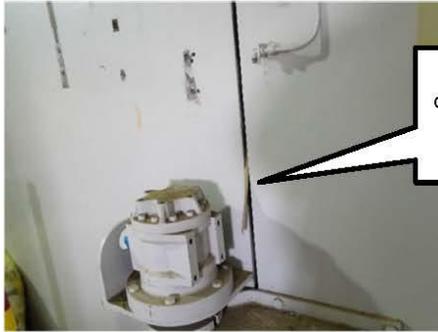
Notice piece of maslin cloth, presumable placed here at some time past to indicate air flow.

3737 Zone 1 door. welded closed yet breeze coming through

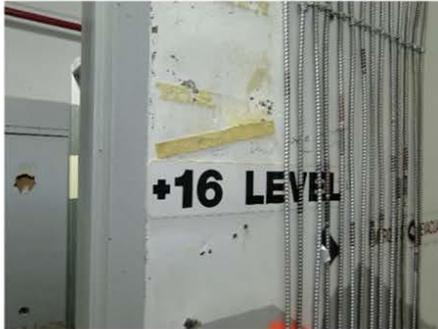
3716 S& M plan labeled 14'6" level. Needs to be changed with next S&M Plan revision

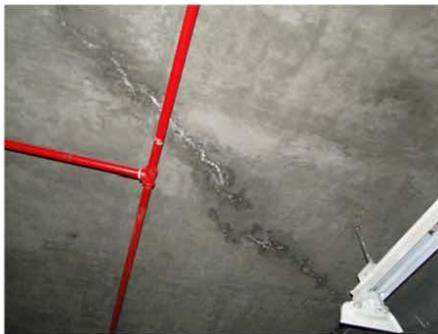
3721 Picture of possible calcium carbonate bleeding on ceiling in room 302

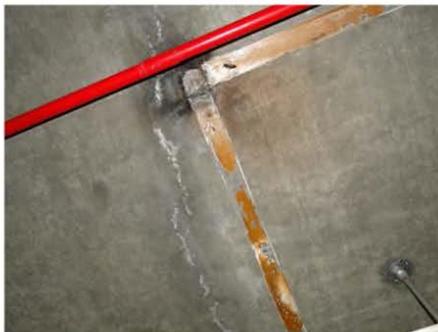
3722 Same as above

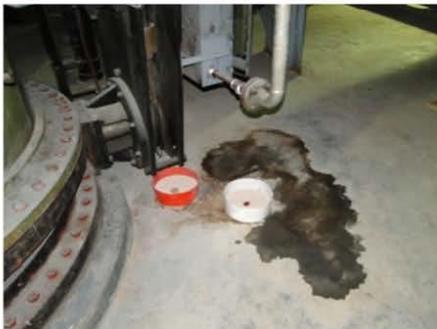
3693 Old fluid stains on floor next to containers of kitty litter. Good practice for weeping hydraulic fluids

Turnover Photo #	New Photo #	Description	Area / Location	Future Inspection/Maintenance Recommendations
422	3693	105N: Rm.#607- NE Corner at El.+60'- 6" dated 02-07-2012	105N +60'	Continue observation, good practice recommended for other weeping hydraulic / oil lines shown in photo 3693.

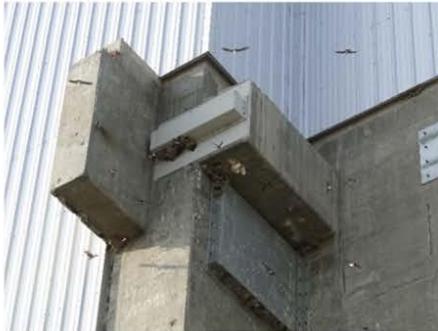
- Swallow nesting at concrete / siding junction point and in some cases (Attachment C, Photo 3682) directly on the steel plate / boxes installed as closures.

3682 Swallow nesting directly on metal caps/closures

Turnover Photo #	New Photo #	Description	Area / Location	Future Inspection/Maintenance Recommendations
	3682	Swallows nesting directly on metal caps/closures	Exterior	Continue observation for damage to any steel surfaces.
	3683	Possible water intrusion/corrosion with backfill @ door	Exterior	Consider moving soil from adjacent to doors and grading away from door sill to ensure no in-leakage and prevent accelerated corrosion of the Zone 1 doors.
	3685	Possible water intrusion/corrosion with backfill @ door	Exterior	
	3686	Possible water intrusion/corrosion with backfill @ door	Exterior

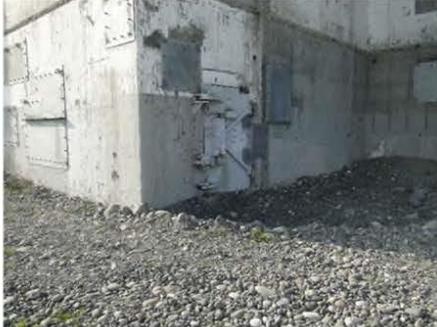
4. Possible water intrusion/corrosion from outside caused by contact with backfill at the door (Appendix F, Photo 3683).

3683 Possible water intrusion/corrosion issue w backfill over bottom sill of door

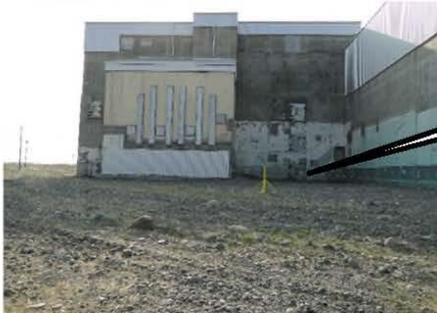
3685 Possible water intrusion/corrosion issue with backfill at door

Same location as photo
3686 below

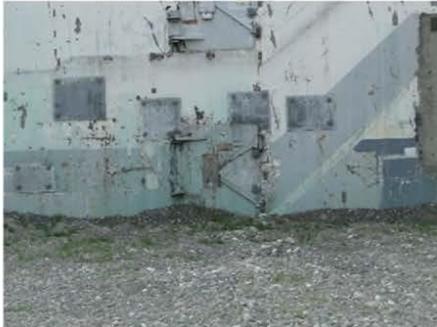
3686 Possible water intrusion/corrosion issue with backfill over the sill at this Zone 1 door

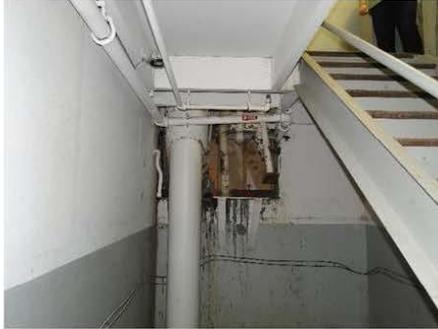
3728 4/15 - Interior pour back framing remains

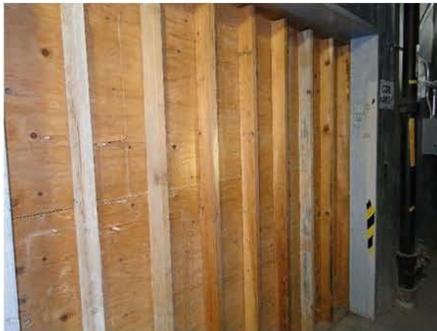
3723 Interior pour back framing remains

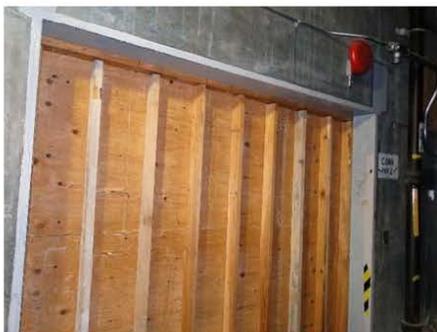
3724 Interior pour back framing remains

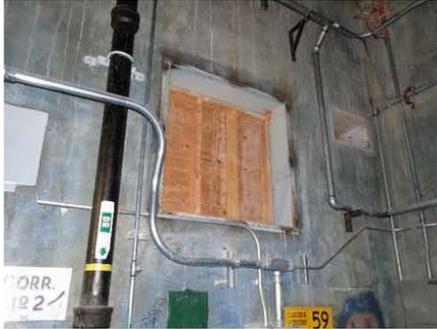
3725 Interior pour back framing remains

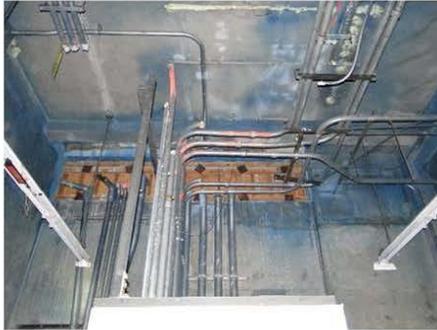
3727 Interior pour back framing remains

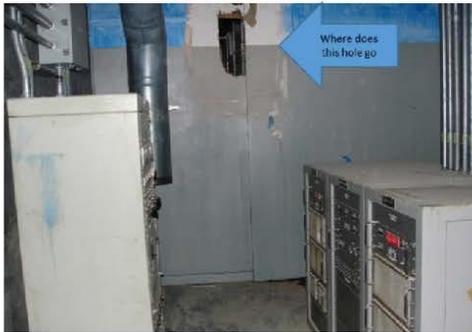
378 - 105N/Rm.#301-Looking West at El.+16'-6" dated 02-15-2012

Confirmed that this "hole" in the photo above is in a drywall partition and goes to an adjacent room on this floor.

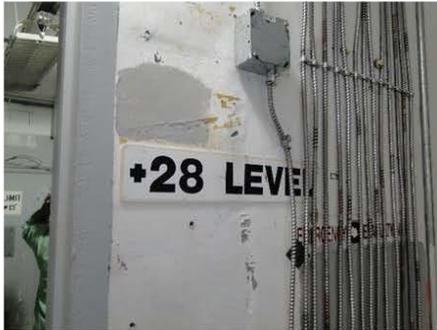
3711 Sign on wall at door entrance from stairwell

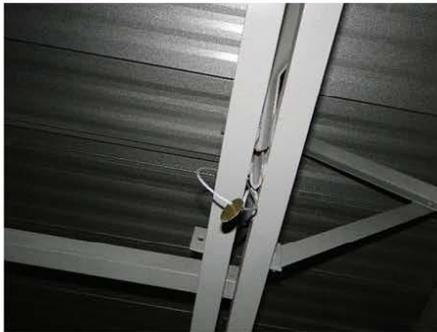
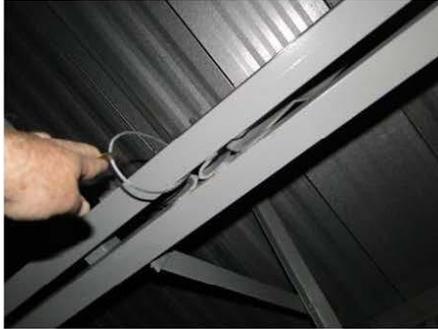
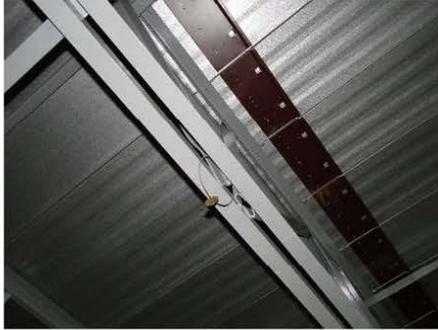
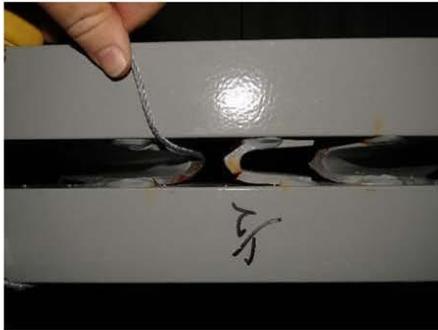
The roof joists tears noted in Ref 1 Section 3.1 were inspected, and although more rust spots which may indicate a tear were noted, thorough independent review of the vendor / constructor assessment of this item showed that these previous assessments were very conservative and no changes were visible during the 2015 visual inspections of a representative portion of these joists.

The following several photos were taken during the inspection efforts in the 109-N "attic" space for the joist tears as called out in Ref 1 Section 3 and Appendix A. As noted in Attachment A of this report, structural evaluation of the 2015 as found conditions and with review the previous evaluation documented in Ref 3, recommend this item not be continued for further inspections.

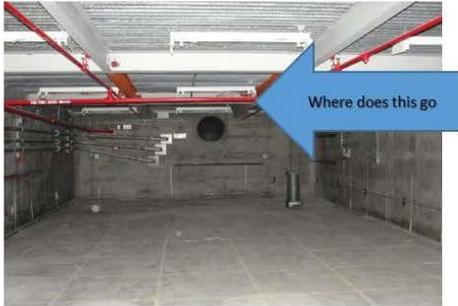
407- 105N: Rm.#602-Looking East at El.+60'-6" dated 02-07-2012

3697 – This photo and the one below shows the “hole” in photo 407 above is actually an open ventilation duct.

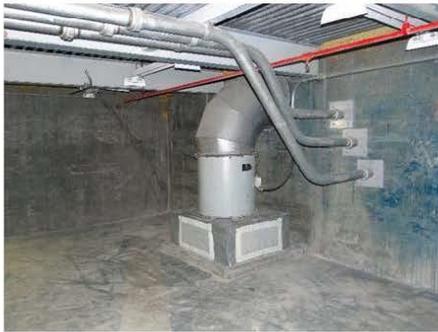
3698 – duct on the opposite side of wall from photo 3697 above

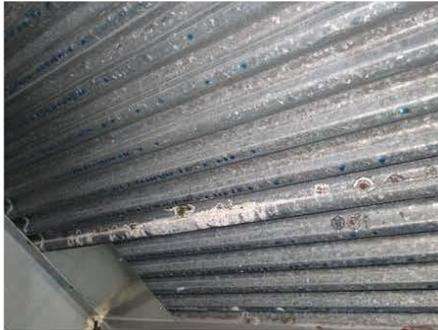
3690 Typical old roof corrosion

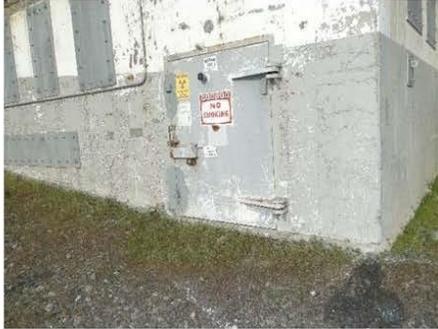
3679 Good clearance at door sill. No concern about water intrusion.

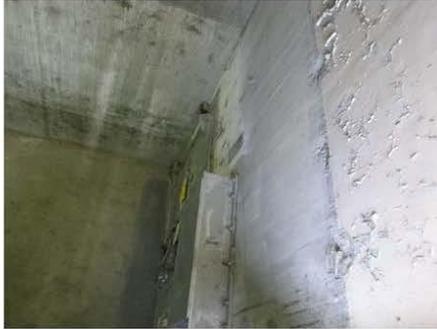
3731 109N Entrance Pit Clean and Dry

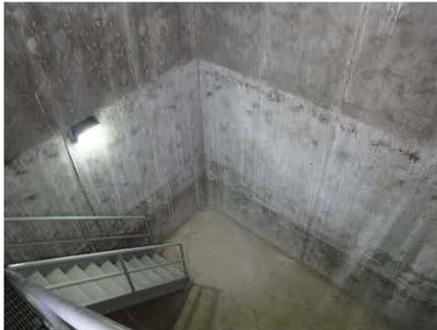
3732 109N Entrance Pit Clean and Dry

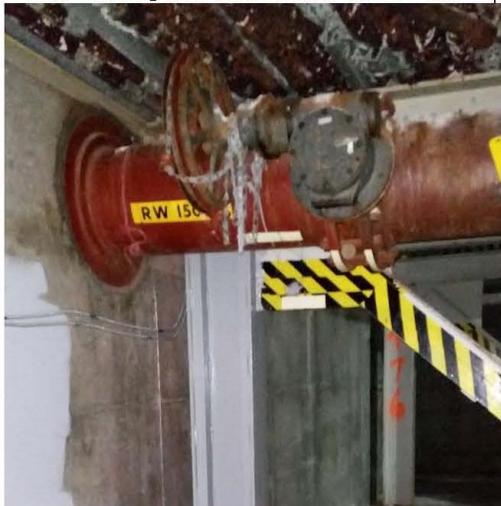
4. Ceiling Corrosion at RW Valve – 60'

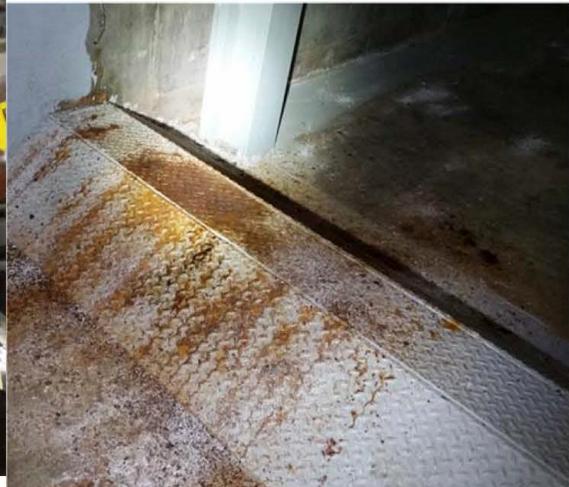
5. Floor under RW Valve – 60'

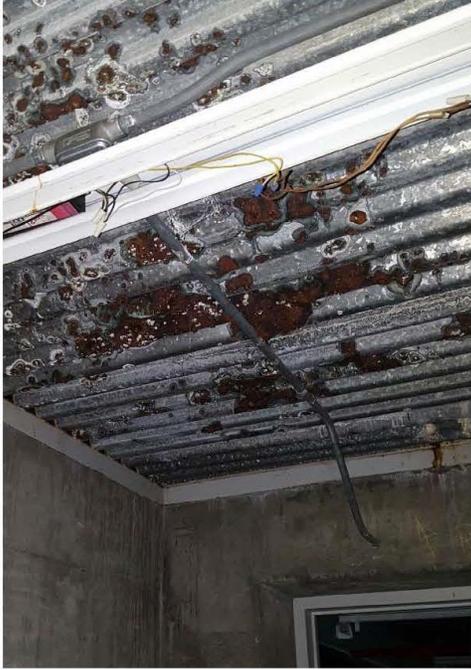
6. Ceiling in Hallway – 60'

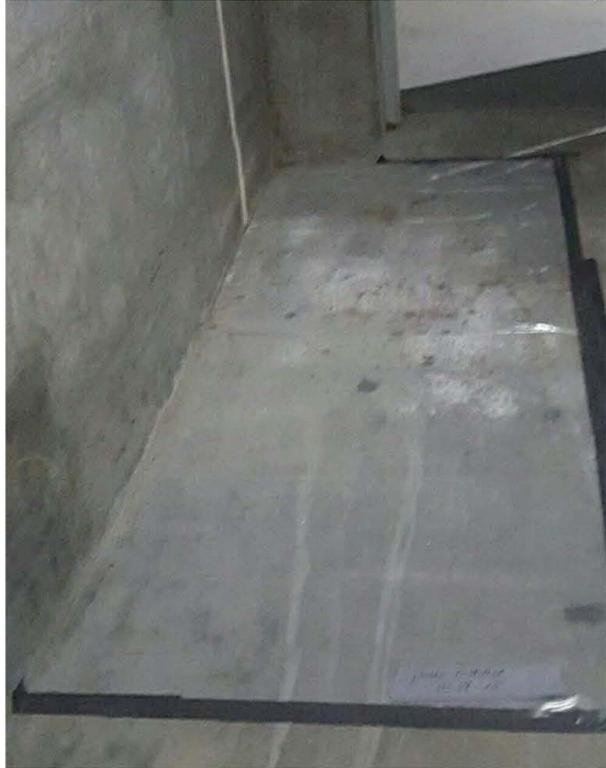
7. Floor in Hallway under Photo #6
