Five-Year Surveillance Report for the 105-DR Safe Storage Enclosure

Program/Project: Long Term Stewardship

Date Published
October 2016

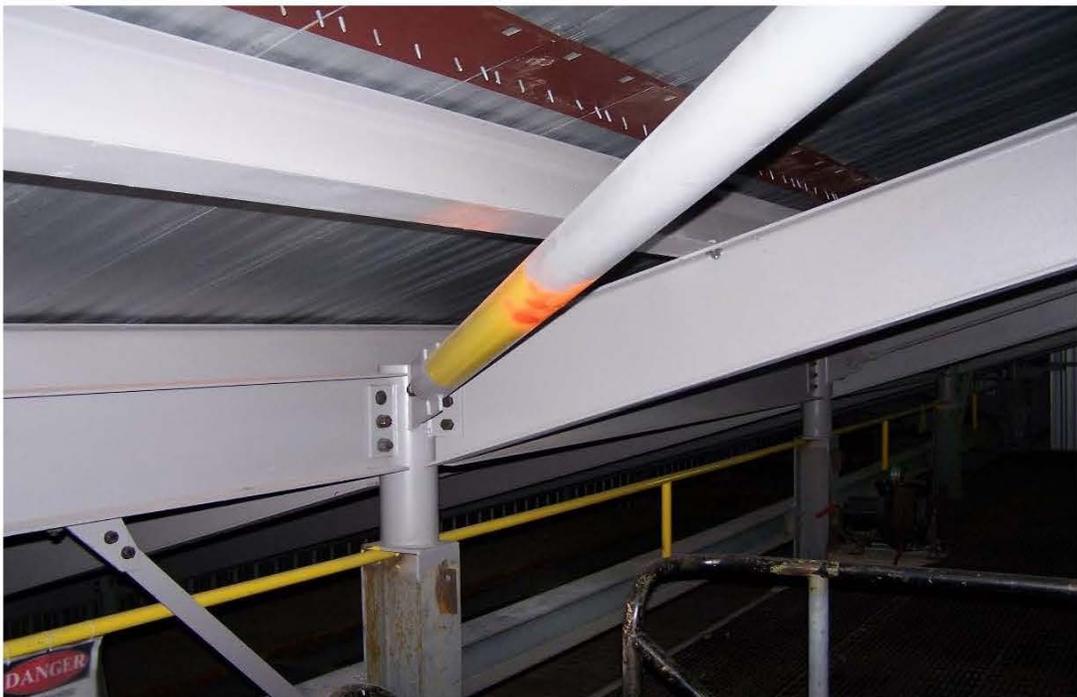
Pic 3

This reactor was left in a very similar condition to the other reactors, with very minimal findings as far as major physical hazards are concerned. There were several steps within the route stair cases that were loose, or wobbly, mostly between the 42' and 56', as well as the 56' to 80' elevations. They all seemed to be marked very well by the previous contractor so they are easy to spot, caution should be used while using these steps (Pic 1). On the 13' elevation along the west wall area, the top rail of the installed guard rail was missing posing a potential fall hazard to the level below. This area was caution taped on the next area to warn of the hazard (Pic 2). On the 56' elevation, there were two areas of concern that went out onto the "old roof" which were not delineated. These areas were caution taped in the next entry to warn of the hazard of stepping onto an uninspected roof. Lastly, upon reaching the mezzanine of the 80' elevation, there is a low hanging support for the new roof. This support is well marked (Pic 3).

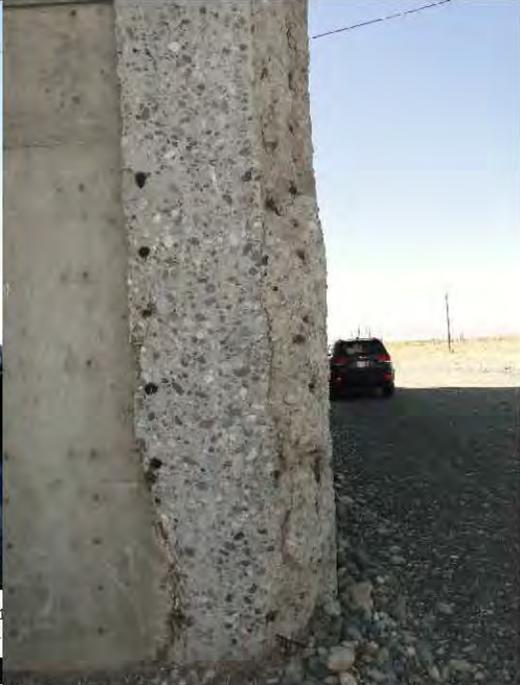
<p>2012 Exterior – Wall, Steel Cover Plates – Elev 0'-0", W Wall, Discoloration, Visible Corrosion on Plates, Existing Damage</p>	<p>DSC04133 Northwest corner of front face. Spalling of concrete on corner, no change from 2012 inspection.</p>

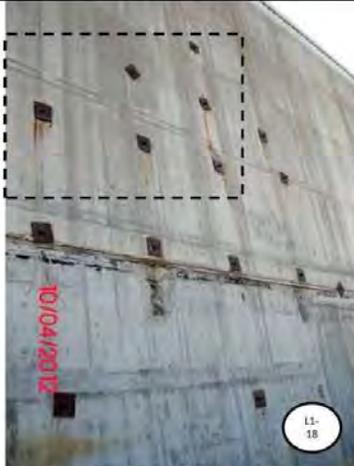
<p data-bbox="266 1486 695 1581">2012 L1-18 – Exterior – Wall, Steel Cover Plates - Elev 0'-0", W Wall, Discoloration, Visible Corrosion on Plates. Existing Damage.</p>

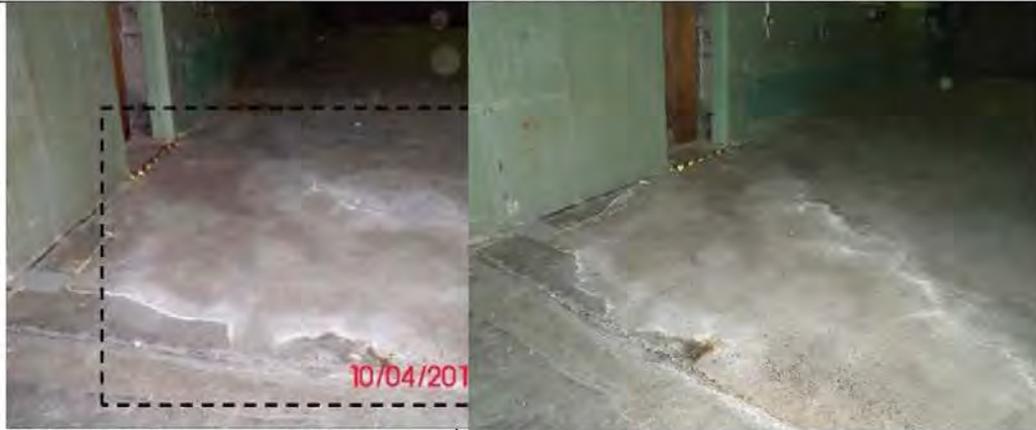
DSC04220

2012 Interior – Floor common to Door
Pourback – Elev 0'-0", W Wall, Discoloration,
Moisture Intrusion

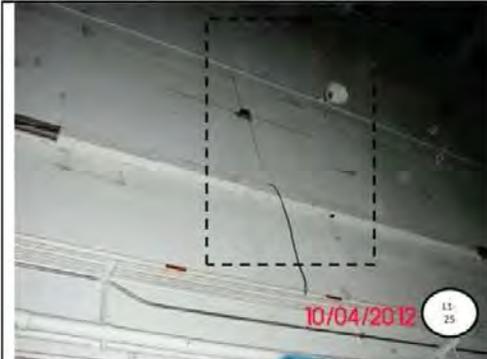
2012 Interior – Wall – Elev 0'-0", W Wall, Discoloration, Moisture Intrusion

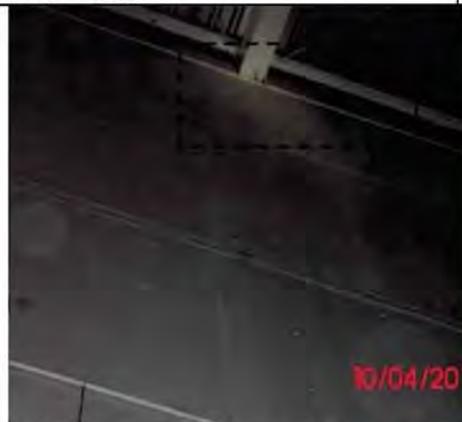
2012 Interior – Ceiling Beam and Wall – Elev 0'-0", W Wall, Discoloration and Corrosion

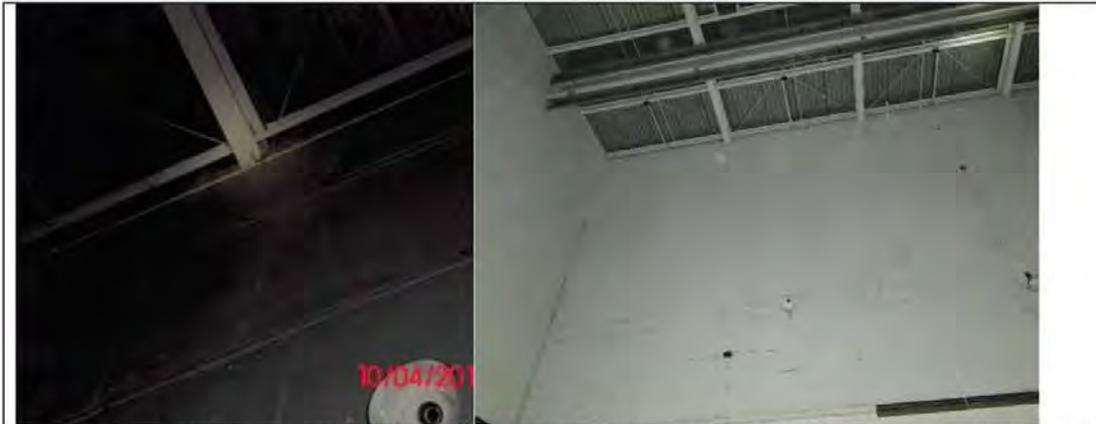
2012 Interior – Ceiling Beam and Wall – Elev 0'-0", W Wall, Discoloration and Corrosion

DSC04226 2012 inspection observed "discoloration and corrosion". 2016 walkdown concluded that corrosion was very minimal.

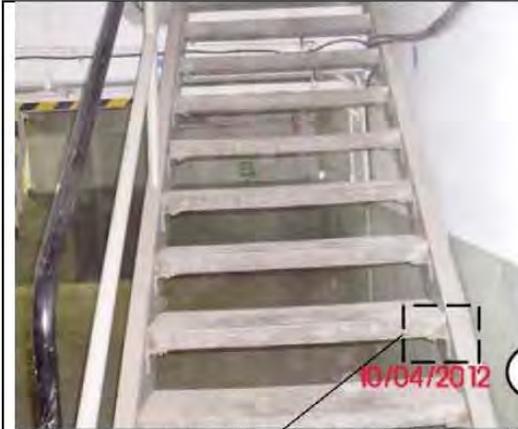
2012 Interior – Stairs – Elev (-)9th-0th, S Wall,
Deflection, Damage, Instability

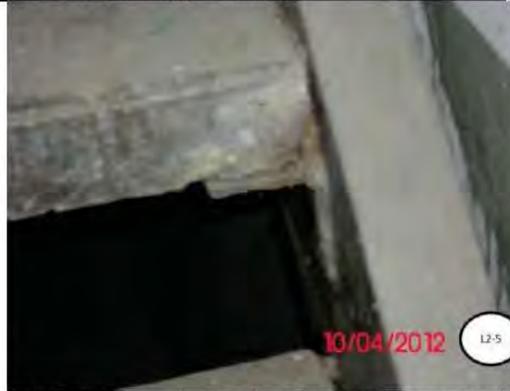
2012 Interior – Stairs Detail – Elev (-)9th-0th, S Wall,
Deflection, Damage, Instability

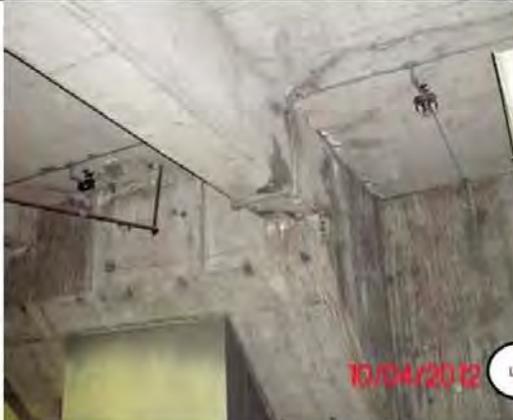
2012 Interior – Beam Ceiling – above 42' landing, Existing Discoloration

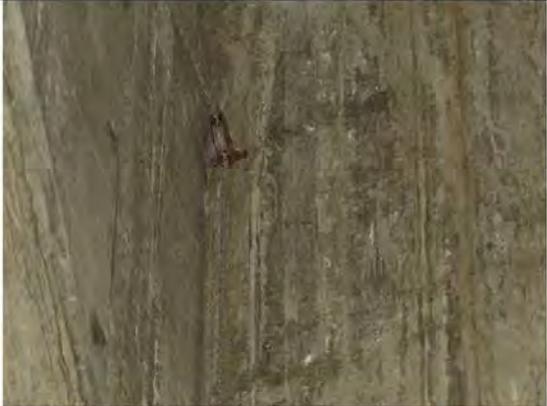
<p>DSC04180 Discoloration/staining on concrete was noted in the 2012 walkdown. Staining still exists, looks the same as in 2012.</p>

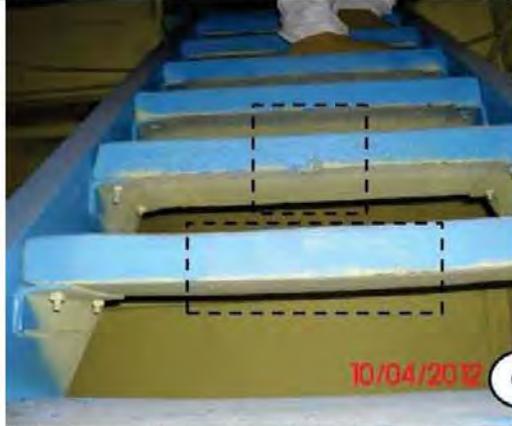
<p>2012 Interior – Stairs – Elev 42' 4-5/8", Interior, Loose Steps, crack in upper step</p>

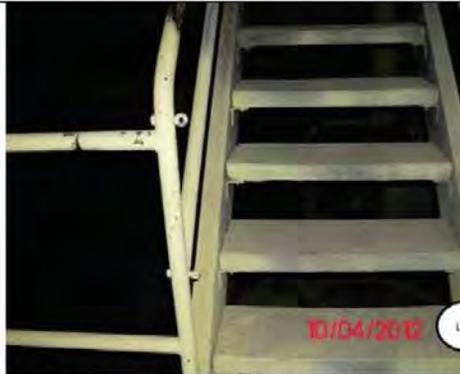
2012 Interior – Stairs – Elev 80' 5-1/4",
Interior, Crack, Loose Steps

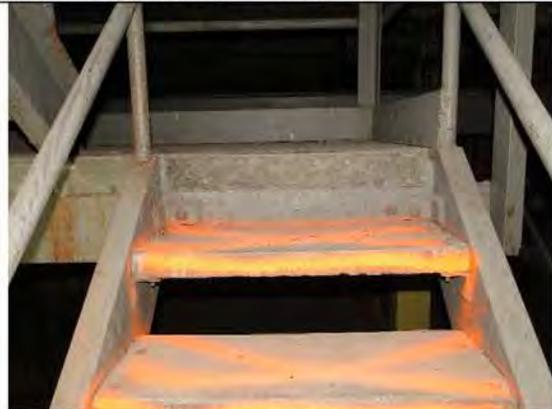
DSC04142 wobbly stairs 56 to 80 foot

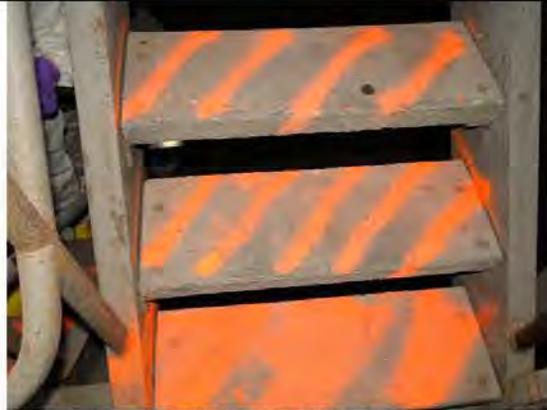
DSC04143 wobbly stairs 56 to 80 foot

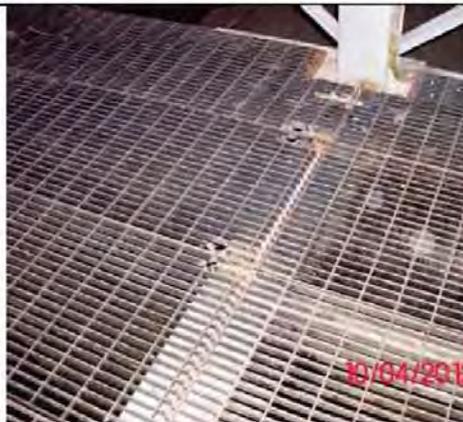
Elevation +80'

2012 Interior – Grating – Elev 80' 5-1/4",
Interior, Damage

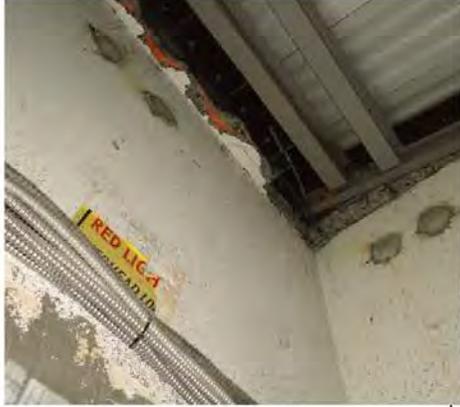
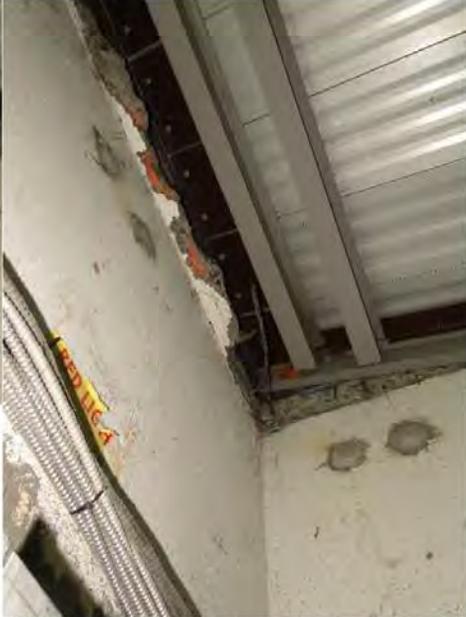
Elevation 0'

DSC40194 Vestibule NE corner under bird droppings	DSC40195 Vestibule NE corner under bird droppings

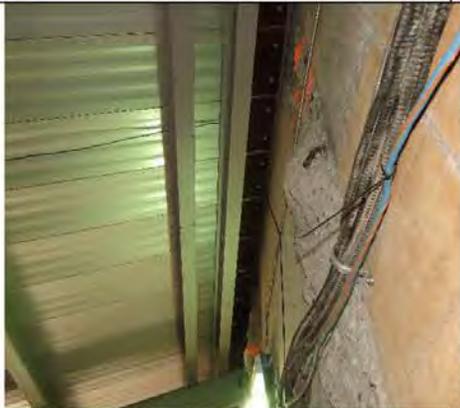
DSC40197 Vestibule	DSC40196 Vestibule

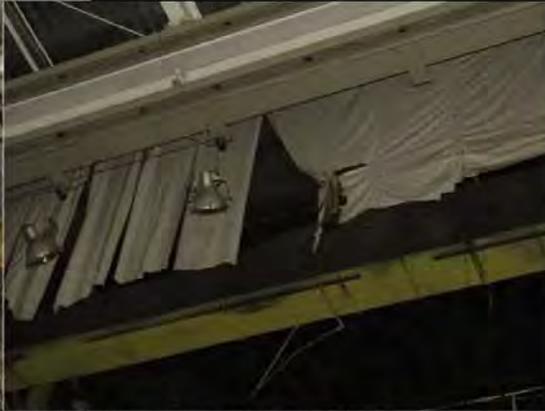
DSC40212 Bats present above front face work area, large amount of bat guano on the floor.

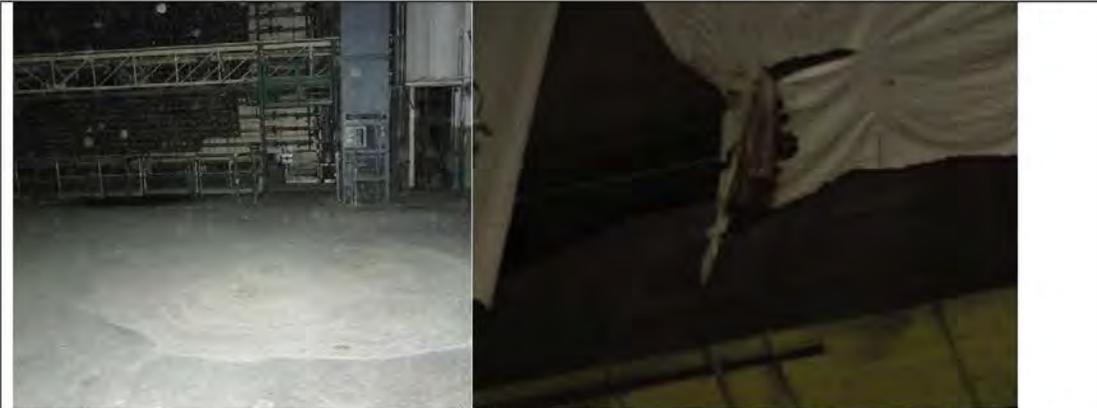
DSC40230 Front Face South moisture indication.

DSC40213 Bats present above front face work area, large amount of bat guano on the floor.

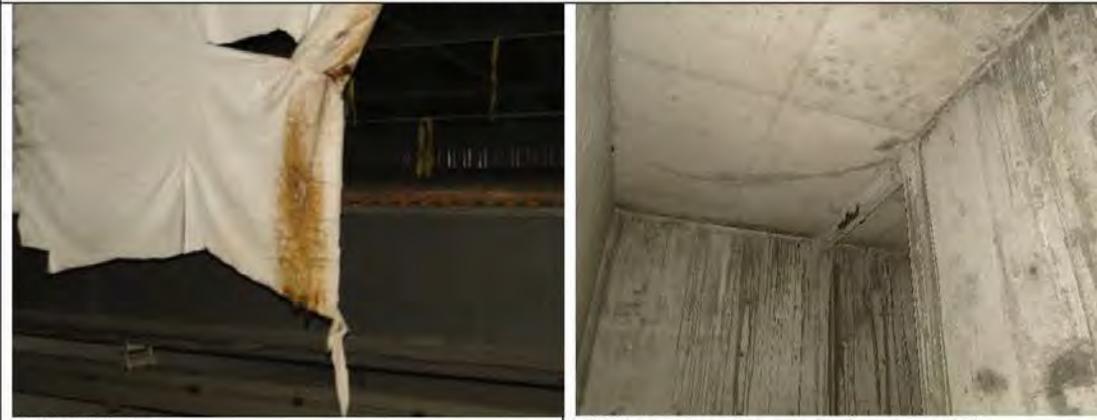
DSC04170 bats

DSC04175 bats above stairs from 42' to 24'

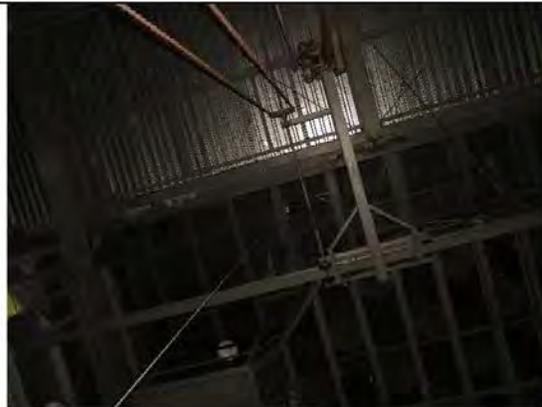
DSC04172

Three winches are leaking from above the 42' 4 5/8" level. Two areas with absorbent pads are located on the floor on the northwest side of floor. One area with absorbent pads is located on top of the top hat. Leakage appears to be very slow in all cases.

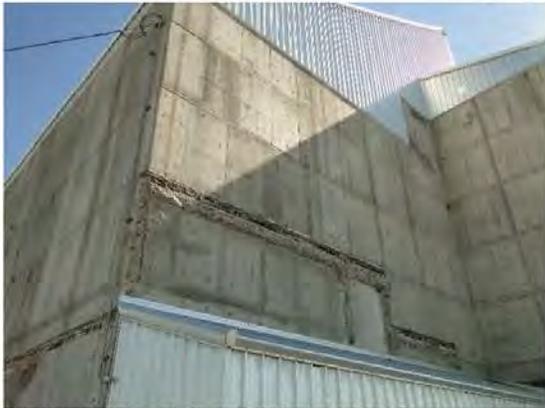
DSC04111– Elev 0'-0", SW Wall, No Visible Issues

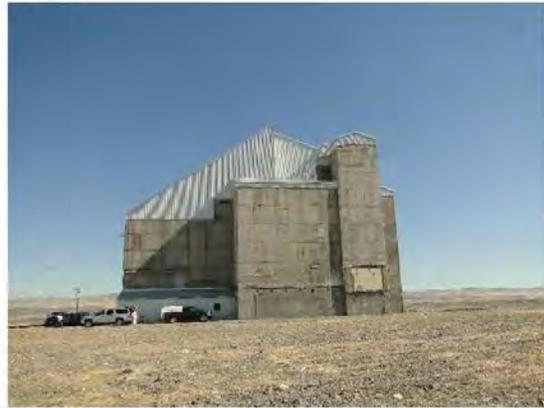
DSC04115– Elev 0'-0" SE Wall, No Visible Issues

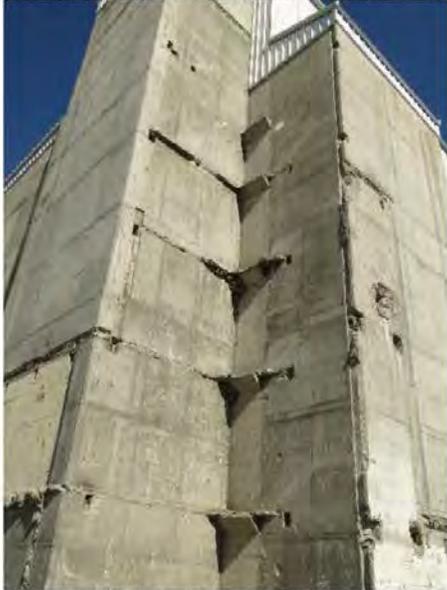
DSC04119 Elev 0'-0" SE Wall, No Visible Issues

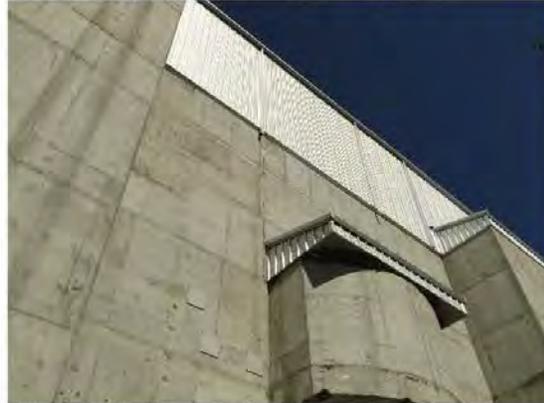
DSC04120– Elev 0'-0", E Wall, No Visible Issues

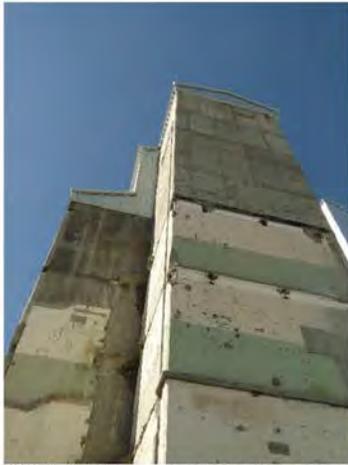
DSC04124- Elev 0'-0", NE Wall, No Visible Issues

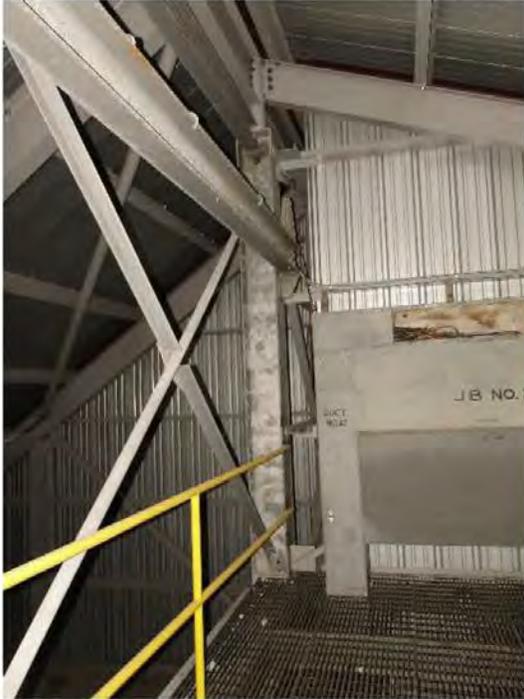
DSC04159

Elevation +80' 5"

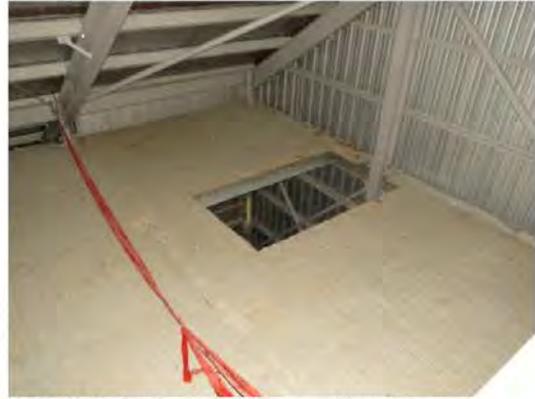
DSC04147 Infill mortar marks on old structure

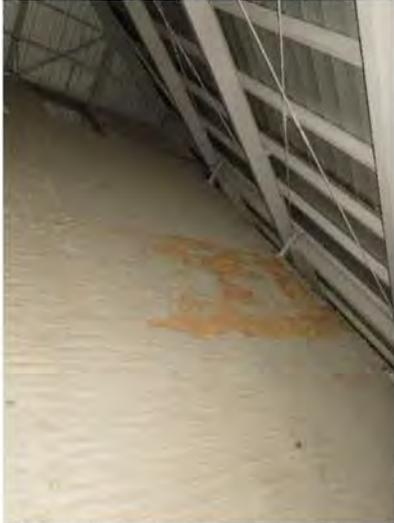
DSC04148 South old front face roof from above
